# Condition Monitoring for Controlling the Stability of the Rotating Machinery

A. Chellil, I. Gahlouz, S. Lecheb, A. Nour, S. Chellil, H. Mechakra, H. Kebir

**Abstract**—In this paper, the experimental study for the instability of a separator rotor is presented, under dynamic loading response in the harmonic analysis condition. The global measurement and analysis of vibration on the cement separator RC500 is carried, the points of measurement used are radial dots, vertical, horizontal and oblique. The measures of trends and spectral analysis for reconnaissance of the main anomalies, the main defects in the separator and manifestation, the results prove that the defects effect has a negative effect on the stability of the rotor. Experimentally the study of the rotor in transient system allowed to determine the vibratory responses due to the unbalances and various excitations.

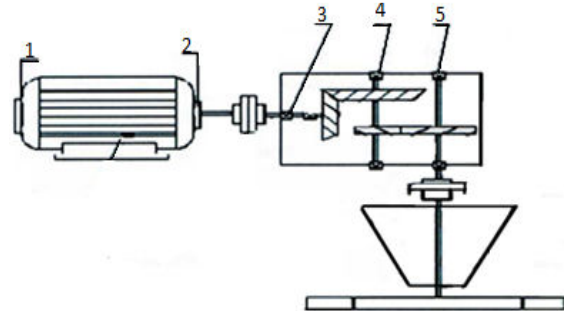
Fig. 3 Measuring points

We noticed that the vibration level by speed measurement in the bearings 02 and No. 03, in the alarm condition, requiring the intervention and the bearings 01 and No. 04 and 05 in alarm status but are acceptable and after the separator Z2 repair we noticed a reduction in the levels velocity and stabilization (correct state) in all bearings the trend curve and the spectrum defined defects in each measuring point.
