Railway Crane Accident: A Comparative Metallographic Test on Pins Fractured during Operation

Abstract—Eventually train accidents occur on railways and for some specific cases it is necessary to use a train rescue with a crane positioned under a platform wagon. These tumbled machines are collected and sent to the machine shop or scrap yard. In one of these cranes that were being used to rescue a wagon, occurred a fall of hoist due to fracture of two large pins. The two pins were collected and sent for failure analysis. This work investigates the main cause and the secondary causes for the initiation of the fatigue crack. All standard failure analysis procedures were applied, with careful evaluation of the characteristics of the material, fractured surfaces and, mainly, metallographic tests using an optical microscope to compare the geometry of the peaks and valleys of the thread of the pins and their respective seats. By metallographic analysis, it was concluded that the fatigue cracks were started from a notch (stress concentration) in the valley of the threads of the pin applied to the right side of the crane (pin 1). In this, it was verified that the peaks of the threads of the

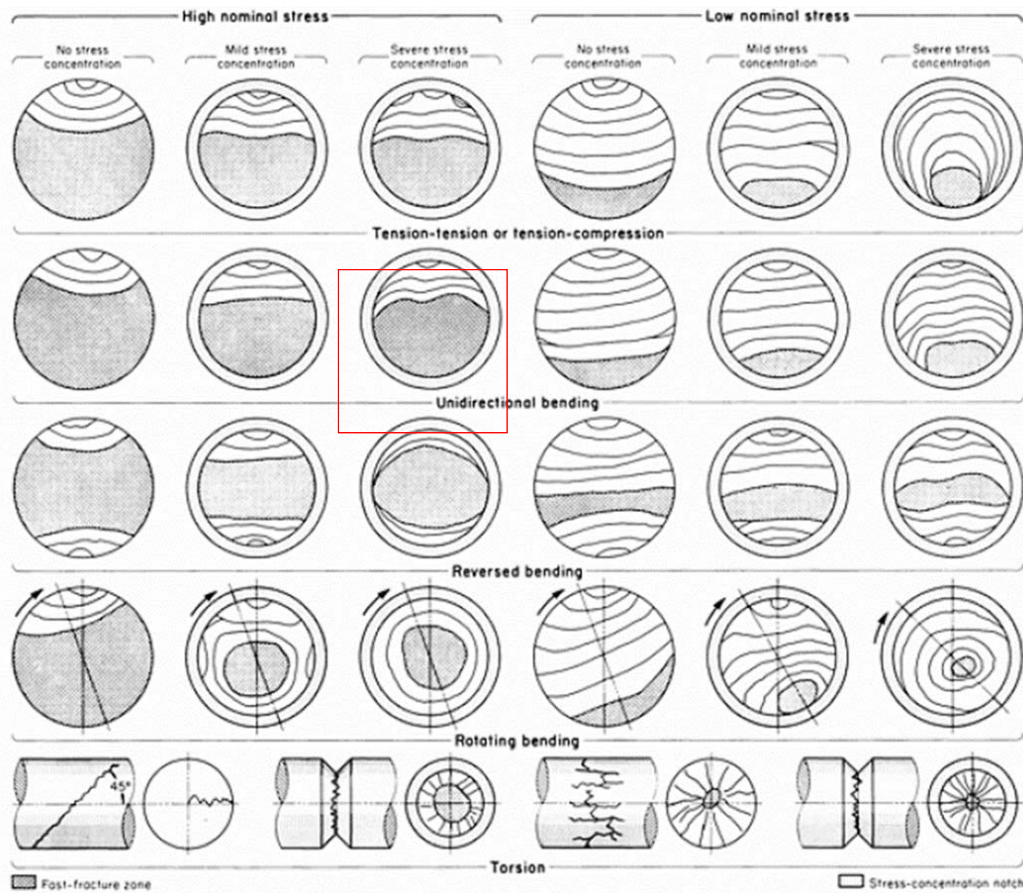
Fig. 4 Schematic diagram to aid in the definition of fatigue fracture type in components with circular cross-section [7]

The schematic drawing highlighted by the red square in Fig. 4 presented in the literature review is similar to the fracture of pin 1. This figure shows that there is a severe stress
