The High Temperature Damage of DV – 2 Turbine Blade Made from Ni – Base Superalloy

Abstract—High pressure turbine (HPT) blades of DV – 2 jet engines are made from Ni – based superalloy. This alloy was originally manufactured in the Soviet Union and referred as ŽS6K. For improving alloy's high temperature resistance are blades coated with Al – Si diffusion layer. A regular operation temperature of HPT blades vary from 705°C to 750°C depending on jet engine regime. An overcrossing working temperature range causes degradation of the protective coating as well as base material which microstructure is formed by the gamma matrix and strengthening phase gamma prime (forming small particles in the microstructure). Diffusion processes inside the material during exposition of the material to high temperatures causes mainly coarsening of the gamma prime particles, thus decreasing its strengthening effect. Degradation of the Al – Si coating caused its thickness growth. All the microstructure changes and coating layer thickness growth results in decreasing of the turbine blade operation lifetime.

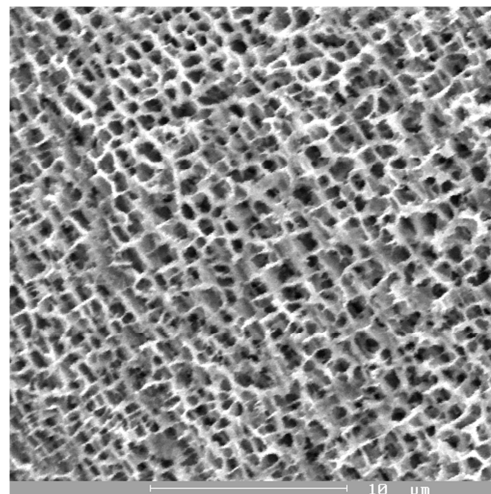
strengthening precipitates, which are a product of artificial age – hardening and has significant influence on mechanical properties and creep rupture life – so called γ' phase (gamma prime, $\text{Ni}_3(\text{Al}, \text{Ti})$ – ordered coherent precipitate phase with L1_2 structure), Fig. 2 (a).

Fig. 2 Ni – base superalloy ŽS6K: (a) morphology of γ' precipitate, as - cast, (b) eutectic cell of γ/γ' , etc. Marble, SEM

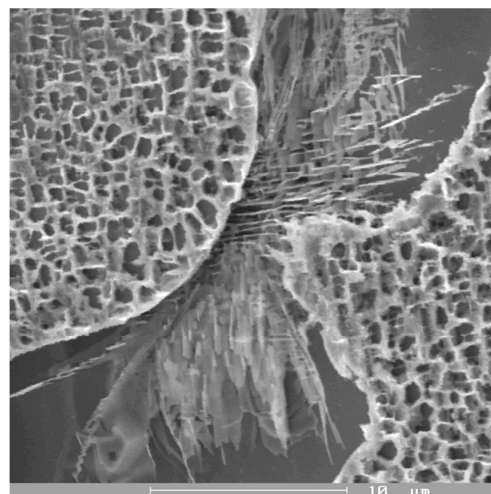
(b)

The γ' precipitates in precipitate strengthened nickel - base superalloys remain coherent up to large precipitate sizes due to the small lattice mismatch between the matrix phase γ and the γ' precipitates. The γ' precipitates are usually present in volume fractions in the range of 20÷60% depending on the alloy, with a typical precipitate size of 0.25 to 0.5 μm for high temperature applications [7]. Both of these phases, γ (gamma) and γ' (gamma prime) are also creating γ/γ' eutectic, Fig. 2 (b).

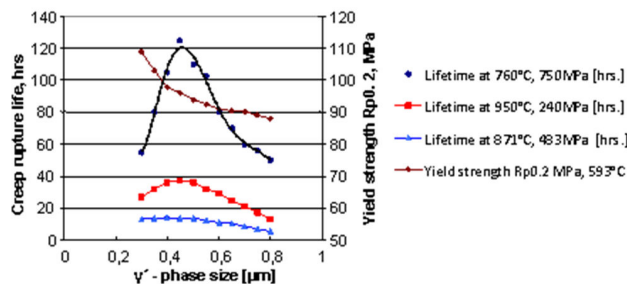
This shape and size changes cause decreasing creep rupture life of alloy, Fig. 7 [8]. As a matter of a fact, creep at high temperatures is driven mainly by diffusion mechanism and deformation rate increases with higher amount of dislocations and their easier slip, which have been previously blocked by tide distribution of cubic morphology of γ' precipitates. Coarsening and spheroiding of γ' precipitates leads to creation of wider channels between γ' particles and dislocations can easier move, so deformation of base material can propagate.

Fig. 7 Influence of γ' - phase size on mechanical properties [8]
