The Effects of Roots Action of Tropical Green Roofs—Replication of German FLL in Singapore

Abstract—Green Roofs offers numerous advantages, including lowering ambient temperature, which is of increasing interest due to global warming concerns. However, there are technical problems pertaining to waterproofing to be resolved. Currently, the only recognized green roof waterproofing test is the German standard FLL. This paper examines the potential of replicating the test in tropical climate and reducing the test duration by using pre-grown plants. A three year old sample and a new setup were used for this experimental study. The new setup was prepared with close reference to the FLL standards and was compared against the three year old sample. Results showed that the waterproofing membrane was damaged by plant roots in both setups. Joints integrity was also challenged.

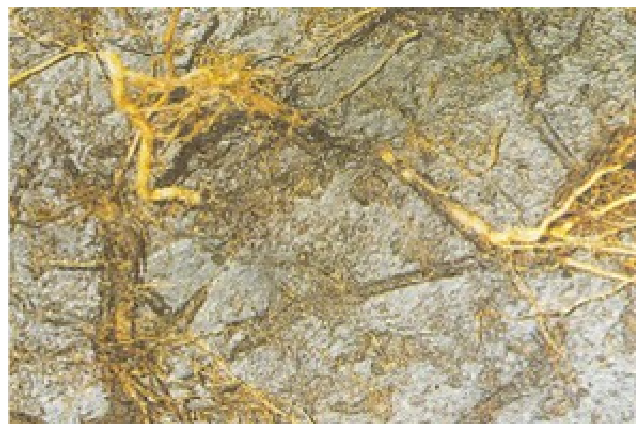
Fig. 1 Roots leaving impression on waterproofing membrane, adapted [10]

However, due to the nature of the construction industry and the scale of building projects, it is almost impossible for a building to be defect free, including green roofs. Defect on green roof waterproofing membranes are reported in [10], as shown in fig. 1.

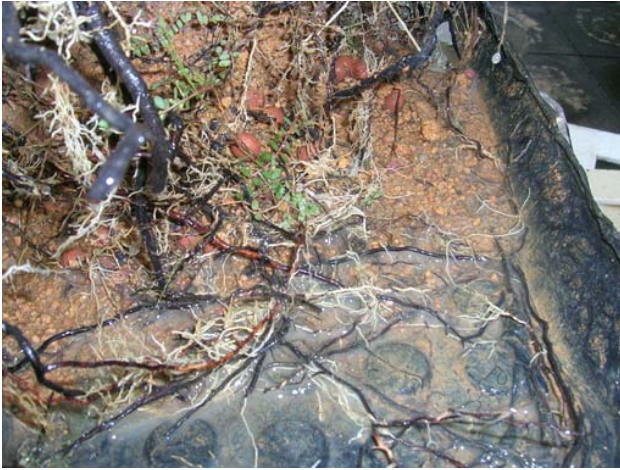
Fig. 5 Secondary roots spreading on membrane surface

From fig. 5, coverage of secondary roots on the membrane was about 15%. This shows that main roots did not force its way across a membrane; main roots will grow above and do not damage the membrane.

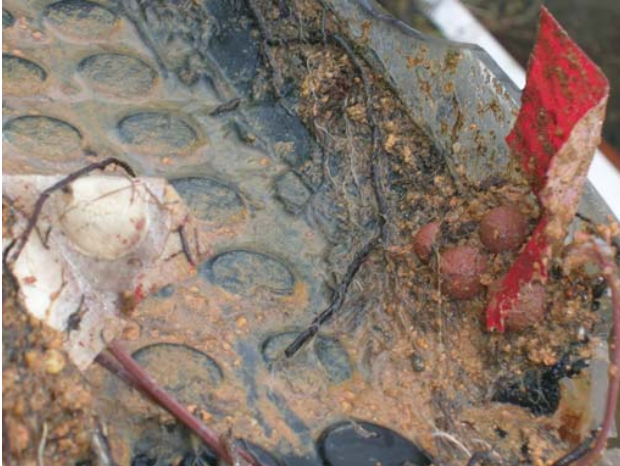
Fig. 6 Roots seemed to have grown into the liquid applied waterproofing at the edge

Roots did not grow into the membrane at this area but did seem to grow into the liquid applied waterproofing material used to seal the edges of the sample box. However, there was no evidence of outright penetration as seen in fig. 6.

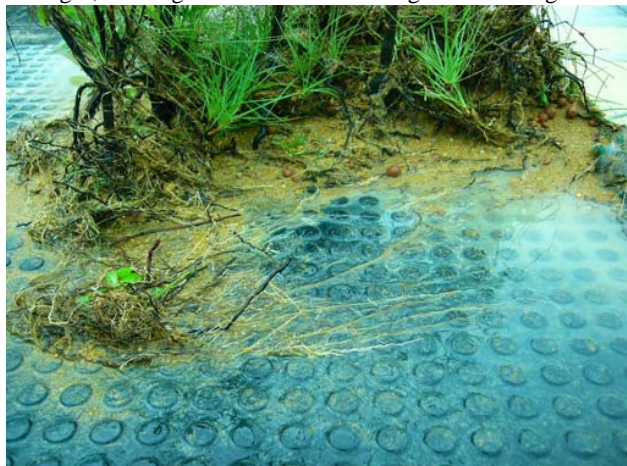
Fig. 8 Roots left on the membrane after some erosion; the plants are removed whereas roots which have anchored on the membrane are cut from the plant

From fig. 8, minor roots which seemed to have anchored on the membrane can be seen. The coverage of these roots was about 40%. Though at closer examination, there was no sign of damages, the long term effect of anchorage cannot be ignored.
