Retrofitting of Beam-Column Joint Using CFRP and Steel Plate

Abstract—This paper presents the retrofitting of beam-column joint using CFRP (Carbon Fiber Reinforced Polymer) and steel plate. This specimen was tested until failure up to 1.0% drift. This joint suffered severe damages and diagonal cracks at upper crack at upper column before retrofitted. CFRP were wrapped at corbel, bottom and top of the column. Steel plates with bonding were attached to the two beams and the jointing system. This retrofitted specimen is tested again under lateral cyclic loading up to 1.75% drift. Visual observations show that the cracks started at joint when 0.5% drift applied at top of column. Damage of retrofitted beam-column joint occurred inside the CFRP and it cannot be seen from outside. Analysis of elastic stiffness, lateral strength, ductility, hysteresis loops and equivalent viscous damping shows that these values are higher than before retrofitting. Therefore, it is recommended to use this type of retrofitting method for beam-column joint with corbel which suffers severe damage after the earthquake.

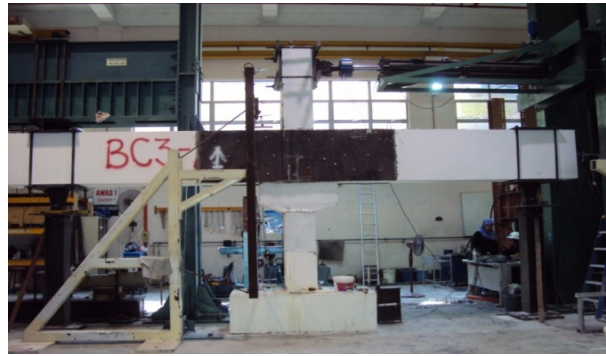
Fig. 2 The specimen BC-23ER is ready for testing

After the crack was repaired, the steel plate was then bolted to both side of the joint region using 23 stainless steel M16 anchor. Before the plate is attached to the specimen, fifteen holes with size of 16mm were drilled on the beam surface. After that, the plates were bonded to the beam-column joint and bolted with the anchor bolts. Fig. 2 shows the specimen BC-23ER after retrofitted with CFRP and steel plate bonding which is ready for testing.

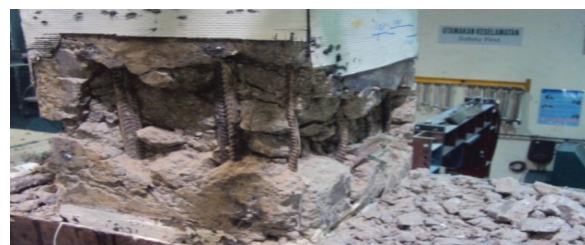
Fig. 6 Damages on BC-23ER; (a) large tear and; (b) bended reinforcement after $\pm 1.75\%$ drift after retrofitting

Fig. 5 shows the diagonal shear crack at top column after $\pm 1.0\%$ drift before retrofitting. During retesting, there are no visible hairline cracks or tearing of the CFRP sheet on the beam and column at 0.01% drift to 0.5% drift. The formation of crack can only be seen along the interface of the column to beam at 0.6% drift. At 1.5% , minor spalling of concrete started to shown at the corner of the side of the column. When the drift is increased up to 1.75% drift, the column failed and tears the CFRP layers showing the large crack and spalling of concrete under the layers to tear completely. At this point, the specimen experienced a complete disintegration at the top column. The test revealed that the reinforcement bar has bended which causes the failing of the top column as shown in Fig. 6.
