# Ageing Deterioration of High-Density Polyethylene Cable Spacer under Salt Water Dip Wheel Test

**Abstract**—This paper presents the experimental results of high-density polyethylene cable spacers for 22 kV distribution systems under salt water dip wheel test based on IEC 62217. The strength of anti-tracking and anti-erosion of cable spacer surface was studied in this study. During the test, dry band arc and corona discharge were observed on cable spacer surface. After 30,000 cycles of salt water dip wheel test, obviously surface erosion and tracking were observed especially on the ground end. Chemical analysis results by fourier transforms infrared spectroscopy showed chemical changed from oxidation and carbonization reaction on tested cable spacer. Increasing of C=O and C=C bonds confirmed occurrence of these reactions.

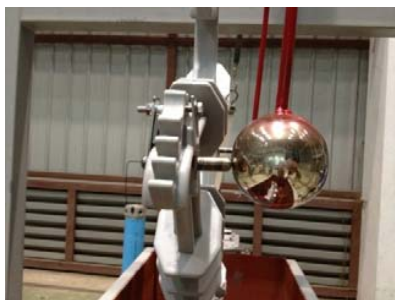
Four items of cable spacers were installed on the wheel as shown in Fig. 2. Only two phases near ground end were energized. Voltage was energized via stainless rods and stainless sphere as shown in Fig. 3

Fig. 3 Voltage Energized via Stainless Rod and Stainless Sphere
