# Image Distortion Correction Method of 2-MHz Side Scan Sonar for Underwater Structure Inspection

**Abstract**—The 2-MHz Side Scan SONAR (SSS) attached to the boat for inspection of underwater structures is affected by shaking. It is difficult to determine the exact scale of damage of structure. In this study, a motion sensor is attached to the inside of the 2-MHz SSS to get roll, pitch, and yaw direction data, and developed the image stabilization tool to correct the sonar image. We checked that reliable data can be obtained with an average error rate of 1.99% between the measured value and the actual distance through experiment. It is possible to get the accurate sonar data to inspect damage in underwater structure.

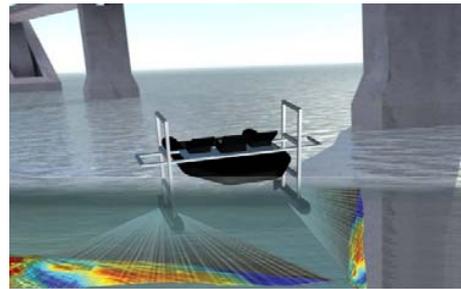
Fig. 1 Underwater Investigation using SS

that occurs during the operation, and to visualize the filtered image through the image stabilization algorithm. Figs. 1 and 2 show the underwater exploration of the SSS.

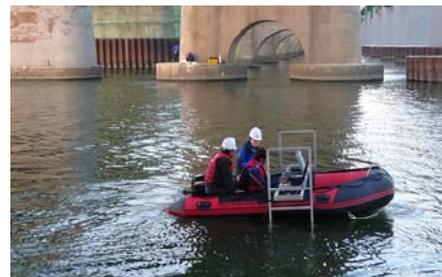
Fig. 2 Underwater structure survey using SSS

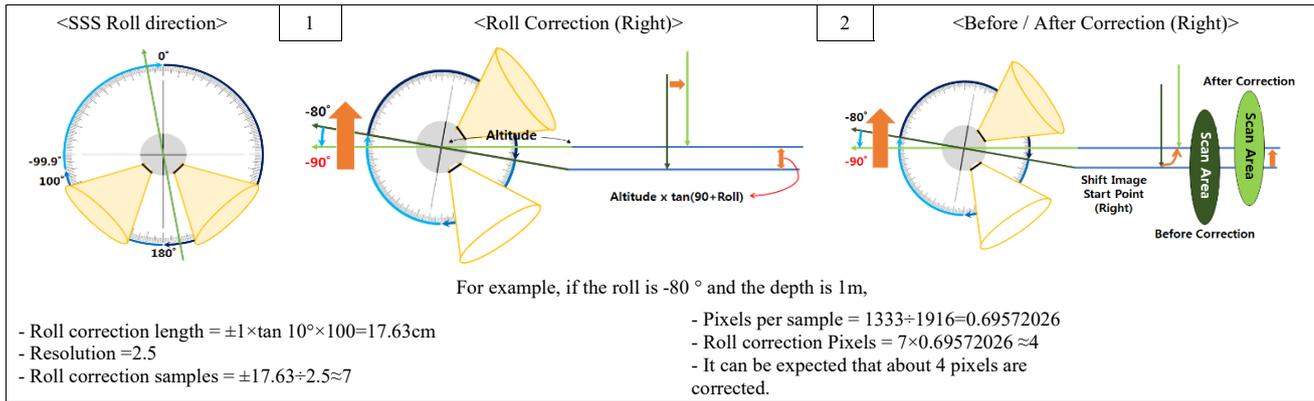
Fig. 5 Image stabilization range and design according to roll range

The SSS is bound to the boat and acquires a 2D image in accordance with the direction of the boat. The roll range is '+0° ~ +180°' in the right direction and '-0° ~ -99.9° and +100° ~ +180°' in the left direction. When the roll range is from -80° to -99.9° and from +100° to +104° to the left, the right side is scanned because the lower side is pointing to the right. Fig. 5 shows schematically the range of shake correction and design method according to the roll range [6].

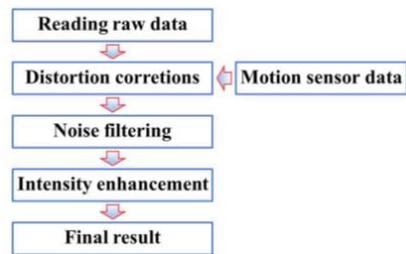
(a) Image correction algorithm Flow Chart

Fig. 6 Image stabilization tool design [5]

The SSS used in this study consists of two programs: RealScan, which is an operating program, and PostScan, which is a post-processing program. The operating program (RealScan) receives the signal information acquired from the towfish by cable and displays it in real time through the monitor of the Deck Unit. It is a program that receives, processes, outputs and stores sonar signals. The post-processing program (PostScan) is a program that analyzes the acquired data. It contains a number of functions for confirming data information such as GPS correction position confirmation, tilt distance correction, mosaic, and altitude information correction. The image stabilization tool developed a UI to incorporate it into a postscan program. The image stabilization tool through UI design is shown in Fig. 6 [7].

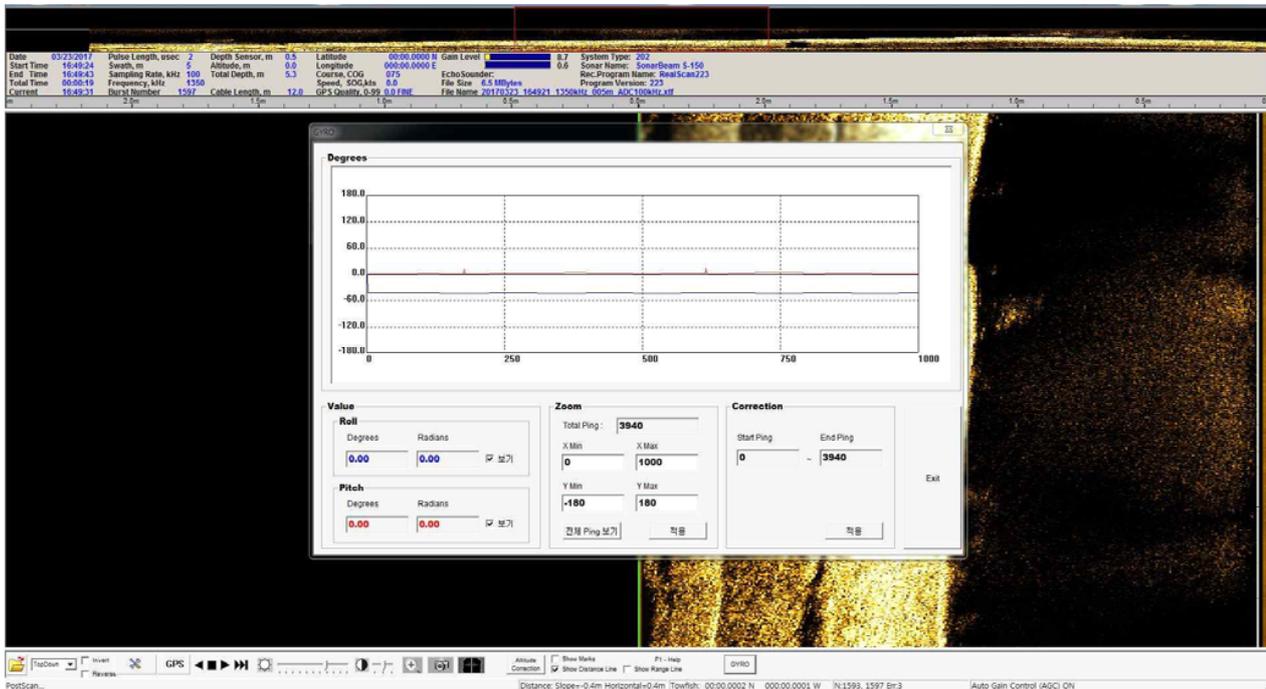
(b) PostScan Tool

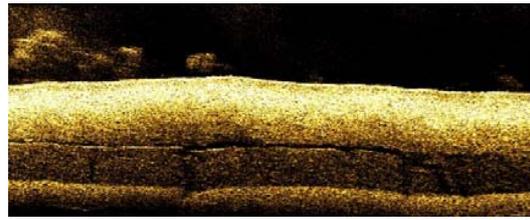
Fig. 7 2-MHz Sonar data before correction

The block joint of the gravity type quaywall structure was scanned using the developed 2-MHz sonar as shown in Fig. 7. As mentioned above, since the boat and the sonar are all acting together, it is seen that the shape of the gravity type block is distorted because of the shaking caused by the rolling phenomenon of the boat by the wave and the operation of inexperienced boat drivers. The roll, pitch and yaw directions obtained from the motion sensor were analyzed, and the data were subjected to image stabilization. As a result, the corrected data were obtained as shown in Fig. 8. It is confirmed that the

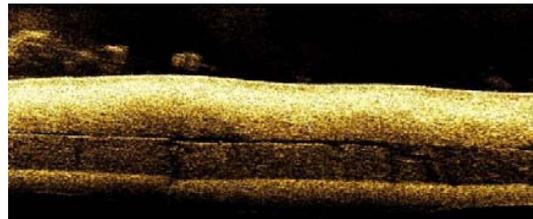
Fig. 8 2-MHz Sonar data after correction

joint shape of the block is corrected to a straight line shape.

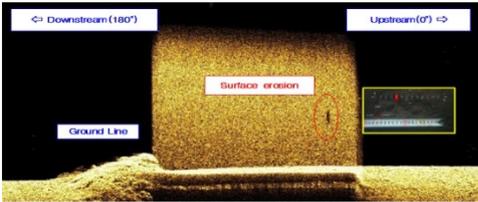
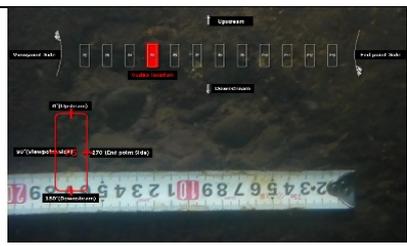
TABLE III  
COMPARISON OF SONAR DATA AND DAMAGE THROUGH MOTION SENSOR

| Case | Bridge location | PostScan confirmation video | Diver confirmation video | Error factor |
|---|---|---|--|---|
| Damage occurred | P5- 270°<br>(End point side) | Difference length (L=0.21m)<br>Depth of water :3.0m | #3. Difference length (L=0.20m)<br>Depth of water :3.0m | 5%<br>0% |

Fig. 6 shows the towfish with the motion sensor and the field survey logarithm. Table III is one of the samples and shows the sonar data corrected by the motion sensor and the damage comparison method.

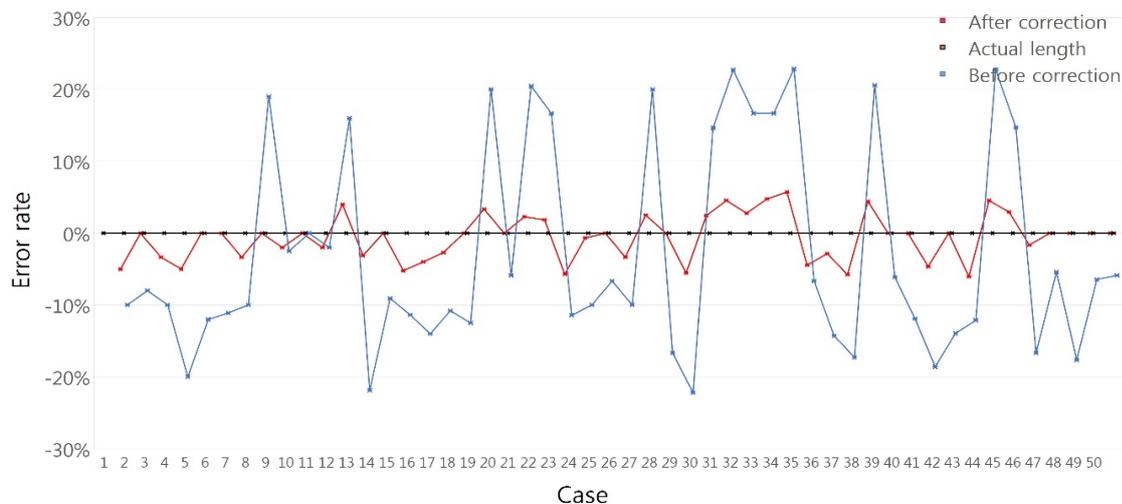
Fig. 9 Error rate comparison between before image stabilization and after image stabilization

The field survey showed the error rate according to the presence or absence of the motion sensor during the SSS sonography. As mentioned above, we compared the pre-corrected sonic image with no motion sensor and the corrected sonic image with motion sensor. We also measured the actual damage length and depth by putting the diver into the suspected damage part. As a result of checking the SSS Sonar images before and after image stabilization, the average error rates were 12.43% and 1.99%, respectively, and the error rate was reduced by 10.43% by using the image stabilization. Table IV shows the field error rate with and without motion sensor. Fig. 9 shows the distribution of error rates for 50 samples before and after correction. The error range before the image stabilization showed 23.79% at -23.50% and the error range after the image stabilization was 7.69% at -7.14%.
