Comparison of Double Unit Tunnel Form Building before and after Repair and Retrofit under in-Plane Cyclic Loading

Abstract—This paper present the experimental work of double unit tunnel form building (TFB) subjected to in-plane lateral cyclic loading. A one third scale of 3-storey double unit of TFB is tested until its strength degradation. Then, the TFB is repaired and retrofitted using additional shear wall, steel angle and CFRP sheet. The crack patterns, lateral strength, stiffness, ductility and equivalent viscous damping (EVD) were analyzed and compared before and after repair and retrofit. The result indicates that the lateral strength increases by 22% in pushing and 27% in pulling direction. Moreover, the stiffness and ductility obtained before and after retrofit increase tremendously by 87.87% and 39.66%, respectively. Meanwhile, the energy absorption measured by equivalent viscous damping obtained after retrofit increase by 12.34% in pulling direction. It can be concluded that the proposed retrofit method is capable to increase the lateral strength capacity, stiffness and energy absorption of double unit TFB.

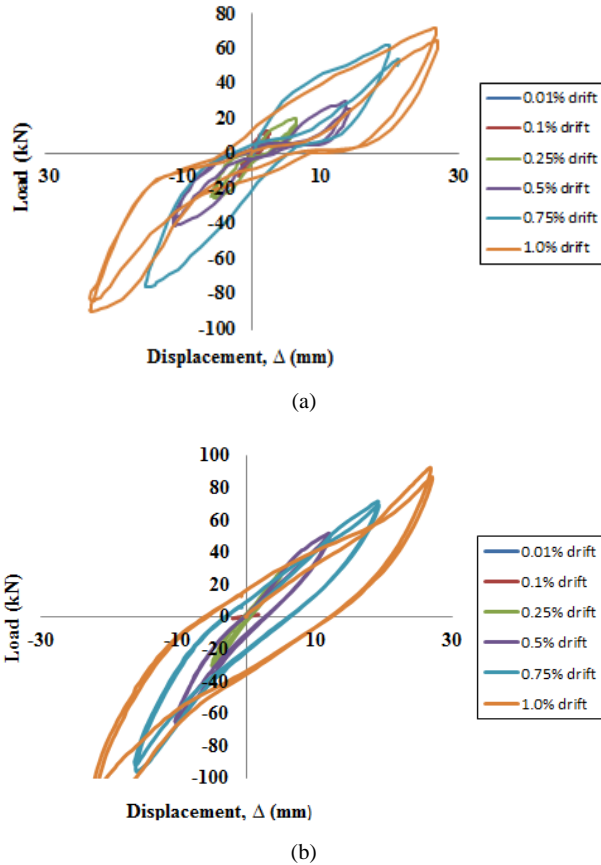
Fig. 2 Hysteresis loop (a) before retrofitting and (b) after retrofitting

Fig. 2 shows the comparison of hysteresis loop of tunnel form building before and after retrofitting up to $\pm 1.0\%$ drift. The enclosed hysteresis loops after retrofitting is bigger than the hysteresis loop before retrofitting. The usage of additional shear wall, angle steel and CFRP sheet give a higher value of lateral strength as compared before retrofitting. The greater

increment of lateral load obtained from the first cycle in pushing direction after retrofitting is 90kN as compared before retrofitting of 70kN. A similar pattern in pulling direction (first cycle) where the lateral load after retrofitting is higher (98kN) than before retrofitting (72kN). It indicates that this retrofit method could increase the lateral strength capacity of TFB in pushing and pulling direction for the first and second cycle.
