Image Distortion Correction Method of 2-MHz Side Scan Sonar for Underwater Structure Inspection

Abstract—The 2-MHz Side Scan SONAR (SSS) attached to the boat for inspection of underwater structures is affected by shaking. It is difficult to determine the exact scale of damage of structure. In this study, a motion sensor is attached to the inside of the 2-MHz SSS to get roll, pitch, and yaw direction data, and developed the image stabilization tool to correct the sonar image. We checked that reliable data can be obtained with an average error rate of 1.99% between the measured value and the actual distance through experiment. It is possible to get the accurate sonar data to inspect damage in underwater structure.

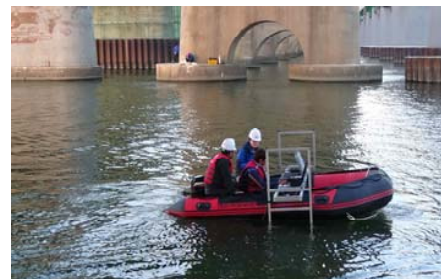
Fig. 2 Underwater structure survey using SSS

that occurs during the operation, and to visualize the filtered image through the image stabilization algorithm. Figs. 1 and 2 show the underwater exploration of the SSS.

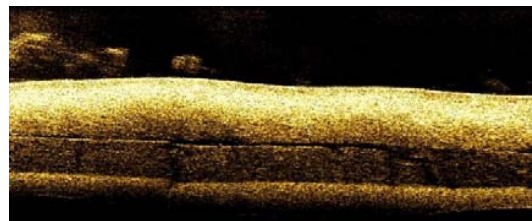
Fig. 8 2-MHz Sonar data after correction

The block joint of the gravity type quaywall structure was scanned using the developed 2-MHz sonar as shown in Fig. 7. As mentioned above, since the boat and the sonar are all acting together, it is seen that the shape of the gravity type block is distorted because of the shaking caused by the rolling phenomenon of the boat by the wave and the operation of inexperienced boat drivers. The roll, pitch and yaw directions obtained from the motion sensor were analyzed, and the data were subjected to image stabilization. As a result, the corrected data were obtained as shown in Fig. 8. It is confirmed that the

joint shape of the block is corrected to a straight line shape.
