Analyses of Wear Mechanisms Occurring During Machining of the Titanium Alloy Ti-6Al-2Sn-4Zr-6Mo

Abstract—Titanium alloys like the modern alloy Ti 6Al 2Sn 4Zr 6Mo (Ti-6246) combine excellent specific mechanical properties and corrosion resistance. On the other hand, due to their material characteristics, machining of these alloys is difficult to perform. The aim of the current study is the analyses of wear mechanisms of coated cemented carbide tools applied in orthogonal cutting experiments of Ti-6246 alloy. Round bars were machined with standard coated tools in dry conditions on a CNC lathe using a wide range of cutting speeds and cutting depths. Tool wear mechanisms were afterwards investigated by means of stereo microscopy, optical microscopy, confocal microscopy and scanning electron microscopy. Wear mechanisms included fracture of the tool tip (total failure) and abrasion. Specific wear features like crater wear, micro cracks and built-up edge formation appeared depending of the mechanical and thermal conditions generated in the workpiece surface by the cutting action.

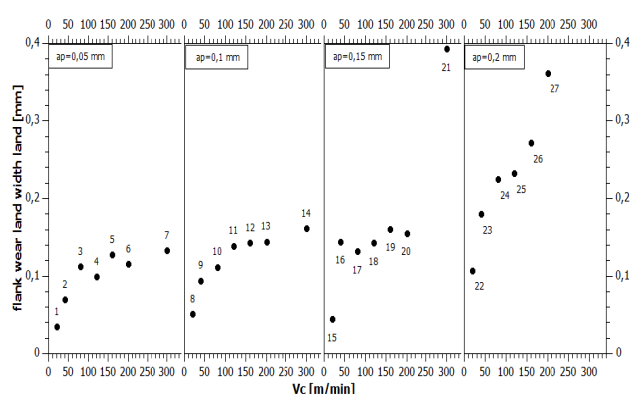
Fig. 1 Specific flank wear land width

Typical forms of tool wear were observed on all samples, namely notch wear on the flank face was observed. In addition, abrasion was measured by an increasing flank wear land width (VB). On the rake face, crater wear, micro cracks and built-up edges (adhesion of Ti-6246 on top of the coating) have been found. Regarding tool life, VB is an important factor as large values would lead to the introduction of additional heat into the finished workpiece. This could lead to Oxygen diffusion into the workpiece and, hence, to α -casing. [1] The results of the flank wear land width analyses for each worn tool are summarized in Fig 1.

This graph shows that with increasing v_c the flank wear land width increases. For $a_p = 0.05\text{mm}$, 0.1mm and 0.15mm VB is independent of the cutting depth whereas a sharp increase of VB is visible in case $a_p = 0.2\text{mm}$. It has to be stated that chip ignition occurred at 300 m/min and 0.15mm causing significant damage of the tool represented by steep rise of the flank wear land width.

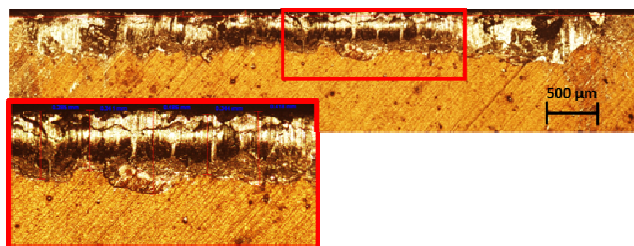
Fig. 2 Details of the rake face of the worn tool ($a_p = 0.15\text{mm}$, $v_c = 40\text{m/min}$)

In a second step, we investigated the crater wear and built-up edge formation. The crater wear on the rake face increased with the increasing a_p and the largest crater wear was found after machining at $v_c = 40\text{m/min}$ and 80m/min . Fig. 2 shows a detailed image of the rake face of the worn tool ($a_p = 0.15\text{mm}$, $v_c = 40\text{m/min}$) showing severe crater wear.

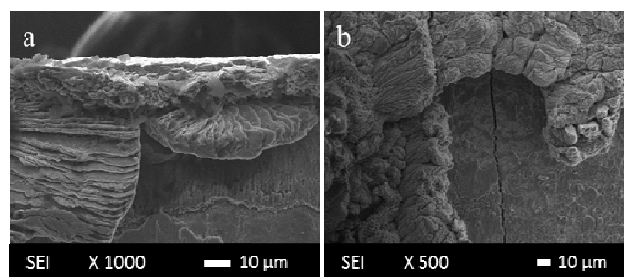
Fig. 4 SEM images of different wear mechanisms. a built-up edge formation, b micro crack formation

The build-up edges (material adhesion to the cutting insert) were found on all tools after the cutting experiments. Fig. 3 shows a photo of the flank face of a worn tool with a built-up edge created on the rake face. Details of build-up edge are shown on fig. 4a. Severe built-up edge formation was observed on tools machined in the following conditions: a_p : 0.05mm and 0.1 mm at v_c between 80m/min and 200m/min and at a_p 0.15mm and 0.2mm in the complete cutting speed regime investigated here.

In addition, micro crack formation has been observed on two tools, see Fig. 4b. The related cutting conditions were: $a_p = 0.2\text{mm}$, $v_c = 160\text{ m/min}$ and $a_p = 0.2\text{mm}$, $v_c = 200\text{m/min}$.

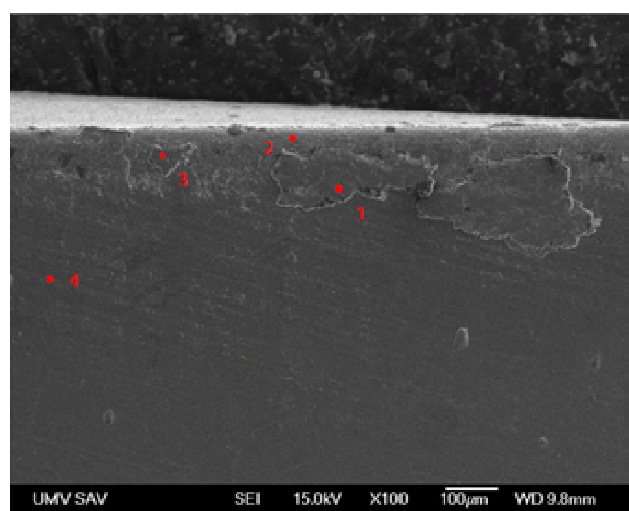
Fig. 5 The EDX point analysis of the worn tool

The EDX point analysis of a built-up edge ($a_p = 0.05\text{mm}$, $v_c = 20\text{m/min}$) is shown on Figs. 5 and 6. The related chemical composition is listed in Table 1. As can be seen from Table 1, the EDX data confirmed that the unworn area (point 4) included titanium (approx. 42 at.%), nitrogen (approx. 46 at.%) and aluminum (approx. 11 at.%), the worn area included elements from the workpiece material. Points 1 and 3 represent the zones of built-up edges formation which consisted of Aluminum, Molybdenum and Zirconium and twice more Titanium compared to the unworn areas.

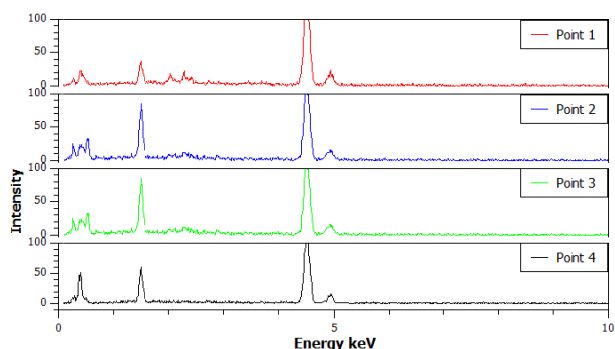
Fig. 6 EDX spectra of the points marked in Figure 6

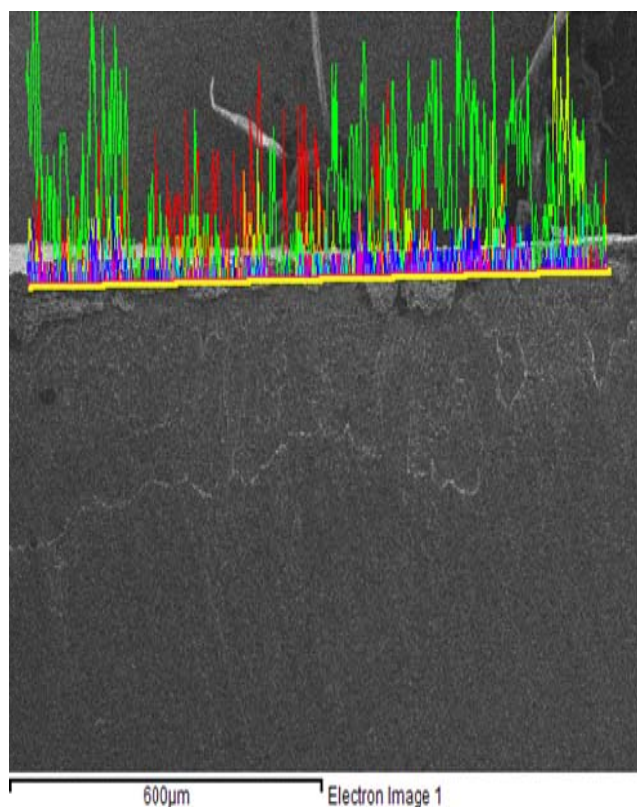
Fig. 7 The EDX linear analysis area

Zones of crater wear (rake face of the worn tool, cutting conditions: $a_p = 0.1\text{mm}$, $v_c = 80\text{m/min}$) were also investigated by EDX. The related EDX line analyses are presented in Figs. 7 and 8. The analysis showed that all elements are almost homogeneously distributed along the worn surface of the tool. Zirconium, Molybdenum, Tin, Titanium and Aluminum represented the Ti-6246 workpiece material. The presence of tungsten and nitrogen indicates a destruction of coating.

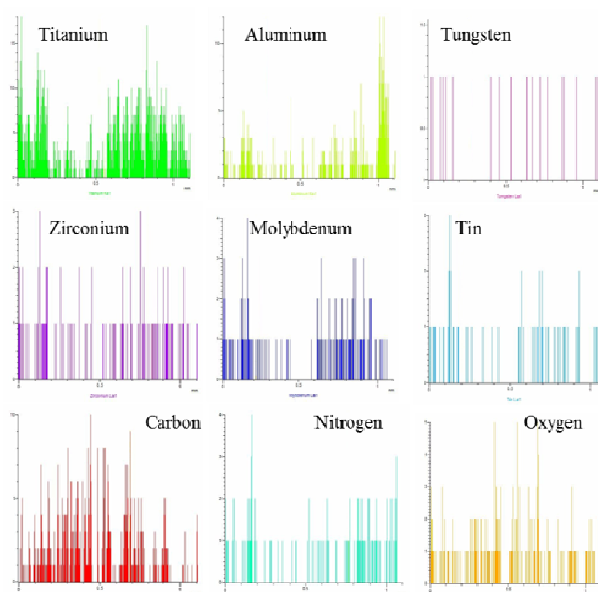
Fig. 8 The EDX line analysis of the worn tool

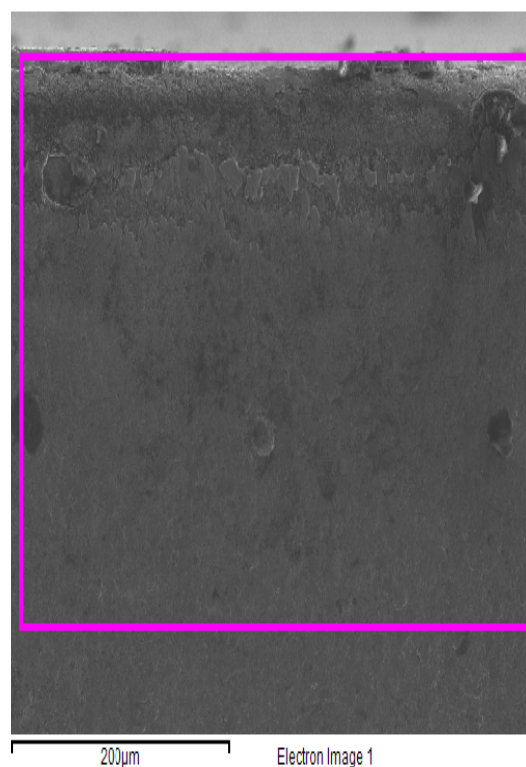
Fig. 9 The EDX mapping area

A chemical elements map of worn part of tool ($a_p = 0.05\text{mm}$, $v_c = 20\text{m/min}$) is shown on Figs. 9 and 10. The distribution of the elements tungsten and aluminum again signalizes a destruction of tool coating and a built-up edge formation. Other elements as Molybdenum, Zirconium and Tin were originating from workpiece material.

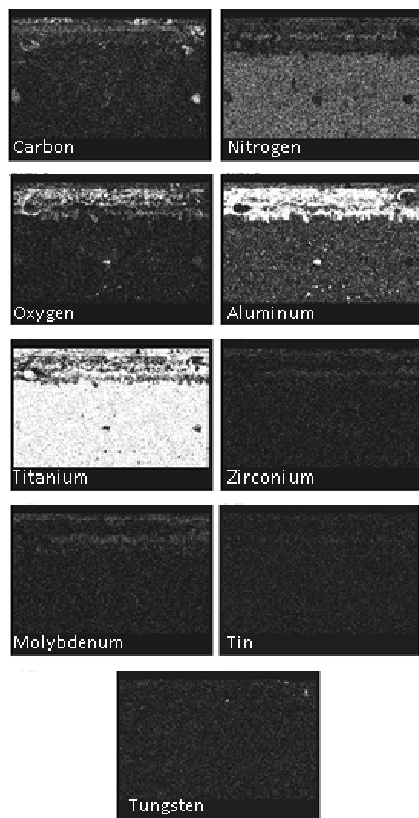
Fig. 10A chemical elements map

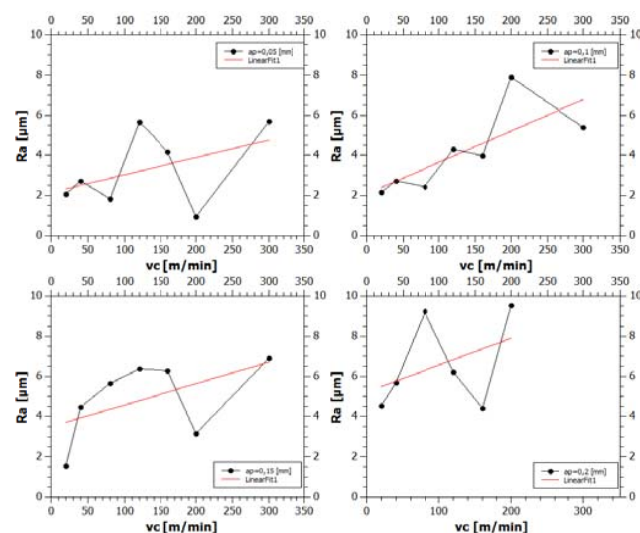
Fig. 11 Indicators of roughness

The roughness was measured by a confocal microscope at a distance of $20\mu\text{m}$ from the edge of tool. As it is very difficult to analyze surfaces with high portion of sharp edges (larger than 70°), the results presented here are only to be taken as rough approximations. Fig. 11 shows the results of the roughness measurements. It is clearly visible that the surface roughness increases with increasing cutting speed for all cutting depths.
