# Artificial Accelerated Ageing Test of Silicone Rubber Housing Material for Lightning Arrester

**Abstract**— This paper presents the experimental results of silicone rubber housing material for 24kV lightning arrester under artificial accelerated ageing test based on IEC 61109 specifications. Specimens having inclined and alternated shed made of HTV silicone rubber with ATH content and having leakage distance 625 mm were tested continuously 1000 hrs in artificial salt fog chamber. After 1000 hrs of salt fog ageing test, obviously surface erosion was observed on trunk between the upper large shed and the lower small shed near the energized end. Decreasing in hydrophobicity and increasing in hardness were measured on tested specimen comparing with new specimen. Chemical analysis by ATR-FTIR confirmed the observation results.

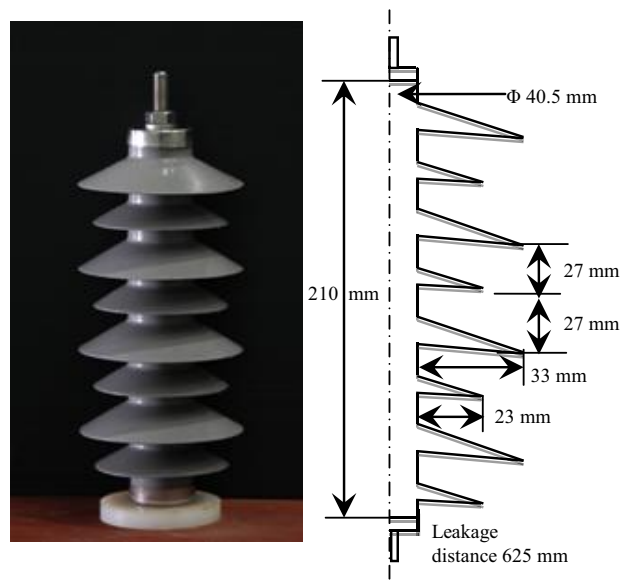
Fig. 1 Configuration and dimensions of specimen.

Insulation housing made of silicone rubber with ATH (Alumina trihydrate) content for 24kV system lightning arrester was used in this experimental. Alternated and inclined shed is configuration of tested specimen. Dimensions of tested specimen are illustrated in Fig. 1.

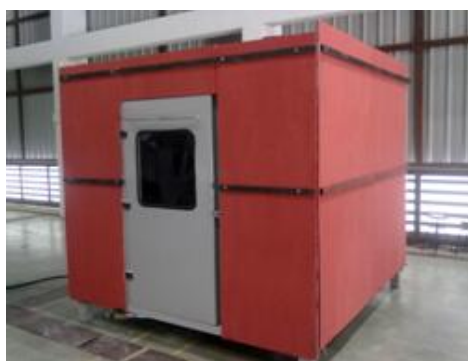
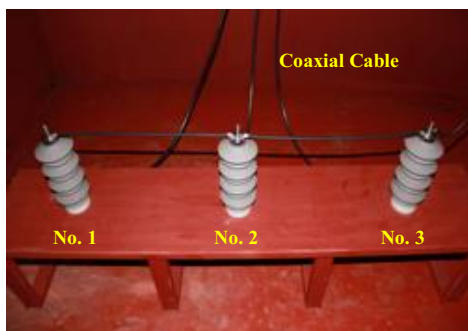
Fig. 3 Illustration of test chamber.

All specimens were placed in the test chamber having volume 9.6 m<sup>3</sup> (2×2×2.4 m<sup>3</sup>). Test chamber made from stainless steel sheet in order to prevent corrosion from salt fog. Salt fog was generated by using ultrasonic humidifier. Test arrangements are shown in Fig. 2 and test chamber is shown in Fig. 3, respectively.

(a) Test chamber

(b) Specimen installation

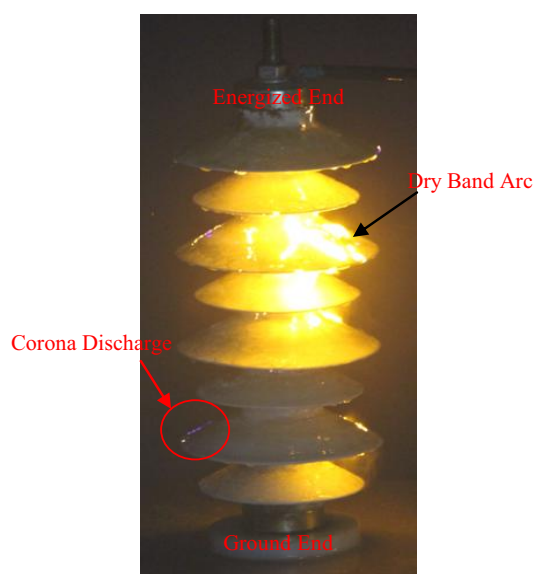
Fig. 4 Discharge Activities

During artificial salt fog ageing test, discharge activities as shown in Fig. 4 were observed. As shown in Fig. 4, yellow light for dry band arcing was observed. Such discharge indicated that large dry band arc discharge occurred on the specimen surface near the energized end. Low power discharge or corona discharge was also observed.

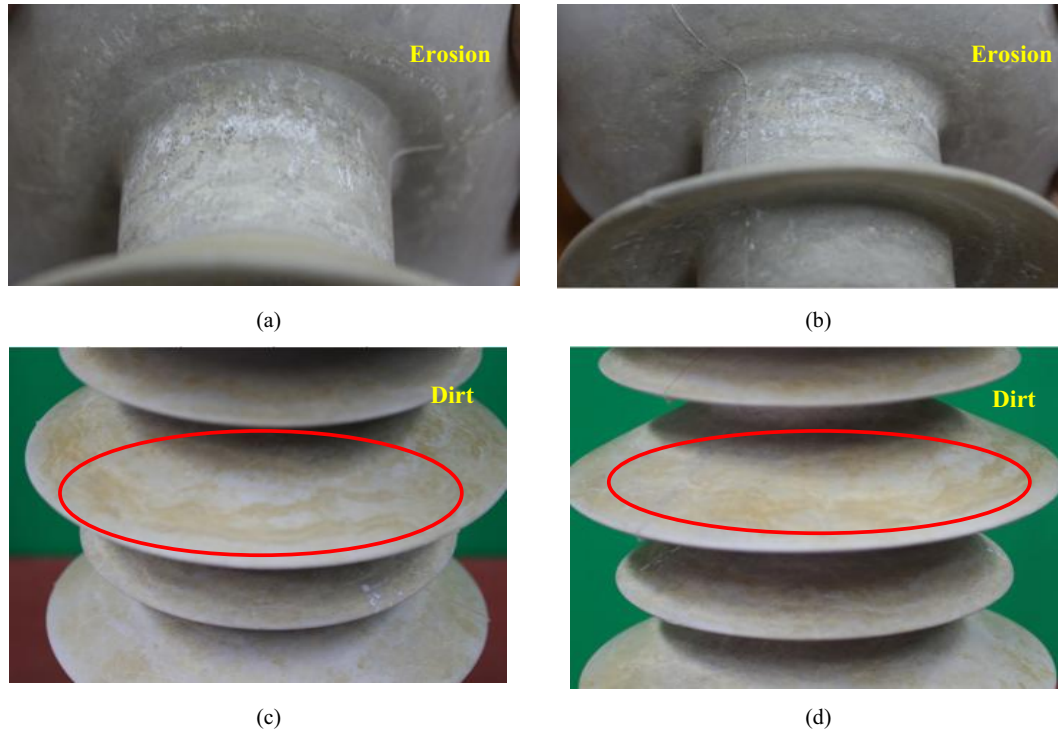
Fig. 5 Visual observation on the surface for lightning arrester.

After 1000 hrs salt fog ageing test, obviously surface erosion was observed on the trunk surface between small and large shed near the energized end of all specimen, as shown in Figure 5 (a) and (b). Slightly surface erosion was also observed on the other trunk portion along the specimen surface. Also, slightly erosion was observed on all shed surface. As shown in Fig. 5 (a), erosion zone on trunk surface occurred close to shed surface and erosion zone on shed surface occurred close to trunk surface. The explanation for such occurring is shown in Fig. 6. In border of wetting zone, dry band arcing easily occurred due to easier formation of dry band than drying and wetting zone. This explanation is supported by no erosion surface on drying and wetting zone.

As shown in Figure 5 (c) and (d), no erosion was observed on the upper shed surface. However, dirt was only observed on such portion.

(1) Surface erosion was observed on the trunk surface between the upper large shed and the lower small shed more than on the trunk surface between the upper small shed and the lower large shed.

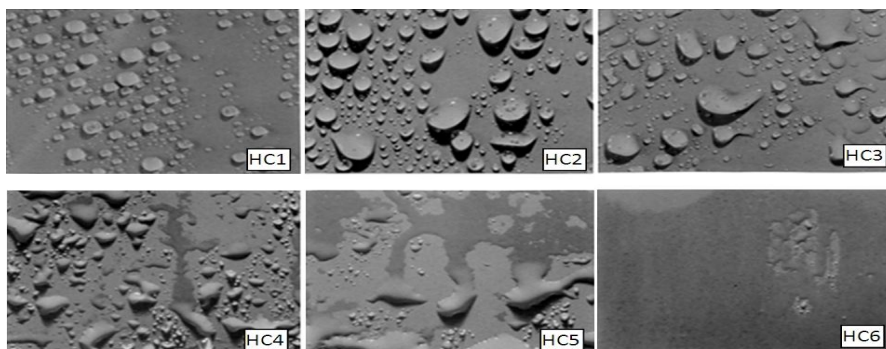
Loss of hydrophobicity on specimen surface after 1000 hrs ageing test was evaluated by STRI guide [11], as show in Fig. 7. Decreasing in hydrophobicity on surface of tested specimen near energized end was obtained from the measuring results. The measurement results are shown in Table IV.

Fig. 7 Characteristics of the sample surface HC1-HC6 [11].
