Retrofitting of Beam-Column Joint Using CFRP and Steel Plate

Abstract—This paper presents the retrofitting of beam-column joint using CFRP (Carbon Fiber Reinforced Polymer) and steel plate. This specimen was tested until failure up to 1.0% drift. This joint suffered severe damages and diagonal cracks at upper crack at upper column before retrofitted. CFRP were wrapped at corbel, bottom and top of the column. Steel plates with bonding were attached to the two beams and the jointing system. This retrofitted specimen is tested again under lateral cyclic loading up to 1.75% drift. Visual observations show that the cracks started at joint when 0.5% drift applied at top of column. Damage of retrofitted beam-column joint occurred inside the CFRP and it cannot be seen from outside. Analysis of elastic stiffness, lateral strength, ductility, hysteresis loops and equivalent viscous damping shows that these values are higher than before retrofitting. Therefore, it is recommended to use this type of retrofitting method for beam-column joint with corbel which suffers severe damage after the earthquake.

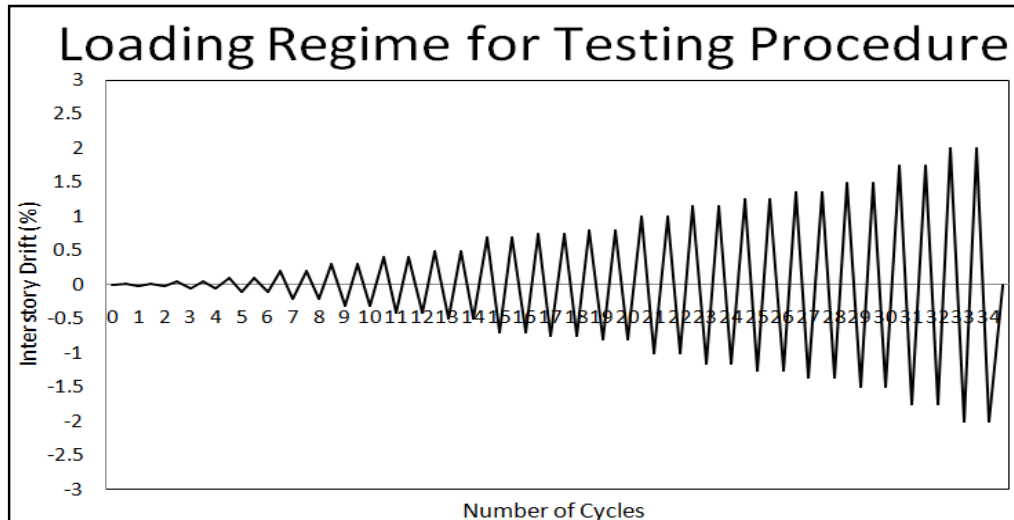
Fig. 4 shows the loading regime (displacement versus number of cycles) for the retrofitting beam-column joint. Table I shows the designation of beam-column joint. The beam-column joint before retrofitting is labeled as BC-23ER.

Fig. 4 Loading regime for testing the specimen

Retrofitting of beam-column joint was retested again using control displacement method at $\pm 0.01\%$ drift until $\pm 1.75\%$ drift with an increment of 0.05% and 0.1%. The applied drift for the retrofitted specimen is similar to before retrofitting which is $\pm 0.01\%$, $\pm 0.05\%$, $\pm 0.1\%$, $\pm 0.2\%$, $\pm 0.3\%$, $\pm 0.4\%$, 0.5% , $\pm 0.6\%$, $\pm 0.75\%$, $\pm 0.8\%$, $\pm 1.0\%$, $\pm 1.25\%$, $\pm 1.5\%$ and $\pm 1.75\%$. Two cycles of loading were applied for each drift.

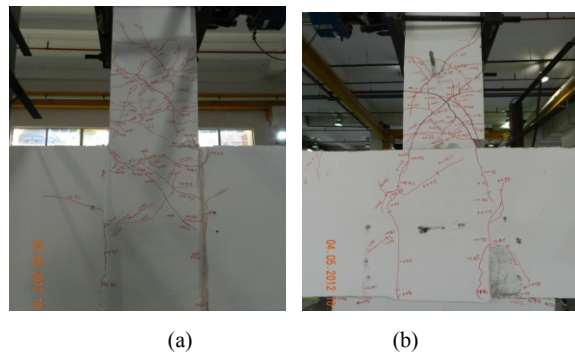
Fig. 5 shows the diagonal shear crack at top column after $\pm 1.0\%$ drift before retrofitting. During retesting, there are no visible hairline cracks or tearing of the CFRP sheet on the beam and column at 0.01% drift to 0.5% drift. The formation of crack can only be seen along the interface of the column to beam at 0.6% drift. At 1.5% , minor spalling of concrete started to shown at the corner of the side of the column. When the drift is increased up to 1.75% drift, the column failed and tears the CFRP layers showing the large crack and spalling of concrete under the layers to tear completely. At this point, the specimen experienced a complete disintegration at the top column. The test revealed that the reinforcement bar has bended which causes the failing of the top column as shown in Fig. 6.

Fig. 5 Diagonal shear crack at top column after $\pm 1.0\%$ drift before retrofitting; (a) front view and; (b) back view

The first crack found on the control specimen occurred at $\pm 0.1\%$ drift at corbel-column interfaces under lateral cyclic loading. At $\pm 0.5\%$ drift, many hairline cracks were observed starting from top of column and beam-column joint. Diagonal cracks started to shown at cast-in-place area at beam-column joint as well as flexural cracks on beam at 0.5% drift. At $\pm 1.0\%$ drift, an extension of the diagonal crack with 5mm width formed which later result in diagonal shear crack. The diagonal shear crack was formed due to the strong beam-weak column design known as soft storey mechanism.

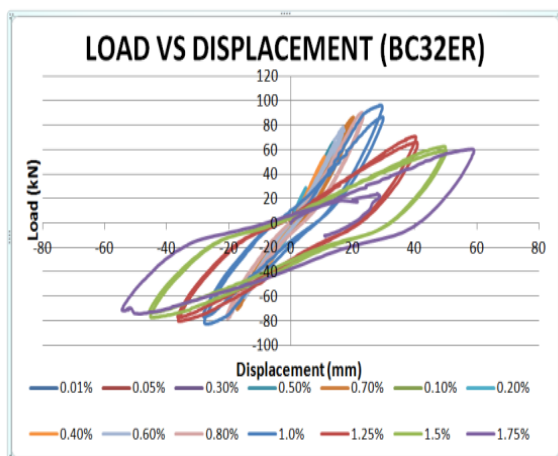
Fig. 8 Hysteresis loops for BC-23ER

Hysteresis loop is used to measure the behavior of structure starting from elastic range until non-elastic range. It can be obtained by plotting the graph of load vs. displacement from loading and unloading branch to complete one cycle of movement. From hysteresis loops, the parameter such as maximum lateral displacement, stiffness, ductility and equivalent viscous damping can be determined. The hysteresis loops of specimen before retrofitting is shown in Fig. 7 and hysteresis loops after retrofitting is shown in Fig. 8. From these graphs, specimen BC23ER has higher lateral strength and bigger ductility. Specimen BC23ER can sustain load up to ±1.0% drift with a significant increase in stiffness and ductility before undergo strength degradation from ±1.25% to 1.75% drift.

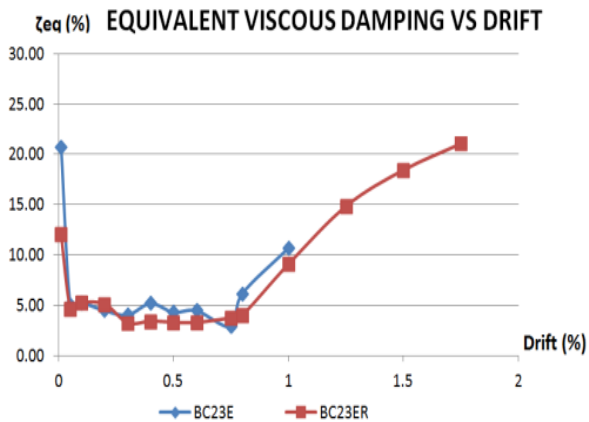
Fig. 12 shows the comparison of equivalent viscous damping during the first cycle of specimen BC-23E and BC-23ER. The initial equivalent viscous damping for specimen BC-23E has higher values compared to specimen BC-23ER which due to the fact that elastic stiffness has reduced for specimen BC-23ER. However, the equivalent viscous

damping for specimen BC-23ER is higher than original specimen because CFRP and steel plate give better confinement concrete and prevent the column to fail earlier than specimen BC-23E.

Fig. 12 Comparison of equivalent viscous damping for first cycle of specimen BC-23E and BC-23ER
