# Finite Element Analysis of Low-Velocity Impact Damage on Stiffened Composite Panels

**Abstract**—To understand the factors which affect impact damage on composite structures, particularly the effects of impact position and ribs. In this paper, a finite element model (FEM) of low-velocity impact damage on the composite structure was established via the nonlinear finite element method, combined with the user-defined materials subroutine (VUMAT) of the ABAQUS software. The structural elements chosen for the investigation comprised a series of stiffened composite panels, representative of real aircraft structure. By impacting the panels at different positions relative to the ribs, the effect of relative position of ribs was found out. Then the simulation results and the experiments data were compared. Finally, the factors which affect impact damage on the structures were discussed. The paper was helpful for the design of stiffened composite structures.

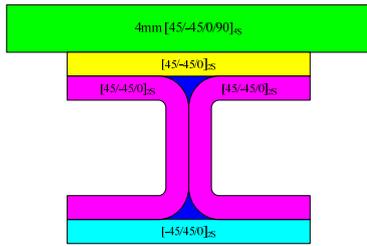
Fig. 1 Lay-ups of I-section stringers stiffened composite panel

The thickness of skin was 4 mm and the space between stringers was 120 mm apart. It was manufactured from Ciba T800/924. The panel skins were laid up with (+45/-45/0/90)<sub>4s</sub> lay-ups for the 4mm thick skins. The I-section stringers were assembled from four uncured laminates, comprising a tapered foot, two C-sections back-to-back and a spar cap. The foot and the C-sections had the same lay-up (+45/-45/0)<sub>2s</sub>, while that of the spar cap was (-45/+45/0). The triangular spaces between the webs and the spars were filled with strips of unidirectional prepreg. The foot and cap of each stringer had balanced lay-ups, but, as a consequence of forming two laminates into C-sections, the web was unbalanced [5], [6].

For 15 J impacts, the geometrical parameters for the stiffened composite panels and I-section stringers stiffened composite panel lay-ups see Figs. 1 and 2.

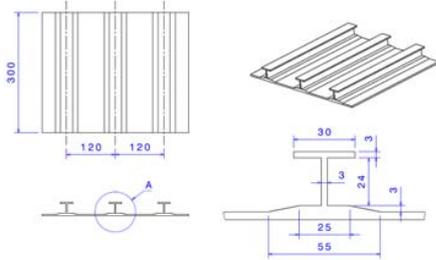
Fig. 2 Geometry of I-section stringers stiffened composite panel

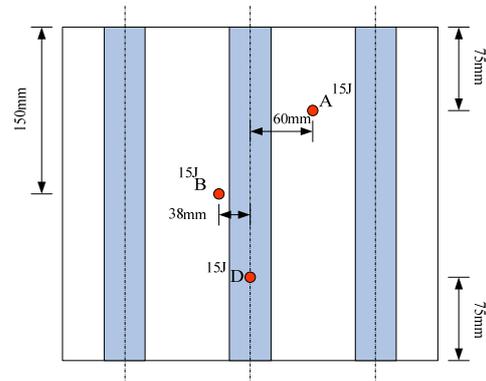
From preliminary studies on plain laminates, a 15 J impact; the highest unreported threat during maintenance to a military aircraft was found to produce a damage size of about 45 mm across. This energy was used to impact the skin-stringer panels at different locations (Fig. 3): (site A) over the center of a bay; (site B) over a bay, 38 mm from a stringer centerline; and (site D) directly over the centerline of a stringer [7].

Fig. 3 Impacting sites

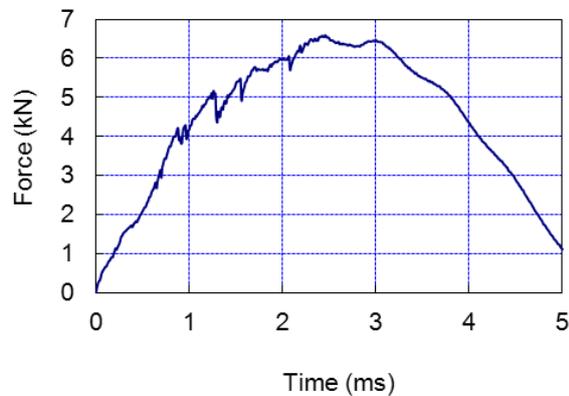
The peak force of simulation value is 6590N, and the experiment value is 6157N, so the error is 7%.

Fig. 4 Peak force on site A

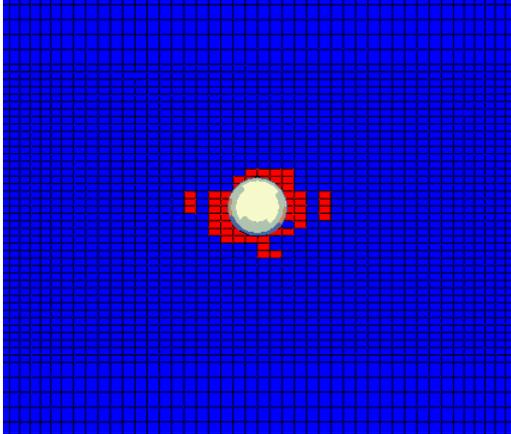
The damage area is  $998 \text{ mm}^2$ , and it is 20% smaller than experiment value.

Fig. 5 Damage area on site A from top view

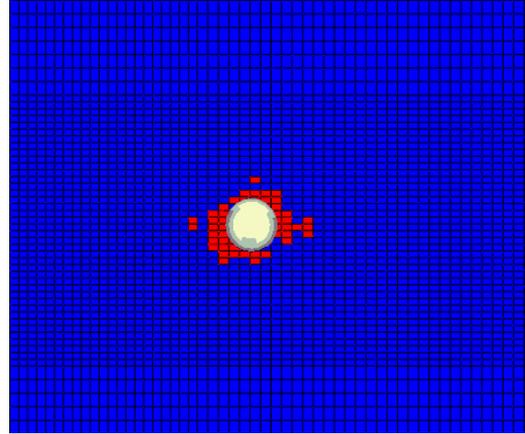
Fig. 8 Damage area on site B from top view

The damage area is  $678 \text{ mm}^2$ , and it is 18% smaller than experiment value .

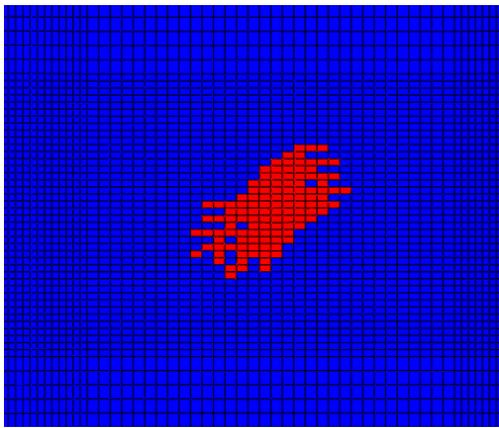
Fig. 6 Damage area on site A from bottom view

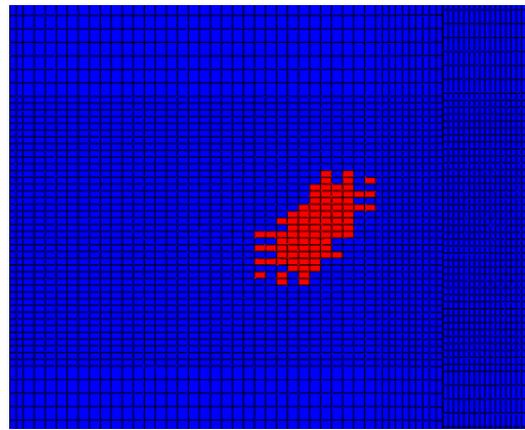
Fig. 9 Damage area on site B from bottom view

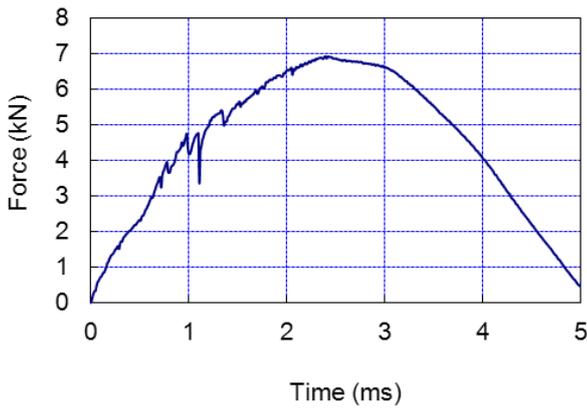
The peak force of simulation value is 6918N, and the experiment value is 6687N, so the error is 3.4%.

Fig. 7 Peak force on site B

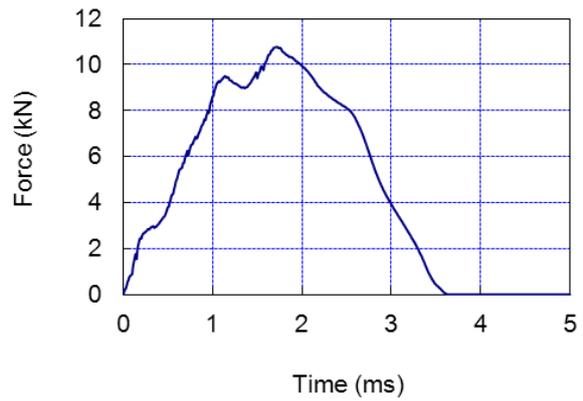
The peak force of simulation value is 10768N, and the experiment value is 10425N, so the error is 3%.

Fig. 10 Peak force on site D

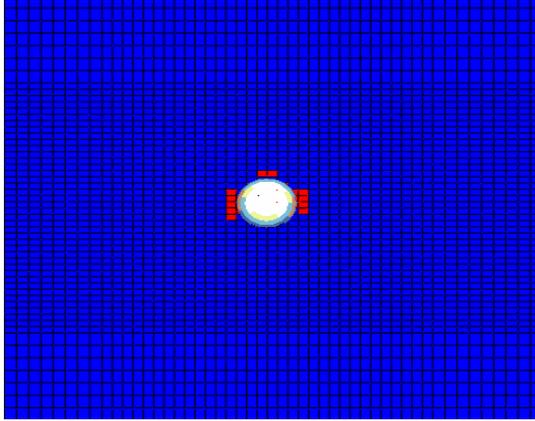
The damage area is  $38 \text{ mm}^2$ , and it is 5% smaller than experiment value .

Fig. 11 Damage area on site D from top view

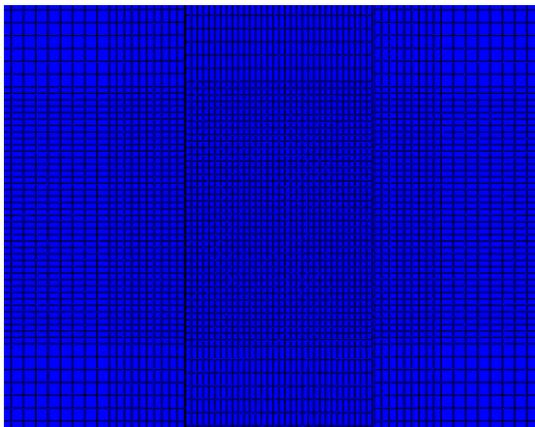
Fig. 12 Damage area on site D from bottom view

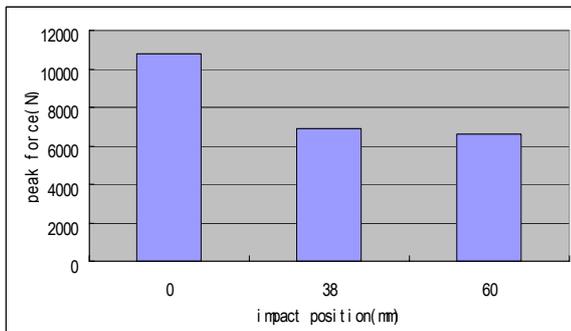
Fig. 13 Peak force on the three impact sites

The locations of the impacts were in centre bay between the stringers, in a bay close to a stringer, and above the stringer centreline. From Figs. 13 and 14, we can figure out that the more it is apart from stringer, the less peak force is; the more it is apart from stringer, the more damage area is. For impacts in the bay, a compliant bay led to increased absorption of the incident energy through elastic structural response. However, for impacts in the foot, a compliant bay led to increased absorption of the incident energy through damage to the substructure. For impacts over the stringer centreline, much of the incident energy was absorbed through elastic deformation of the substructure. So the result in my paper is acceptable.

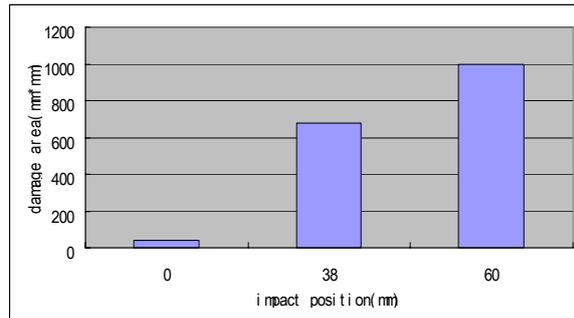
Fig. 14 Damage area on the three impact sites
