Image Distortion Correction Method of 2-MHz Side Scan Sonar for Underwater Structure Inspection

Abstract—The 2-MHz Side Scan SONAR (SSS) attached to the boat for inspection of underwater structures is affected by shaking. It is difficult to determine the exact scale of damage of structure. In this study, a motion sensor is attached to the inside of the 2-MHz SSS to get roll, pitch, and yaw direction data, and developed the image stabilization tool to correct the sonar image. We checked that reliable data can be obtained with an average error rate of 1.99% between the measured value and the actual distance through experiment. It is possible to get the accurate sonar data to inspect damage in underwater structure.

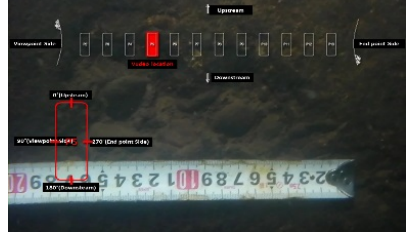
<p>#3. Difference length (L=0.20m)</p> <p>Depth of water :3.0m</p>	<p>The whole average 1.99%</p> <p>5%</p> <p>0%</p>

TABLE III
COMPARISON OF SONAR DATA AND DAMAGE THROUGH MOTION SENSOR
