Finite Element Analysis of Low-Velocity Impact Damage on Stiffened Composite Panels

Xuan Sun, Mingbo Tong

Abstract—To understand the factors which affect impact damage on composite structures, particularly the effects of impact position and ribs. In this paper, a finite element model (FEM) of low-velocity impact damage on the composite structure was established via the nonlinear finite element method, combined with the user-defined materials subroutine (VUMAT) of the ABAQUS software. The structural elements chosen for the investigation comprised a series of stiffened composite panels, representative of real aircraft structure. By impacting the panels at different positions relative to the ribs, the effect of relative position of ribs was found out. Then the simulation results and the experiments data were compared. Finally, the factors which affect impact damage on the structures were discussed. The paper was helpful for the design of stiffened composite structures.

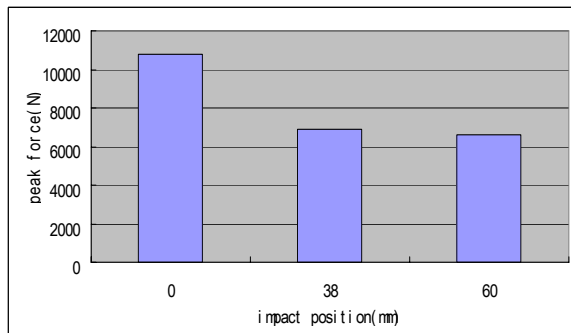
Fig. 13 Peak force on the three impact sites

The locations of the impacts were in centre bay between the stringers, in a bay close to a stringer, and above the stringer centreline. From Figs. 13 and 14, we can figure out that the more it is apart from stringer, the less peak force is; the more it is apart from stringer, the more damage area is. For impacts in the bay, a compliant bay led to increased absorption of the incident energy through elastic structural response. However, for impacts in the foot, a compliant bay led to increased absorption of the incident energy through damage to the substructure. For impacts over the stringer centreline, much of the incident energy was absorbed through elastic deformation of the substructure. So the result in my paper is acceptable.

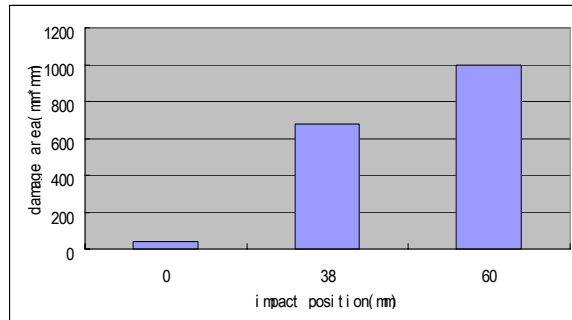
Fig. 14 Damage area on the three impact sites
