Retrofitting of Beam-Column Joint Using CFRP and Steel Plate

Abstract—This paper presents the retrofitting of beam-column joint using CFRP (Carbon Fiber Reinforced Polymer) and steel plate. This specimen was tested until failure up to 1.0% drift. This joint suffered severe damages and diagonal cracks at upper crack at upper column before retrofitted. CFRP were wrapped at corbel, bottom and top of the column. Steel plates with bonding were attached to the two beams and the jointing system. This retrofitted specimen is tested again under lateral cyclic loading up 1.75% drift. Visual observations show that the cracks started at joint when 0.5% drift applied at top of column. Damage of retrofitted beam-column joint occurred inside the CFRP and it cannot be seen from outside. Analysis of elastic stiffness, lateral strength, ductility, hysteresis loops and equivalent viscous damping shows that these values are higher than before retrofitting. Therefore, it is recommended to use this type of retrofitting method for beam-column joint with corbel which suffers severe damage after the earthquake.

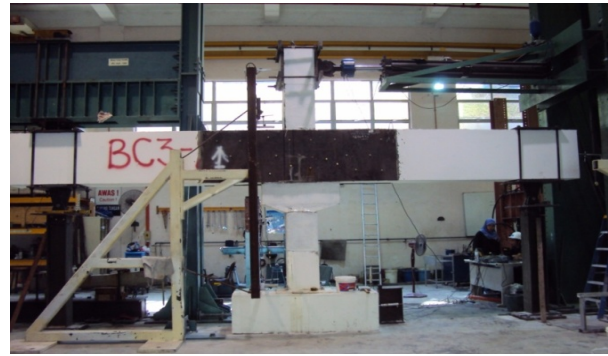
Fig. 2 The specimen BC-23ER is ready for testing

After the crack was repaired, the steel plate was then bolted to both side of the joint region using 23 stainless steel M16 anchor. Before the plate is attached to the specimen, fifteen holes with size of 16mm were drilled on the beam surface. After that, the plates were bonded to the beam-column joint and bolted with the anchor bolts. Fig. 2 shows the specimen BC-23ER after retrofitted with CFRP and steel plate bonding which is ready for testing.

The retrofitting and strengthening of beam-column joint take place using CFRP and steel plate. The first step of retrofitting and strengthening the beam-column joint is to treat and close the gaps of cracks. This is to ensure that the cracks are properly treated prior to retesting of specimen under lateral cyclic loading. The diagonal crack at top column was treated with epoxy to cover up the structural cracks. The wrapping of CFRP sheets on prime coat epoxy resin takes place once the epoxy injection grouting dried. The top column is retrofitted with three layers of CFRP sheets while the bottom column and corbel were retrofitted with two layers of CFRP sheets. The transverse beam near the joint region was strengthened using 2500mm x 750mm x 8mm steel plate on both side of the joint.

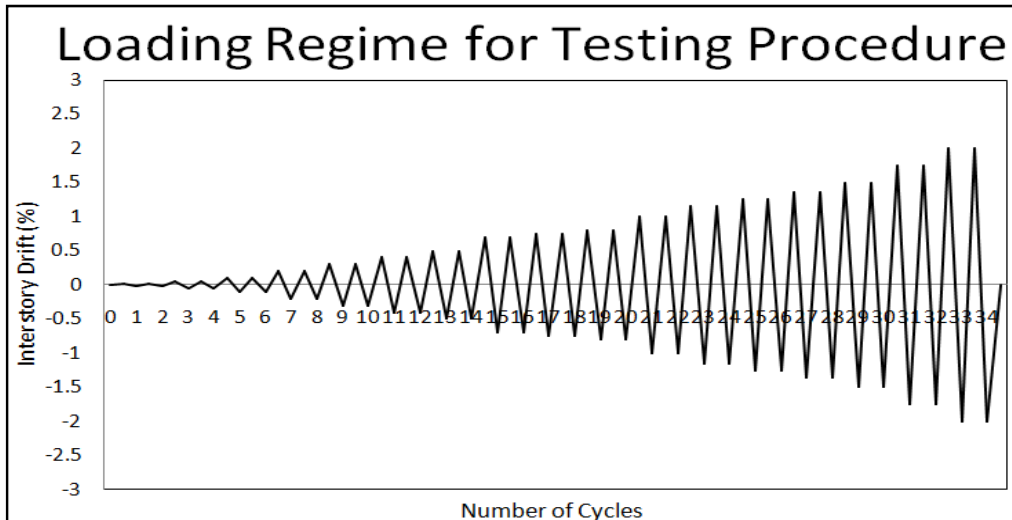
Fig. 4 shows the loading regime (displacement versus number of cycles) for the retrofitting beam-column joint. Table I shows the designation of beam-column joint. The beam-column joint before retrofitting is labeled as BC-23ER.

Fig. 4 Loading regime for testing the specimen

Retrofitting of beam-column joint was retested again using control displacement method at $\pm 0.01\%$ drift until $\pm 1.75\%$ drift with an increment of 0.05% and 0.1%. The applied drift for the retrofitted specimen is similar to before retrofitting which is $\pm 0.01\%$, $\pm 0.05\%$, $\pm 0.1\%$, $\pm 0.2\%$, $\pm 0.3\%$, $\pm 0.4\%$, 0.5% , $\pm 0.6\%$, $\pm 0.75\%$, $\pm 0.8\%$, $\pm 1.0\%$, $\pm 1.25\%$, $\pm 1.5\%$ and $\pm 1.75\%$. Two cycles of loading were applied for each drift.

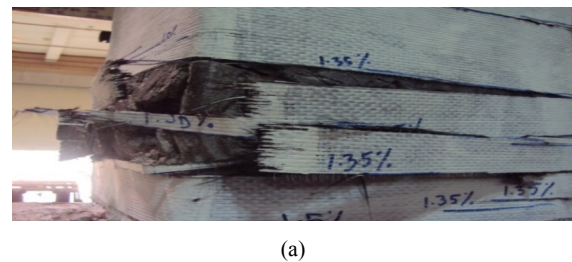
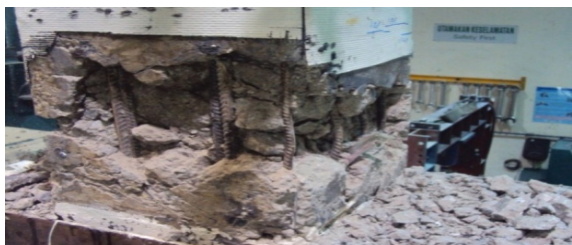
(a)

(b)

Fig. 6 Damages on BC-23ER; (a) large tear and; (b) bended reinforcement after $\pm 1.75\%$ drift after retrofitting

Fig. 5 shows the diagonal shear crack at top column after $\pm 1.0\%$ drift before retrofitting. During retesting, there are no visible hairline cracks or tearing of the CFRP sheet on the beam and column at 0.01% drift to 0.5% drift. The formation of crack can only be seen along the interface of the column to beam at 0.6% drift. At 1.5% , minor spalling of concrete started to shown at the corner of the side of the column. When the drift is increased up to 1.75% drift, the column failed and tears the CFRP layers showing the large crack and spalling of concrete under the layers to tear completely. At this point, the specimen experienced a complete disintegration at the top column. The test revealed that the reinforcement bar has bended which causes the failing of the top column as shown in Fig. 6.

- 2) The control specimen experienced diagonal shear failure at the top column that contributed to the soft-storey mechanism phenomenon when tested under lateral cyclic loading at 1% drift. However, the retrofitted specimen experienced cracking at interfaces and rupture of CFRP sheet and banded reinforcement when retested under lateral cyclic loading at 1.75% drift.

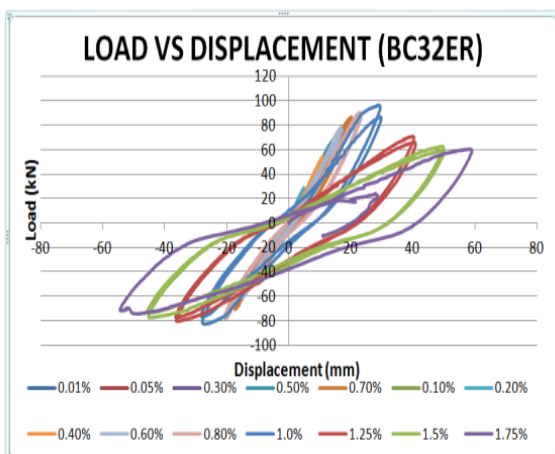
Fig. 8 Hysteresis loops for BC-23ER

The seismic retrofitting behavior of the beam-column joint after retrofitting depends on the number of CFRP layers applied to the damage area. Since the specimen was retrofitted with CFRP and steel plate, the stiffness of the beam-column joint with corbel also increases and can withstand higher loading with smaller displacement as compared to the before retrofitted specimen as shown in Fig. 7.

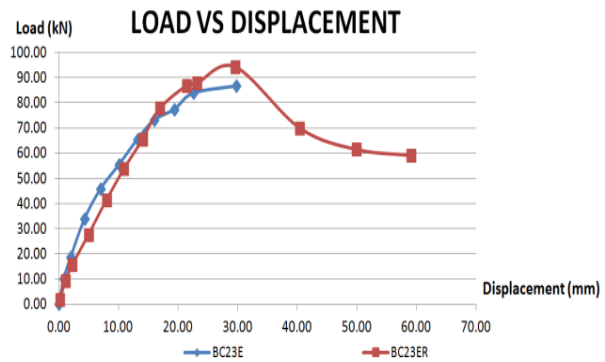
Fig. 9 Load vs. displacement for BC-23E and BC-23ER

Fig. 9 shows the load vs. displacement curve for BC-23E and BC-23ER. Both specimen undergo linear behavior starting from 0.01% to 0.6% , therefore the yield point for both specimen is observed at 0.6% drift. The yield strength had increased by more than 5% at the 0.6% drift. The before retrofitted specimen proceeds to an ultimate load of 86.79kN at 1.0% drift while the ultimate load for retrofitted specimen is 94.2kN . This proves that the lateral strength of the retrofitted specimen increased by 7.9% . The strength degradation that starts to occur after 1.0% drift for the retrofitted specimen is due to the diagonal shear failure formed at the top column.

The inelastic behavior of the control and retrofitted beam-column joint in terms of load-displacement (hysteresis loop) relationship was compared. Based on the result, both load carrying lateral strength capacities of specimen (BC-23E and BC-23ER) under linear elastic region and continue to reach the ultimate load under inelastic behavior before reaching strength degradation at $\pm 1\%$ drift for control specimen and 1.75% drift for retrofitted specimen.
