Laser Welded Ni-Cr Dental Alloys Inspection

Abstract—Minor problems arising from optimizations by welding of fixed prostheses frameworks can be identified by macroscopic and microscopic visual inspection. The purpose of this study was to highlight the visible discontinuities present in the laser welds of dental Ni-Cr alloys. Ni-Cr base metal alloys designated for fixed prostheses manufacture were selected for the experiments. Using cast plates, preliminary tests were conducted by laser welding. Macroscopic visual inspection was done carefully to assess the defects of the welding rib. Electron microscopy images allowed visualization of small discontinuities, which escapes visual inspection. Making comparison to Ni-Cr alloys taken in the experiment and laser welded, after visual analysis, the best welds appear for Heraenium NA alloy.

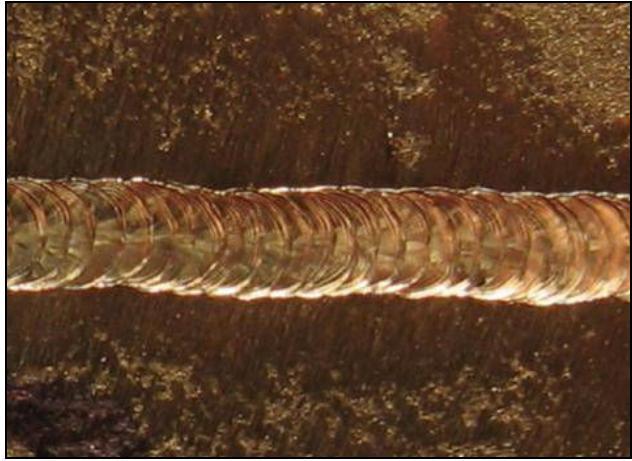
Fig. 1 Aspect of a welded Ni-Cr alloy sample (welding without filler): uniform overlapping of the spots, no visible defects

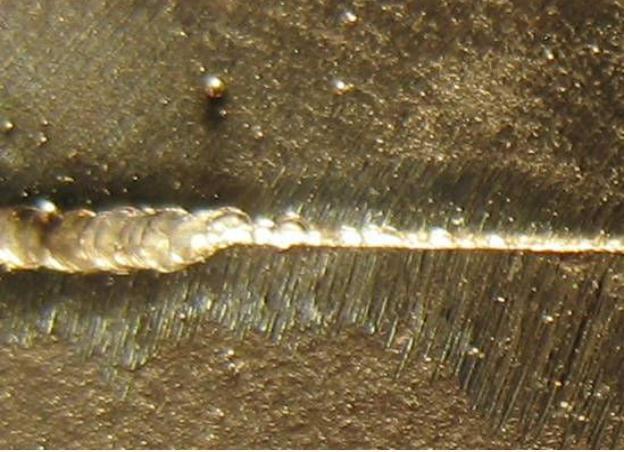
Fig. 4 Aspect of Ni-Cr alloy sample (welding with filler material): poor penetration on the opposite side

In practice metal frameworks have different thicknesses and this have to be also taken into account. Even if the weld penetration at higher power is also high, too strong power produces too much penetration that may induce formation of pores, which implicitly reduces weld strength. A very low penetration may not be able to determine enough strength. It is therefore important to determine the optimal parameters to achieve proper penetration. Welding on both sides could avoid these disadvantages [2].

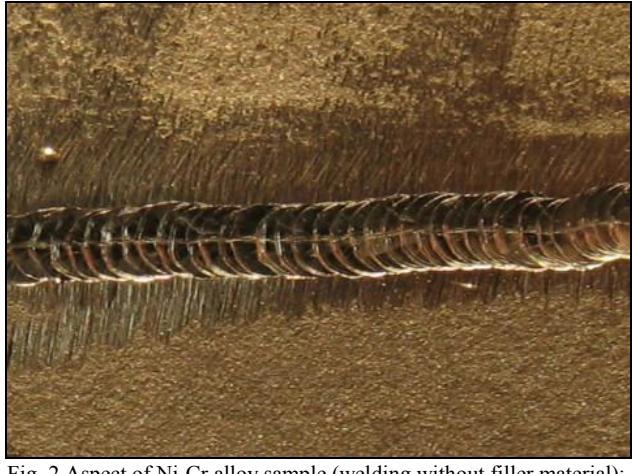
Fig. 2 Aspect of Ni-Cr alloy sample (welding without filler material): uniform width of the weld, continues crack along the joining line

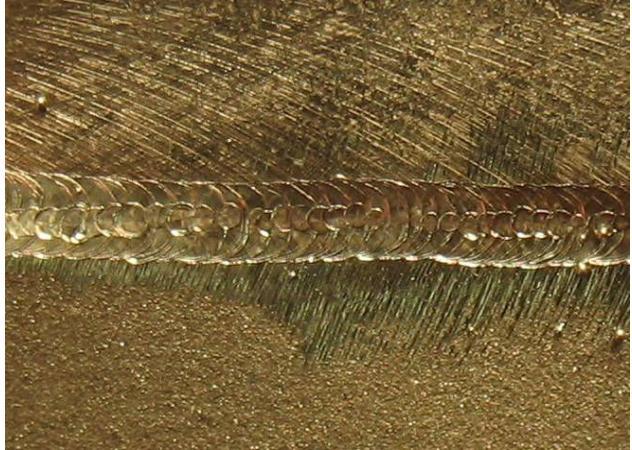
Fig. 3 Aspect of Ni-Cr alloy sample (welding without filler material): good penetration on the opposite side

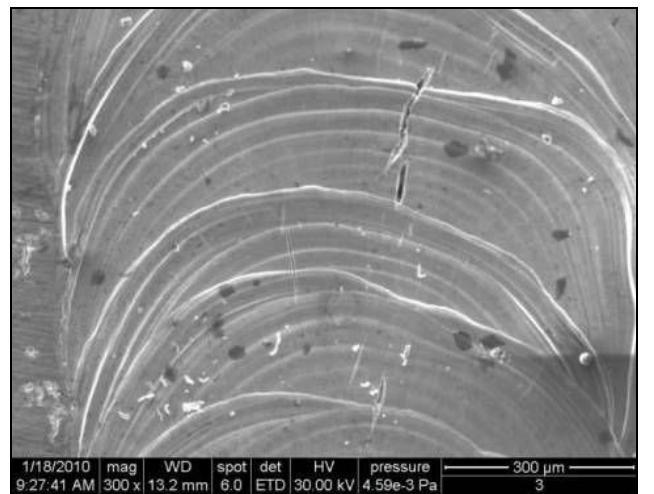
The examined samples revealed some small cracks in the welding rib, both longitudinal and transverse or oblique. Some start from the main longitudinal cracks, some from the middle spot, others are completely isolated.

Fig. 6 Electronomicroscopic image of a Ni-Cr alloy welded joints without filler material: short longitudinal cracks on the welding rib (mag 300x)

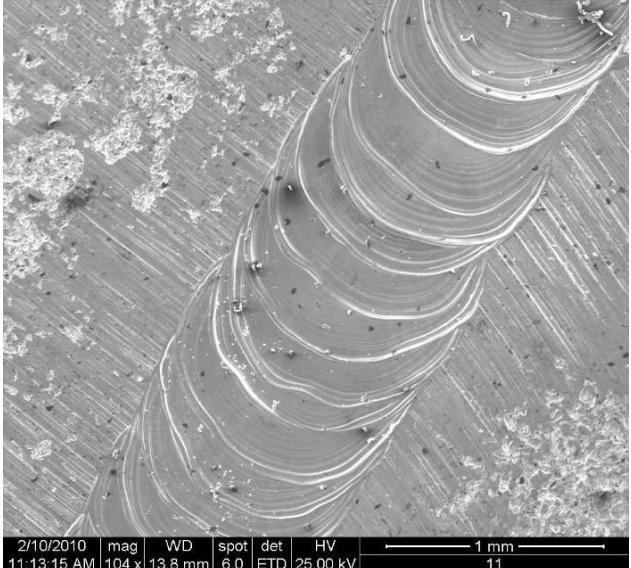
Fig. 7 Electronomicroscopic image of a Ni-Cr alloy welded joints without filler material: no visible defects on the welding rib (mag 104x)

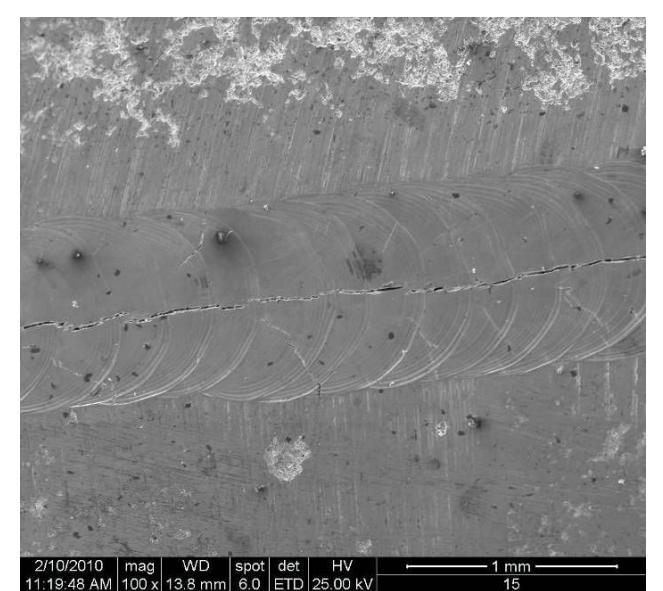
Fig. 8 Electronomicroscopic image of a Ni-Cr alloy welded joints without filler material: continuous longitudinal crack on the welding rib (mag 100x)
