Energy Saving, Heritage Conserving Renovation Methods in Case of Historical Building Stock

Viktória Sugár, Zoltán Laczó, András Horkai, Gyula Kiss, Attila Talamon

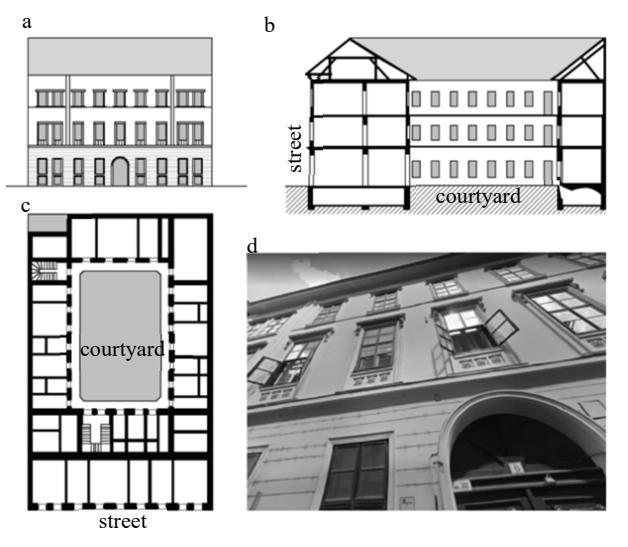
Fig. 1 shows an example of the aforementioned type. Usually, this type has been functioning as condominium with different size and variously equipped flats. The building is built around a courtyard. The street front wing is – as usual in this type – more decorated, containing larger flats. Traditionally, the owner or a rich renter occupied these. The courtyard wings contain simpler flats, often only with a kitchen and a room. Older examples of the type have common lavatories at the end of the corridors, as a conventional solution of hygiene in the 19th century.

The courtyard can be accessed by using the gate on the street front. Near the gate is the main staircase. The flats on the upper stories can be entered from the hanging corridors running parallel the walls. This type is mostly built in an unbroken row along the narrow streets of the 19th century Pest, connecting to each other with firewalls on three sides.

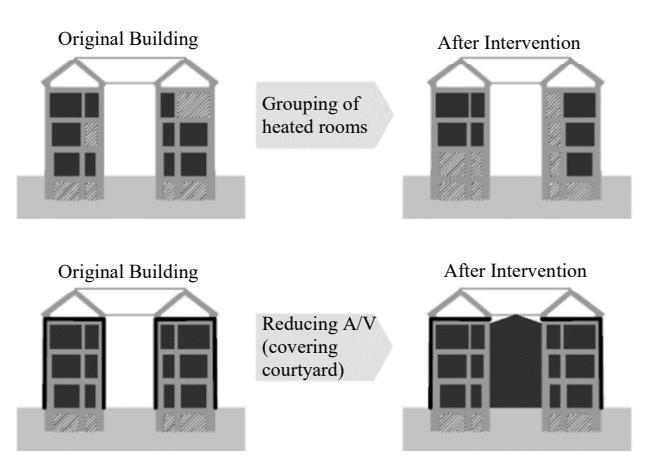
To reduce the energy demand, the following architectural interventions can be utilized (examples on Fig. 2):

- reducing the heated volume,
- reducing the enveloping surface area per heated volume (A/V) ratio (for example covering the inner courtyard),
- repositioning (grouping) of heated rooms,
- increasing solar gains by new openings.

Fig. 2 Architectural intervention examples in case of historical buildings of Budapest (black color represents the heated volume)

In case of historical buildings, however, not all the above measures can be used, as mentioned above: reduction of heated volume could be achieved by demolishing wings, an also construction new openings on the façade would change the set of values. The repositioning of functions or for example covering the courtyard to decrease A/V can be an option.

As a modification of the above scenarios, we calculated the effect of covering the inner courtyard also (as shown on Fig. 2), thus decreasing the enveloping area but increasing the heated volume. Thus, the above scenarios have two versions: original geometry and modified geometry.

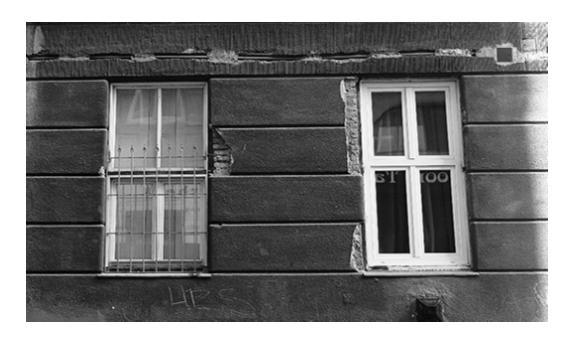
Fig. 3 Disagreeable modernization of a window by neglecting historical values (photo of Attila Zsoldos BSc Architect student)

The suggestions of Table I in real life photos show that these standard solutions in case of historical buildings are damaging the values (especially in case of façade insulation and fenestration exchange). Fig. 3 shows the old, wooden window changed to a new, plastic one, while the original ratios and look were mainly neglected.

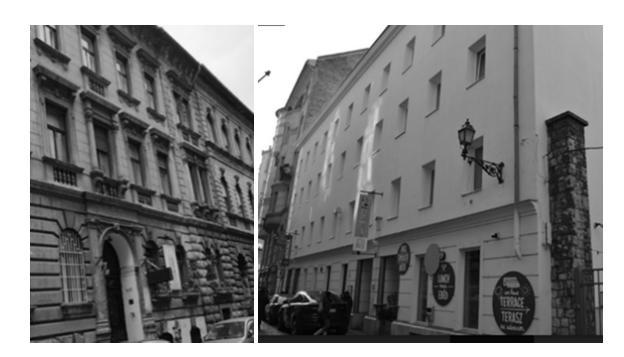
Fig. 4 shows a once historical building after application of external insulation, and compared to it, a façade of a same age building: the standard insulation sheets clearly damaging the appearance of the building.

Fig. 4 Traditional building with original decoration, and a same age building with external insulation on a historical building,

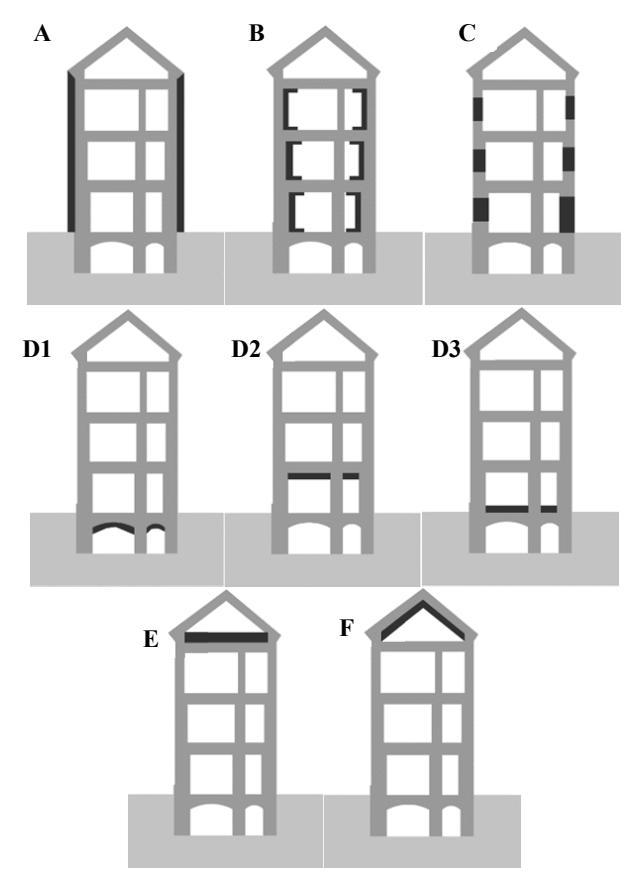
Apart from the above, there are several options for enveloping surface insulation. Fig. 5 shows the possible insulated surfaces of the given type in case of heritage respecting modernization.

Fig. 5 Heat insulation possibilities on enveloping structures in case of heritage respecting modernization A: Outside insulation of the facade, B: Inside insulation of the facade, C: Window renovation, D:

Bottom slab insulation; D1: Underside insulation of cellar vault, D2: Underside insulation in case of arcade, D3: Floor insulation, E:

Closing slab insulation under pitched roof, F: Pitched roof insulation

Outside insulation of the façade (A): As mentioned before, this standard solution should be avoided due to the damage in the façade ornaments. There are, however, cases when it can be utilized. For example, in case of inner, usually less elaborate facades and firewalls, it can be reasonable.

Inside insulation of the façade (B) [14]: installing insulation on the inner, heated side of a structure is not without difficulties. Three main disadvantages can be listed:

Window renovation (C): As 40-50% of the façade is glazed surface in case of this type, the energetic state of the fenestration is an important question. Apart from the box-type window structure mentioned before, the traditional shading solutions are remarkable. Unfortunately, nowadays the residents tend to remove the old wooden shadings oblivious of its positive effect if energetics.

Bottom slab insulation (D1, D2, D3): Most commonly these buildings have cellars (especially the ones built after 1838, where the new regulations prescribed the cellars after the Great Flood of River Danube, which destroyed most of the building stock [15]). As the average cellar is vaulted, bendable insulation can be installed (for example rock or glass wool), but otherwise standard technologies can be utilized (D1). In case of flat slab, the averagely used solutions are: polystyrene or wood-wool plates. The solution is the same in case of the arcade slab of the gate (D2). An alternative solution for the not heated cellar insulation is to renovate the structure from the upper side: install insulation into the floor structure from the ground floor side (D3). In this case, the most commonly wooden parquet should be ripped up, which is not an ideal solution. It is unavoidable, however, in the case where there is no cellar, and the floor layers are on the soil.

Closing slab insulation under the pitched roof (E): As the building types nearly in all cases have empty pitched roof without attic rooms, the solution is not problematic. As the

Pitched roof insulation (F): In case of built-in attic, the commonly used solution is rock or glass wool filling between and underside the rafter. In the case of building in the winter, heat loss is not the main concern. The summer overheating caused by the insufficient thermal mass is much bigger problem.

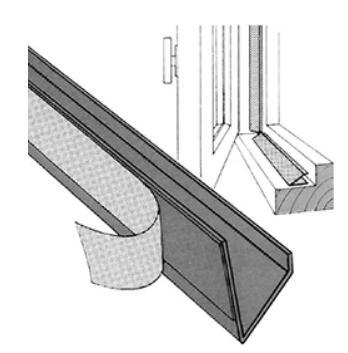
Fig. 10 Plastic filling for U value decrease [16]

First and foremost, as these wooden-glass structures are average 120-year-old windows, their connection points are mostly displaced, the wings are warped. By correcting the warping and using for example plastic strips (Fig. 10) to level out the uneven surfaces, the thermal transmittance value (U, W/m^2K) can already be decreased from 2.23 W/m^2K to 2.12 W/m^2K [7].

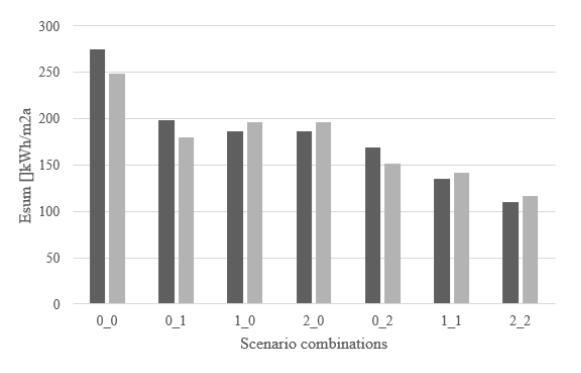
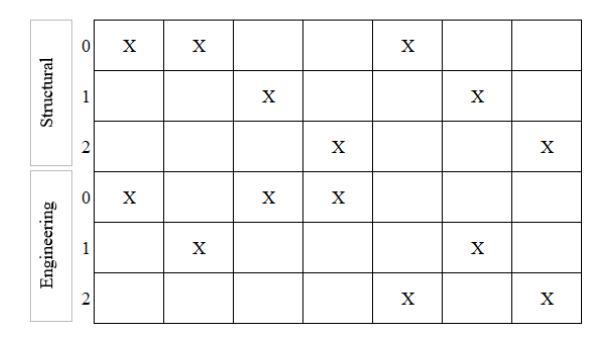
Fig. 11 shows the results of Table IV on diagram which includes the total energy usage of the building in case of the above variations, either in case of original (darker shade) and changed geometry (lighter shade).

Fig. 11 Results of case study building renovation scenarios

The original state (0_0) of the building with either geometry variation uses the largest quantity of energy. In this case, the covered courtyard as a modification decreases the energy usage in response to the change of A/V ratio. Variation 2_2 is the most energy saving solution, offering 60.1% saving of energy in case of original structure and 53.3% in case of covered courtyard. Also, the CO₂ emission of the building decreases by 60t/year in with these scenarios.

In case of combination 1_0 and 2_0 the enveloping structures had been upgraded, which is resulting a significant

decrease of energy intake; however, in these cases the geometry modification increases the energy intake. The explanation of this is the following: the heated volume is increased slightly, but these two scenarios are not containing the engineering modernization, the engineering is the original, not effective convector heating, which increases the energy usage compared to the non-changed geometry. Also, in case of 1_1 and 2_2 , the covered courtyard does not decrease the energy intake, the increased heated volume has more effect on energy intake than the decreased enveloping surface ratio.
