Repairing & Strengthening Earthquake Damaged RC Beams with Composites

H. Murat Tanarslan

International Journal of Architectural, Civil and Construction Sciences ISSN: 2415-1734 Vol:7, No:6, 2013

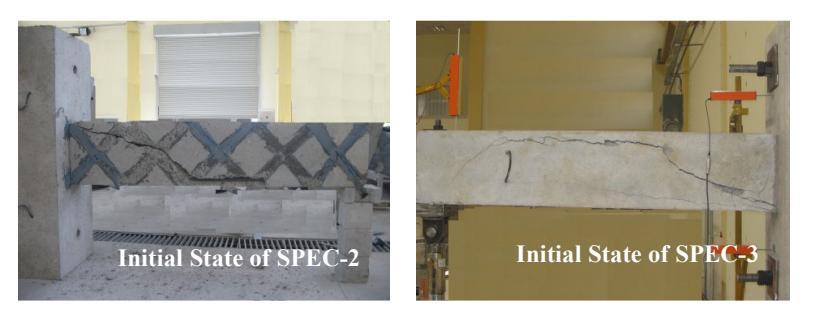
Fig. 1 Photos of the Collapsed Specimens

group were initially tested up to failure. It was aimed to evaluate the behavior of RC beams with different damage degree. To acquire different damage form and degree, one specimen was tested without strengthening. It was planned to obtain the damage within the limits permitted by ACI 224 committee report [8]. One major and both large and small cracks was observed for the specimen. Remaining was tested after strengthening. Photos of the collapsed specimens are presented in Fig. 1. SPEC-3, which shear damage was limited with one major and both large and small scaled cracks, were strengthened with side-bonded CFRP strips. As the tension and compression face of SPEC-2 was heavily damaged, specimens were wrapped to obstruct similar cracking pattern after strengthening. CFRP spacing was ideal to hinder crack propagation [7].

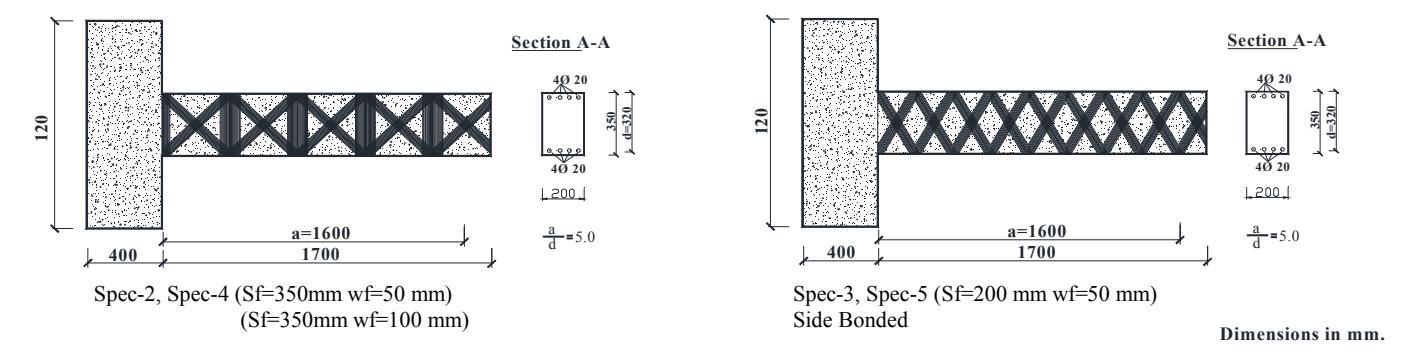
Fig. 2 CFRP Arrangements for Specimen Beams

Undamaged specimens, two specimens, Spec-4 and Spec-5, from the second group, were strengthened with the identical strengthening schemes of repaired & strengthened specimens for comparison [10]. The details of different ways of strengthening schemes are presented in Fig. 2

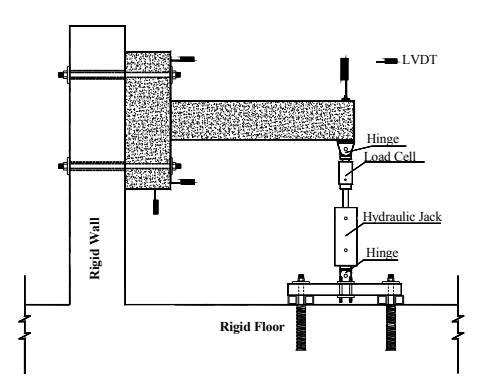
Fig. 3 Test Setup and Instrumentation

All specimens were tested under cyclic loading. To perform cyclic load to the specimen, a loading column was designed with hinges by the beam's free end. Loading column contained two hinges, a load cell and a hydraulic jack. The capacity of the hydraulic jack was 500kN while the load cell's capacity was 400kN with 0.06% linearity. Load was applied in cycles of loading and unloading. Load cycles were selected as they will help to evaluate the flexure and shear crack propagations and their affect to behavior. Loading was increased up to yield of flexural reinforcements or until the failure of the specimen. Four linear variable differential transformers (LVDTs) were used to monitor displacements. The LVTD's are located at the end of the beam for maximum displacement, under the rigid support to calculate the undesired displacement and finally on the rigid support to calculate the rotation. A schematic view of experimental set-up is shown in Fig. 3.

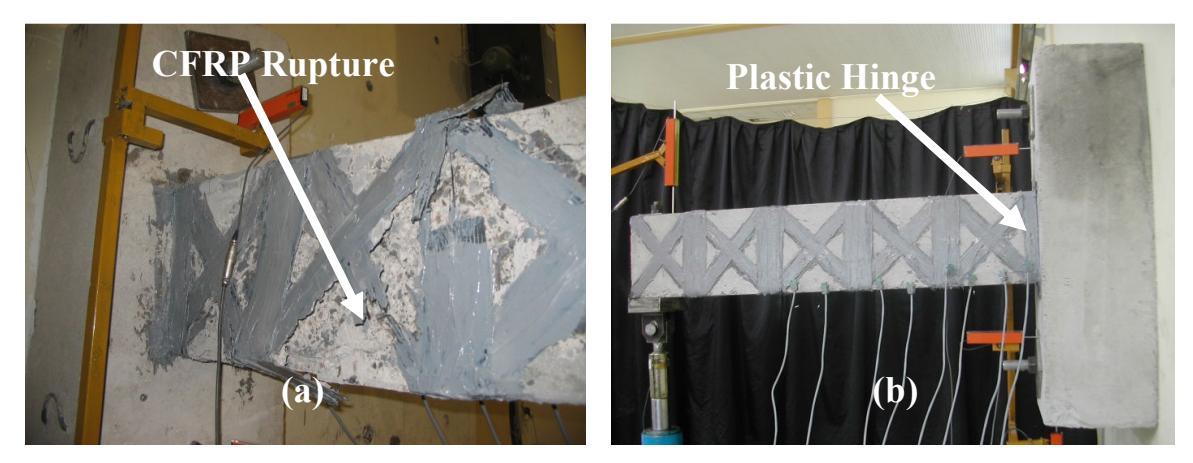
Fig. 4 Failure modes of Specimens

SPEC-2 was strengthened by considering that the tension face was heavily damaged and a main crack at the beam body was situated. In this instance, inclined CFRP strips in which vertical CFRP strips were wrapped the beam at the overlapping regions was preferred for strengthening. Although the beam was heavily damaged, beam behavior was developed by the evaluated repair and CFRP strengthening technique. Longitudinal compressive and tension reinforcements of the beam were reached at their yield strengths at 106.33kN and -105.21kN load, respectively. Specimen was constrained and finished two more load cycles after the yield of the longitudinal reinforcements. However, localization of shear cracks at a section compelled the strips to higher stresses that they can resist and right after CFRP strips were ruptured at -103.82kN load level. As the strengthened part lost its resistance against shear, critical shear crack propagation was materialized abruptly at the decayed section as can be seen from Fig. 4 (a). The repaired main crack was endured until the rupture but abandoned and heavily damaged right after the failure occurrence. The behavior of SPEC-4 did not bear a resemblance to SPEC-3. In spite of the new load cycles that were exposed to the SPEC-4, no significant increase on the number and size of cracks has seen after the yield of the longitudinal reinforcements. In addition, the new propagated and previously developed shear cracks did not intensify at a section. Therefore, CFRP strips were not compelled under increasing stresses as much as SPEC-2. As the specimen's behavior was reliable, a plastic hinge was formed between the supporting base and all through the cross section of the beam. This resulted in a ductile beam, which is able to undergo visible deflection without losing its load carrying capacity (Fig. 4).

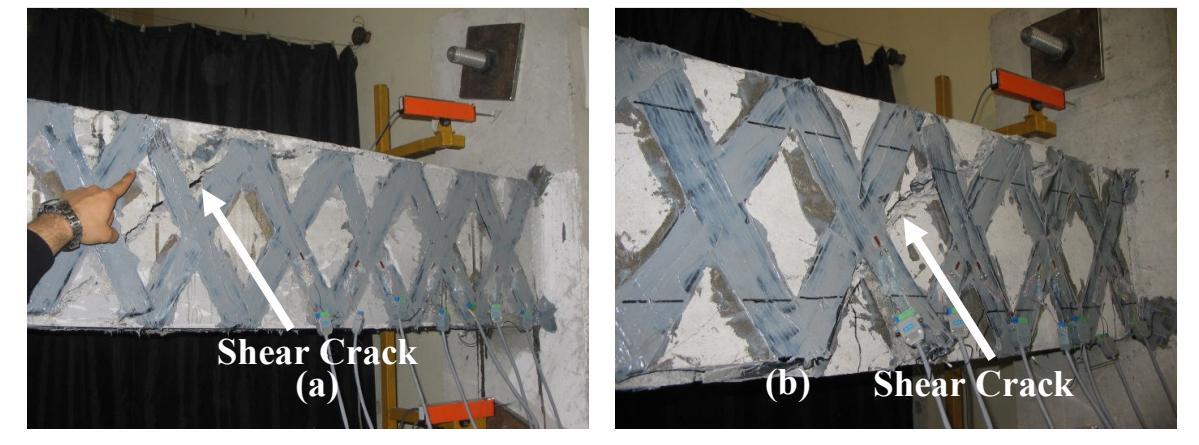
Fig. 5 Failure modes of Specimens

SPEC-3 and SPEC-5 showed similar behavior and strength when tested. The only distinction between these specimens is the region where the main shear cracks were advanced. Various shear cracks were developed at the shear span until completing the 90 kN load level but none of these cracks were critical. However, during the forward loading step of 90 kN load cycle, both large and small scaled shear cracks were intensified between the fifth inclined cross and the sixth inclined cross. There after specimen strength was decreased %1. Notwithstanding, an increase at strength was observed and specimen straightened up that unconscious state without failure. As the load increased, small scaled cracks' length and wideness was increased at once and that cause the specimen to fail in shear at 93.92 kN load level (Fig. 5 (a)). Shear cracks were not propagated at a specific section but all throughout the shear span for SPEC-5. Besides, less shear crack propagations were also observed according to SPEC-3. It was expected that specimen behavior will be directed to flexural while testing. However, at 97.31 kN load level main shear crack, which was developed between the third inclined cross and the fourth inclined cross, was advanced abruptly and caused the beam to fail in shear as seen from Fig. 5.
