International Journal of Mechanical, Industrial and Aerospace Sciences ISSN: 2517-9950 Vol:5, No:11, 2011

# Damage of Tubular Equipment in Process Industry

Pavel Lošák, Tomáš Létal, Radek Nejezchleb

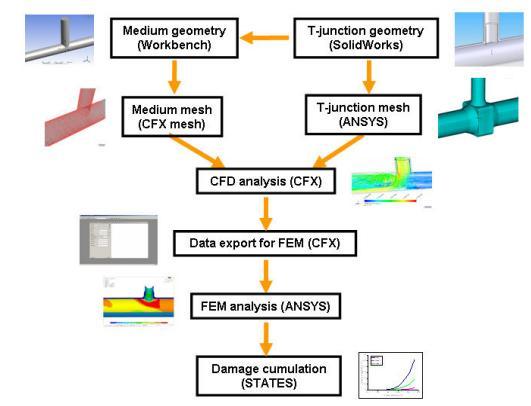
As it is not possible to assess equipment only from the operational temperature and pressure point of view, a very often used method for solving different kinds of tasks is the method of interactions of CFD and FEM analysis (FSI). These interactions of heat-hydraulic and tension analyses are called Fluid Structure Interaction (FSI). This method has been frequently used for solving different tasks in many industrial branches for several years [1], [2]. One of the possible procedures of solving tasks with the FSI method including assessment of fatigue is depicted in the Fig. 1 It is an analysis of a nozzle where flows of different temperatures and flow rates are being mixed.

Fig. 1 Diagram of design procedure of the FSI method including the assessment of fatigue

Thanks to the FSI method influences of the current speed and the distribution of temperature fields that contribute significantly to fatigue damaging of critical parts of the equipment are taken into account. This is often omitted in case of common calculations.

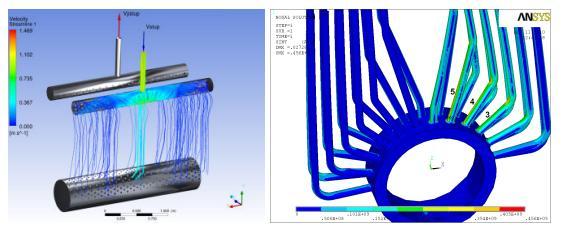
In this case it was an economizer of a waste-heat boiler, where after certain operation time spots where pipes connected to collectors were being damaged. It was not possible to determine the cause of the damage on the basis of operational conditions, because the stress in critical regions was negligible. Based on analytic heat-hydraulic calculations and CFD simulations the distribution of temperature fields was determined thus making this problem clear. The crucial problem was the low speed of water in the economizer and its imperfect distribution into other pipes. Because of that the speed in pipes under the distribution piping was high and in surrounding pipes it was significantly lower. In some of them the emerging negative pressure even caused flow in opposite direction (in the Fig. 2 on the left there are depicted the flowlines of medium in the correct direction, those not depicted flow in opposite direction).

Because of the uneven flow of medium the pipes were unevenly heated and those that were cooled better were gradually damaged. In the Fig 2 on the right one can see the stress distribution in critical areas near the connection of the pipes to the collector. Here there are apparent increased stress values in welded joints that were gained via stress analysis of temperature fields obtained from previous analyses and that confirm the cases of damaging in these areas.

Fig. 2 The results of CFD and FEM analysis of the economizer

The corrective action in this case would be to come with more appropriate structural design that would distribute the working medium better (the input and output piping must not be placed perpendicularly to the collectors but from the side) and that would be able to compensate the dilatations of the tube nests (avoid the connection of many pipes of small dimensions on firm piping of a large dimension). Thanks to these modifications it is possible to ensure a trouble-free operation of the boiler. Revision controls that must be planned and carried out should not be underestimated though.

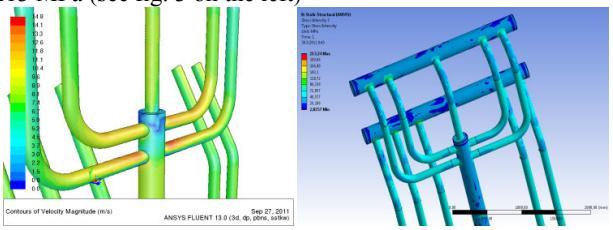
The second case solved in practice was a connecting piping of individual drafts of the evaporator of the fluidized bed boiler. It was a special construction that should have eliminated the dilatation of particular pipe manifold and distributed the working medium from one coil to another better (see Fig. 3). The working medium was saturated steam with the pressure of 3.3 MPa and working temperature about 290°C.

When carrying out the classical stress analysis using the FEM it was discovered that in the welded joint of the pipe and the main pipe the maximum tension was about 150 MPa. But this value was not significant considering the used material. That is why the examination of temperature fields was carried out, because water was distributed into the main vertical pipe through a little pipe coupling to regulate the temperature of the steam. In the Fig. 3 the flowlines are depicted, thanks to which it was found out that the flow rates of the working medium are not the same in all the pipes. Thanks to this analysis the distribution of the temperature fields that is crucial from the stress point of view was obtained.

The discovered distributions of temperature fields were the end conditions for the stress analysis of the transfer tubular construction. Because the temperature fields were specified, there occurred areas where the stress increased significantly to 213 MPa (see fig. 3 on the left)

Fig. 3 The results of CFD and FEM analyses of the transfer pipe of the boiler
