Non-Chronological Approach in Crane Girder and Composite Steel Beam Installation: Case Study

International Journal of Architectural, Civil and Construction Sciences ISSN: 2415-1734 Vol:11, No:4, 2017

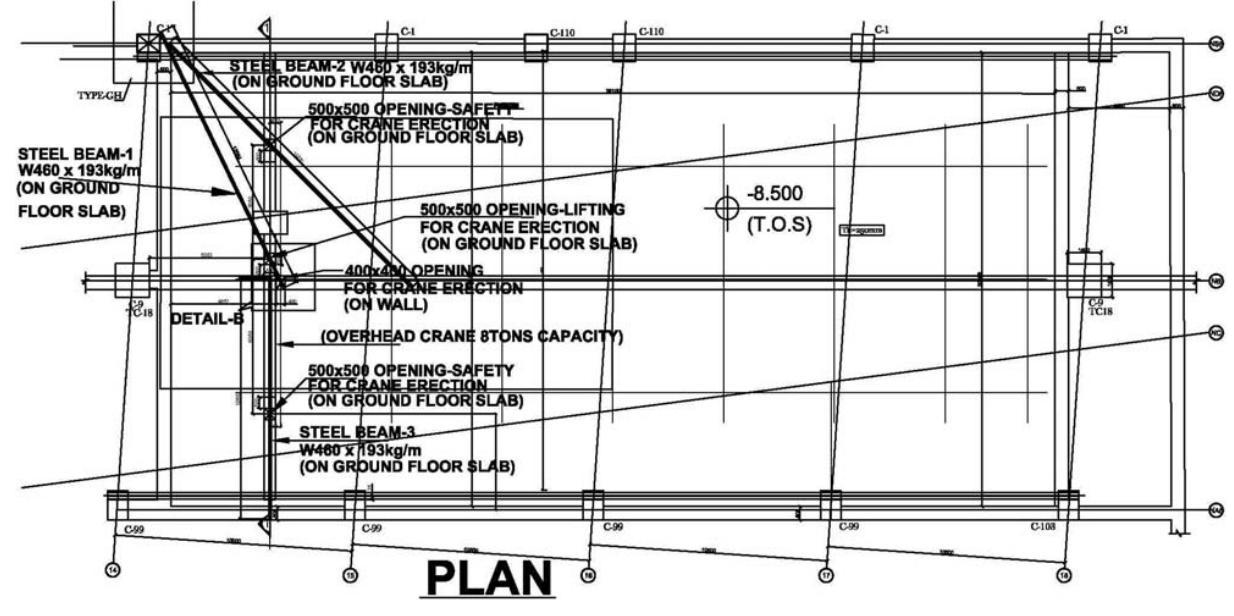
Fig. 1 Plan view of crane-girder below the ground floor slab

In a project with two-story massive building, we have to install a 19-meter long overhead crane girder just below the ground level. There was a composite beam (steel and concrete) of 42-meter length at the ground floor and it crosses 90 degrees at the center of overhead crane girder. There were five numbers of composite columns located above the ground floor composite beam and similar structure continued up to second floor. Moreover, the composite beam supports floor slabs and beams of 10 m wide on both sides at each floor. The usual chronological procedure is described as below:

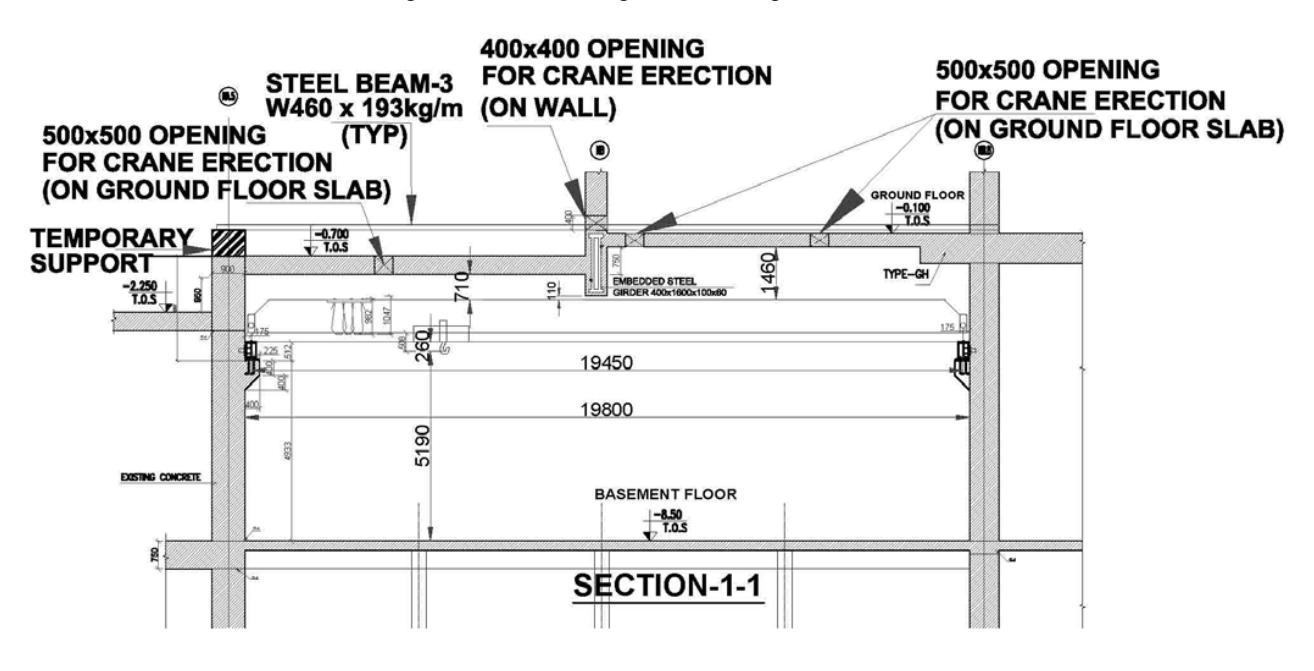
Fig. 2 Section view of crane-girder below the ground floor slab

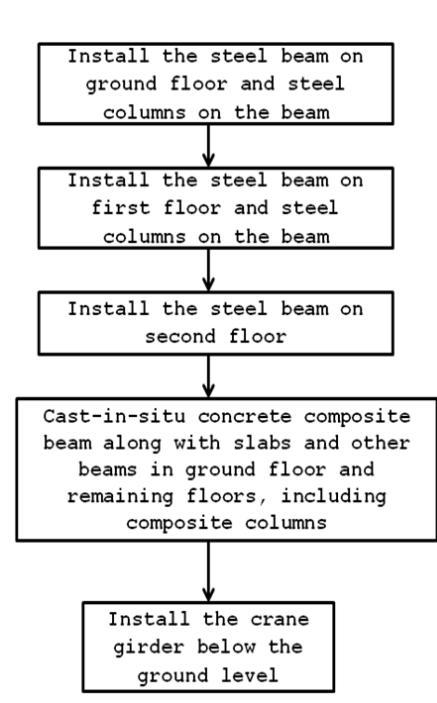
Fig. 3 Proposed non-chronological procedure

After careful study of the actual situation, the following sequences of work activity (as illustrated in Fig. 3) decisions were taken with pre-measure activities.

We started with the installation of steel beams and steel columns starting from ground floor based on our proposed approach, as illustrated in Fig. 3. The steel beams are of 400 X 1400 mm, 400 X 1700 mm, and 400 X 2000 mm. The columns are of 400 X 1600 mm, 400 X 1400 mm, and 400 X 1000 mm. The overhead crane girder is of 19 m long.

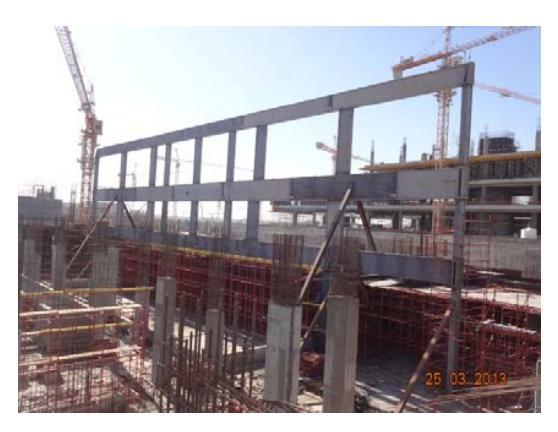
Fig. 4 (a) Installation of steel beams and columns (basement view)

The installation of steel beams and steel columns from ground floor view is illustrated in Figs. 4 (a) and (b). The complete structure after the installation of overhead crane girder is illustrated in Fig. 5. The spacing between the top of the overhead crane girder and the bottom of the beam is 250 mm.

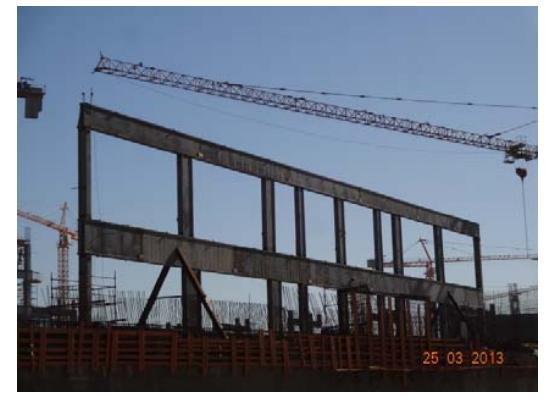
Fig. 4 (b) Installation of steel beams and columns (ground floor view)

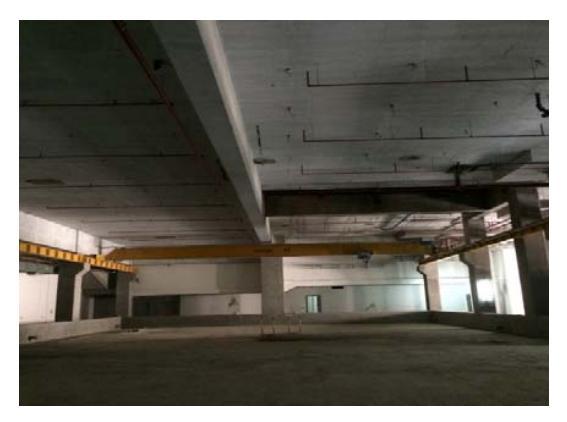
Fig. 5 Installation of overhead crane girder

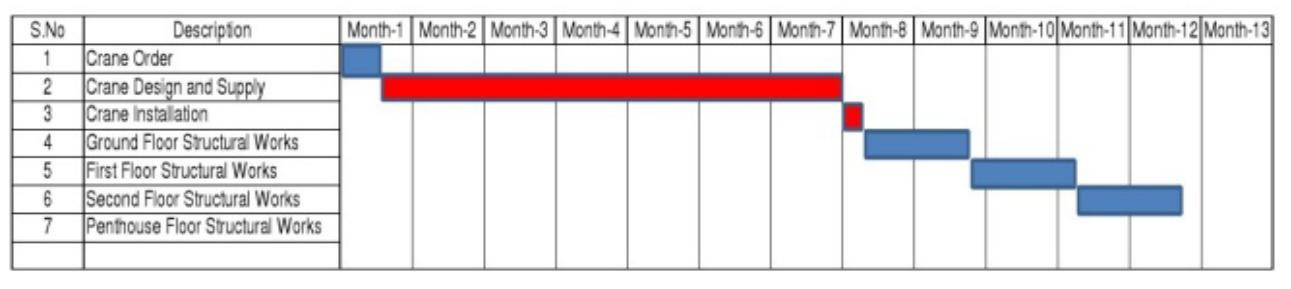
Fig. 6 (a) Chronological project planning

The scheduling of the sequential construction activity and the change from sequential to parallel activity, are demonstrated as in Figs. 6 (a) and (b), using the partial planning chart. Hereby, it is observed that the sequential construction activity leads to a 12-month time period, whereas the proposed parallel activity reduced the time span to eight months. Our creative approach saved 33% (approx.) of the time span.
