# Preservation of Isparta Yılan Kırkan (Yılan Kıran) Fountain within the Scope of Sustainability

Meryem Elif Çelebi Yakartepe, Ayşe Betül Gökarslan

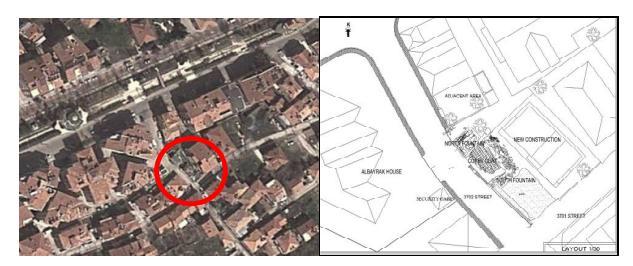
Fig. 2 Yılan Kırkan Fountain location and layout (relief)

Yılan Kıran (Yılan Kırkan) Fountain is located in Isparta Province, Sülübey Neighborhood, İğci Street (street no 3702), in front of the house known to be owned by İlyasoğulları (Fig. 2) It is located in parcel 55 in island 1321. It's also known as "Dolma" or "Çukur" Fountain. It was built by İsa Fakıh, son of Mehmet.

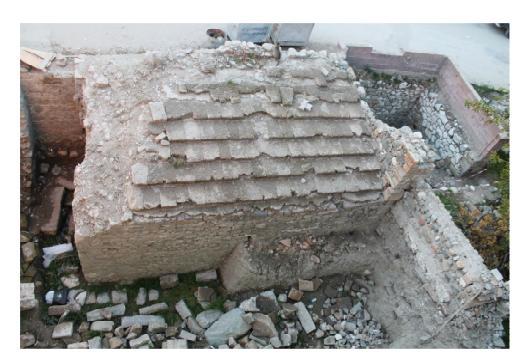
Fig. 4 Yılan Kırkan Fountain, from worksite which located besides fountain

The debris on the immovable was cleaned in 1999 and the fountain was revealed. During the debris cleaning, an inscription of the fountain with the proportions of  $0.26 \times 1.01$  m was found. A cleaning excavation was carried out with the by the decision no. 3087 by Antalya Cultural Heritage Preservation Board dated 30.04.2009 [3] (Fig. 4).

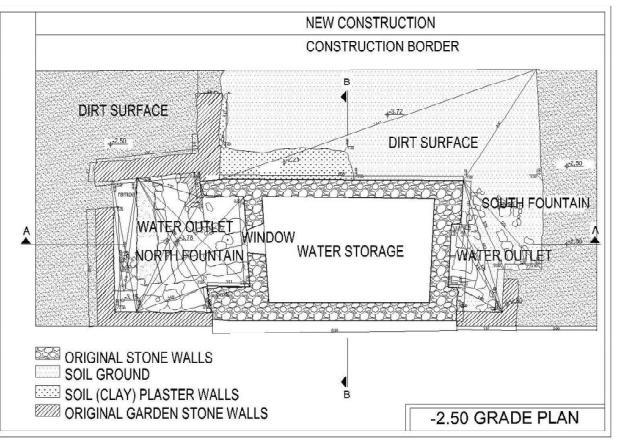
Fig. 5 Yılan Kırkan Fountain's plan (relief)

Yılan Kırkan Fountain consists of a rectangular water reservoir and the fountains to the north and south of this reservoir (Fig. 5). Water reservoir 7.00 m. x 4.60m. It fits on a field and is 4.40 meters high.

Yılan Kırkan Fountain was built with grey local material, known as grey "sav" stone that was common in the area, through using masonry construction technique. The body walls built with debris stone technique was covered with the squared stones.

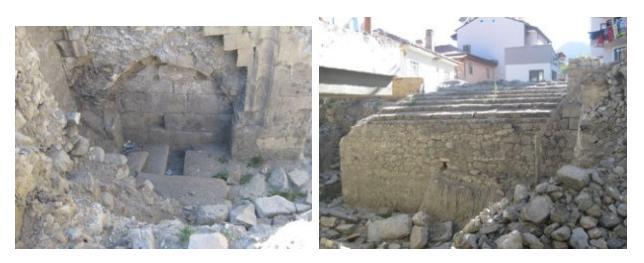
Fig. 6 Fountain's south and east facades

The north and south sides of the fountain consist of niches with semi-circle arch within a rectangular molding. It is known that there were inscriptions in these sides; however, this inscription did not survive to these days. In the north side of the fountain, there is a semi-circle arch window gap opening to the water reservoir (Figs. 6 and 7).

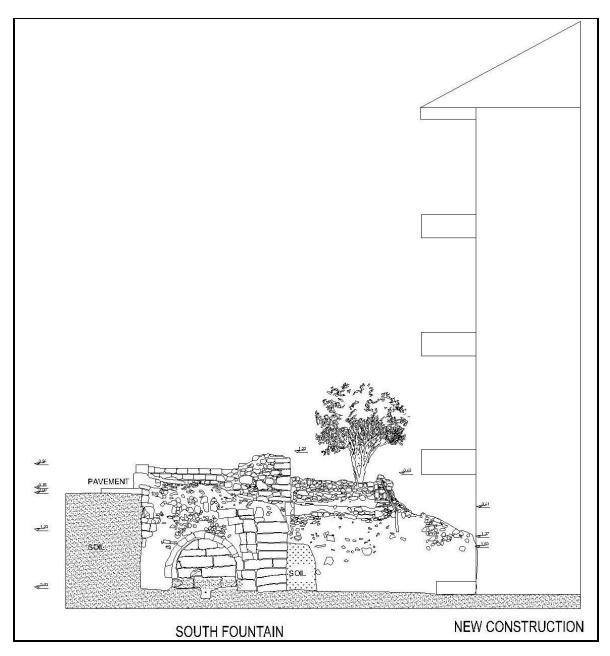
Fig. 8 Yılan Kırkan Fountain's south facade (relief)

Today, the attempts of contractor-style structuring crushes, even destroys many historical constructions. The construction, structuring of which started in the same parcel with Yılan Kırkan Fountain, got too close to the fountain and due to elevation difference, the fountain which went below remained neglected and desolate (Fig. 8 and 9).

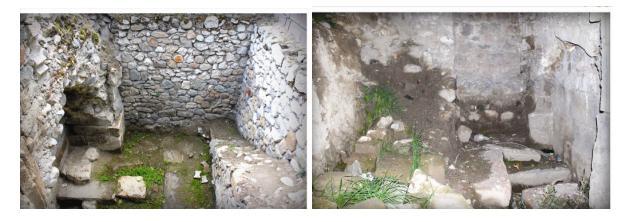
The debris removed during the structuring works too close to the fountain was thrown on the historical fountain and while starting the structuring on the fountain yard, the cover coat of the historical fountain was damaged during the cleaning of the debris. Most of the cover stones on the sides of the fountain have dropped.

A large portion of the fountain is destroyed; material losses occurred in the north and south sides. There are vegetation problems on the sides and dampness and mossiness problem on the ground. The west side remained under the rising road elevation and the main mass of the structure remained in the construction yard of an apartment that is being built. The distance between the apartment and the fountain is less than 1 meter (Fig. 10).

Fig. 10 Fountain deteriorations (material losses, vegetation on the sides, dampness, mossiness problems from the ground etc.)

It is suggested that the fountain should be moved to an area appropriate for its nature in the town center and repaired, since;

After the historical fountain is moved, the restoration should be completed with reintegration, consolidation and liberating techniques.
