# SEM and AFM Investigations of Surface Defects and Tool Wear of Multilayers Coated Carbide Inserts

Ayman M. Alaskari, Samy E. Oraby and Abdulla I. Almazrouee

## International Journal of Mechanical, Industrial and Aerospace Sciences ISSN: 2517-9950 Vol:5, No:1, 2011

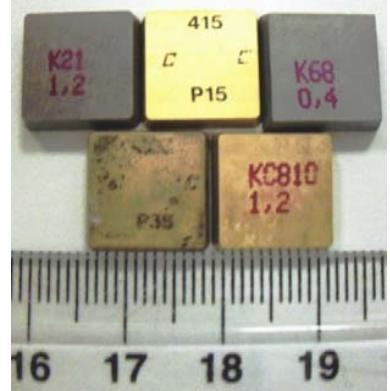
Fig.1 Types of some of the employed coated and uncoated carbide inserts

Five as received different types of tool inserts are tested throughout the different stages of this study; two uncoated and three multilayer coated with a cemented carbide substrate (as shown in Figure 1). The uncoated types are Kennametal K68 and K21 carbide inserts with ISO application range: M10-20 K05-20 (ANSI Range: C3). It consists of a hard, low binder content, unalloyed grade WC/Co fine-grained grade. As claimed by manufacturer, grade K68 has excellent abrasion resistance for machining cast irons, austenitic stainless steels, non-ferrous metals, nonmetals and, it is recommended by manufacturer to be used as a general purpose grade for non-ferrous materials.

The specifications of each of the three coated inserts are given as follow: the first coated carbide insert to test is the Kennametal multicoated KC810 CVD coated carbide with ISO Range: P10-30 (ANSI Range: C6-C7). It consists of a multilayered coating over an alloyed carbide substrate. As recommended by manufacturer, it is used for general steel machining at low to moderate speeds. Another two types of coated carbide inserts are used in this study: Sandvik CVD multicoated GC415 and GC435. The CVD TiN-Al2O3-TiC multilayer GC415 coated inserts are intended for turning steel and cast iron (P05-30, K05-20, C6-8). Due to its high wear and plastic deformation resistance, it is recommended for high metal removal rates within a broad application range. The multilayer coated GC435 (1 µm TiN followed by 3 µm Al<sub>2</sub>O<sub>3</sub> and finally a layer of 5  $\mu m$  TiC over the sintered carbide substrate) is used for steel cutting (ISO P35 range) with decreasing rates of plastic deformation and growth of thermal and mechanical fatigue cracks. Inserts are of SPUN 12 03 12 (thickness = 3.18 mm & r=1.2 mm & l=12.7 mm, clearance angle = 5-7 rake angle = 6).

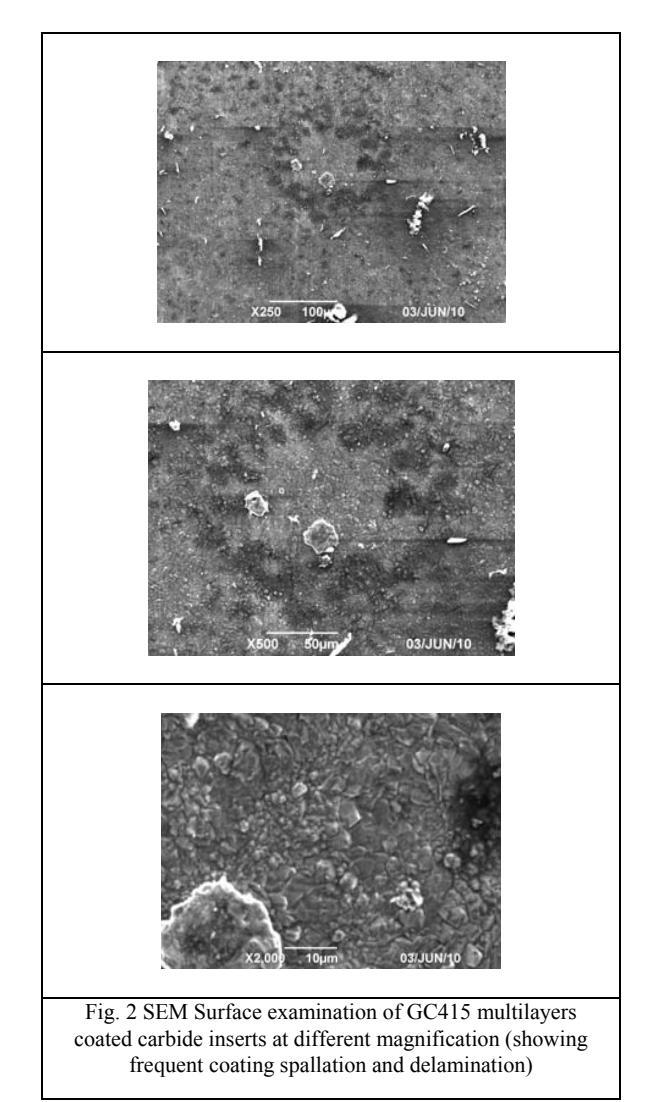
Generally, since SEM can provide a wider area for examinations than AFM, SEM investigations were first carried out for the unused multi-layers coated and uncoated carbide inserts to assess any manufacturing defects. Different defects were found in the unused carbide insert that include spallation, delamination and macro-particles of the coating. Different image magnification was taken to show the overall defected areas. For example, Figure 2 shows the spallation and delamination of coating in different magnifications. Agglomeration of coating particle was also present in some spots of the coated inserts.

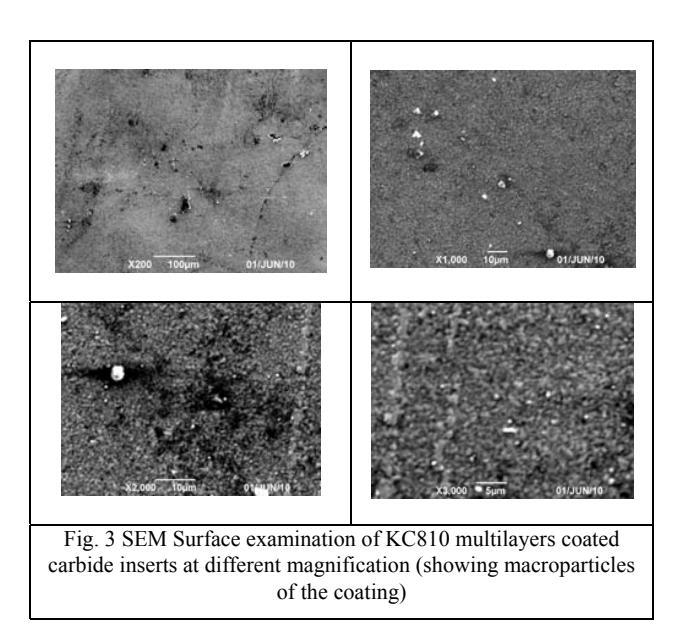
Macroparticle of coating is found in secondary electron image of multilayer coated sample as shown in Figure 3. AFM was then used to investigate the same area of the sample and it gave another set of beneficial data as shown in Figure 4. The quality of surface smoothness can be assessed from the data obtained. The software of AFM provides many topographical aspects including classical roughness values, peak and summit texture data and surface area calculations for the entire image. The roughness of the surface and a coating droplet were found.

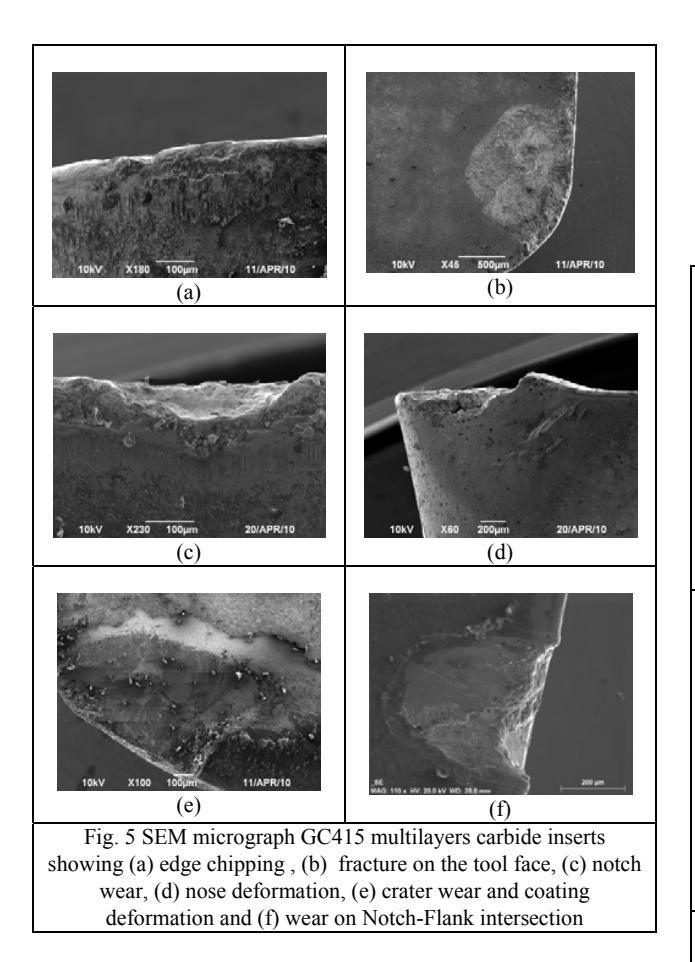
The second stage was to investigate the worn inserts. The same procedure used early was used here namely starting with the SEM then AFM. Low magnification secondary electron images were taken for the flaws and defects of the worn surfaces. Different modes of tool wear and deformation such as edge chipping, fracture on the tool face, notch wear, nose deformation, crater wear and coating deformation are shown in Figure 5.

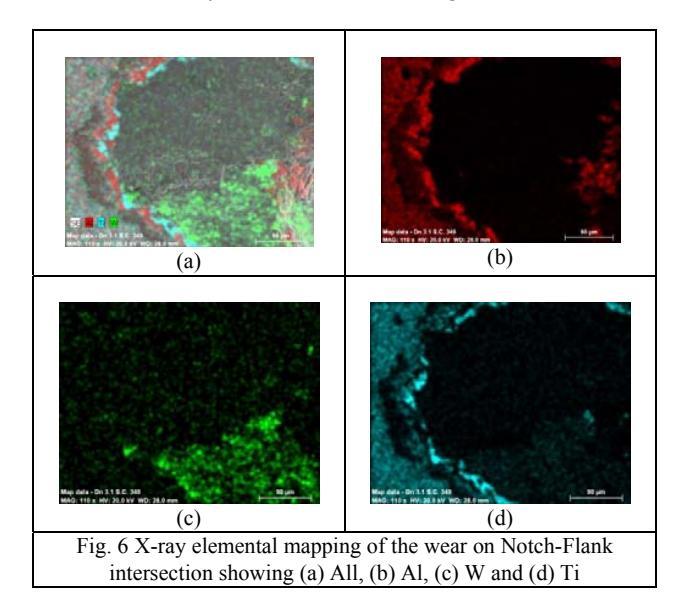
The X-ray elemental mapping attached with SEM allows the user to investigate the elements present in the worn layers of mulilayers coating. This was carried out to assess the wear extent in each layer and it is shown in Figure 6.

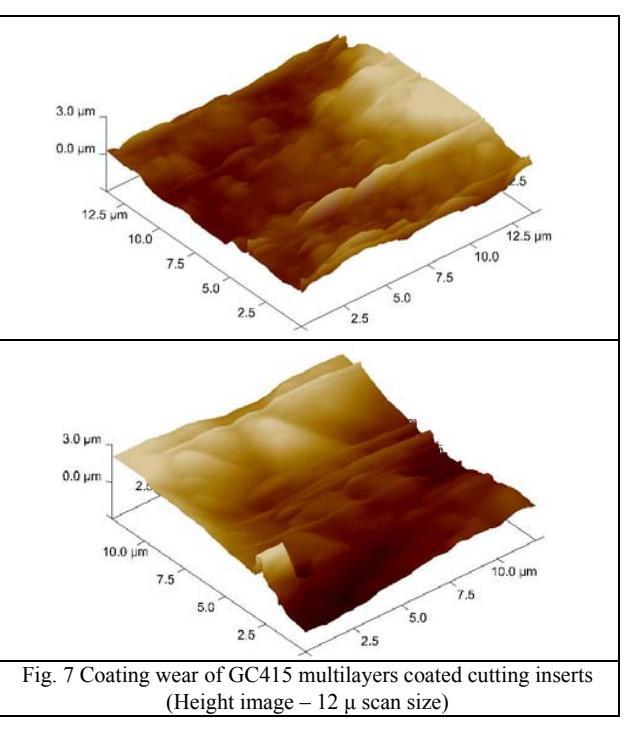
EDS was also utilized to check the semi-quantitative chemical composition of certain areas and points. The second stage was to use the AFM in some worn area to measure the different topographical parameters such as horizontal, vertical and surface distances. Two 3D Height images are shown in Figure 7 below.
