Diagnostics of Fatigue Damage of Gas Turbine Engine Blades by Acoustic Emission Method

Abstract—the work contains the results of complex investigation related to the evaluation of condition of working blades of gas turbine engines during fatigue tests by applying the acoustic emission method. It demonstrates the possibility of estimating the fatigue damage of blades in the process of factory tests. The acoustic emission criteria for detecting and testing the kinetics of fatigue crack distribution were detected. It also shows the high effectiveness of the method for non-destructive testing of condition of solid and cooled working blades for high-temperature gas turbine engines.

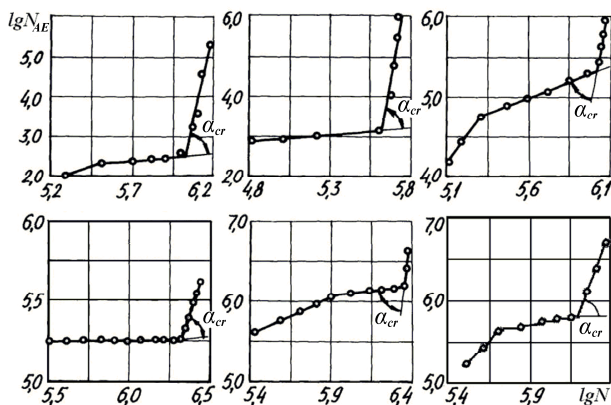
Fig. 1 presents the data characterizing dependencies $lgN_{AE} = f(lgN)$ at the example of six tests of the first lot of solid working blades. It is obvious that all dependencies have qualitatively similar nature: areas of slow growth of total AE are followed by areas of its sharp increase.

Fig. 1 Change of total AE during cyclic loading of solid blades with the use of α -criterion

Intersection of the specified areas form angles α_{cr} (α -criterion) [5, 6] that characterize the presence of inflection point in the graph. Tests of the first lot of blades were stopped at the point when α_{cr} appeared. For the second lot, reaching maximum value E_{max} (energy criterion – E_{cr}) by AE energy E was considered the criterion for stopping the tests.

In spite of different testing conditions from the point of view of stresses in the dangerous section of the body of the first and second lot of working blades, the behaviour of dependencies $lgN_{AE} = f(lgN)$ with the use of both α -criterion and E-criterion was identical (see Fig. 1, 3). The difference between graphs lies in the fact that testing of the first lot was stopped with the first appearance of α_{cr} (see Fig. 1), while the use of E_{cr} for the cessation of tests is followed by the appearance of one or more α_{cr} (see Fig. 3). Thus the graphs obtained for blades 2 and 3 have one α_{cr} ; the ones obtained for blades 1 and 4 have two α_{cr} ; the ones obtained for blade 5 have four α_{cr} .

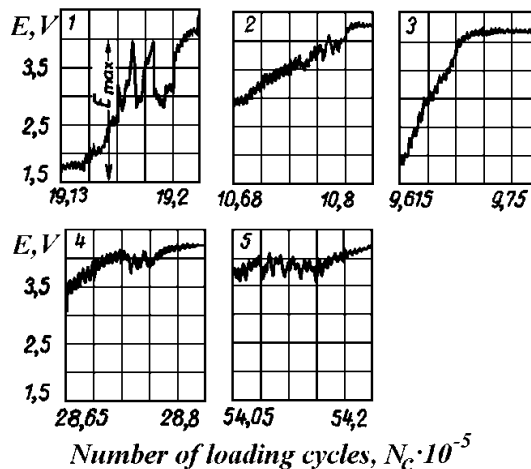
Acoustograms of energies and graphs of dependencies $lgN_{AE} = f(lgN)$ for tests of five solid blades from the second lot are shown in Fig. 2 and 3.

Fig. 2 Acoustograms of AE energy change during cyclic loading of solid blades with the use of E-criterion

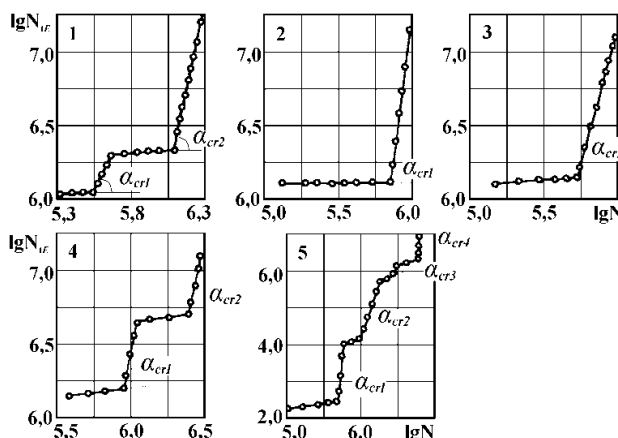
Fig. 3 Change of total AE during cycling loading of solid blades with the use of E-criterion

However, the results of subsequent luminescent control revealed the presence of fatigue cracks in each of the both tested lots of working blades. The number of α_{cr} formed in the process of using E-criterion usually corresponds to the number of fatigue cracks that appeared during the tests.

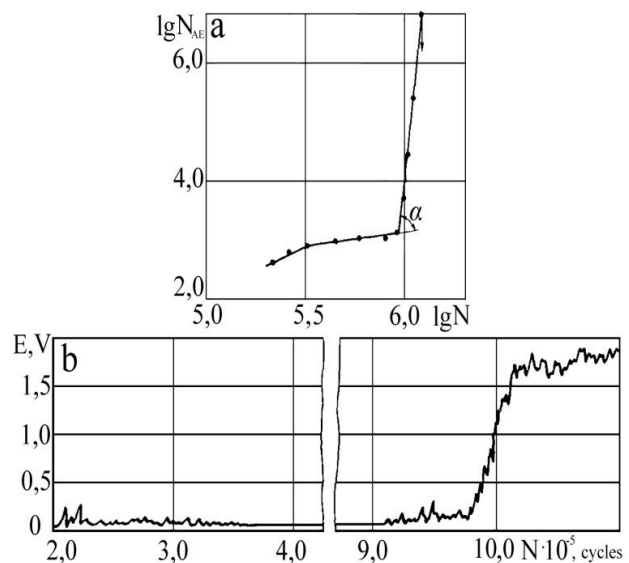
For cooled blades, investigation was carried out in three stages. At first, in the conditions of stationary cyclic loading with the stresses of $\sigma = 220$ MPa, the tests were carried out until the operation of the “roughest” criterion E_{cr} . In this case, the nature of dependencies $\lg N_{AE} = f(\lg N)$ is identical to the one that was obtained earlier for solid blades: areas of slow growth N_{AE} are followed by areas of sharp increase. Intersection of the specified areas form angles α_{cr} , similarly to the case with solid blades. At the same time none of the tested blades lost its rigidity properties (natural-vibration frequency of blade body remained constant). Fig. 5 presents the results of specified dependencies change at the example of one of the tested blades.

Fig. 5 The change of total (a) and energy (b) of AE signals in the process of cyclic loading of a cooled working blade (the point at which the tests were stopped is shown with an arrow)

after its opening. It is seen that the fatigue crack in the blade, for which the dependency was obtained and which is presented in Fig. 5, appeared near the base of the cooling intensifier of a cylindrical shape (shown with an arrow). Fig. 6b presents a photo of fracture area along the crack. It is seen that the fatigue crack in this blade has developed to the depth, which is greater than half the thickness of the wall of blade body back, however it has not reached the outside surface yet. The metallographic analysis of other fractures along such cracks showed that they also had fatigue nature and were developing from the inner surface of hollow blades to their outside surface.

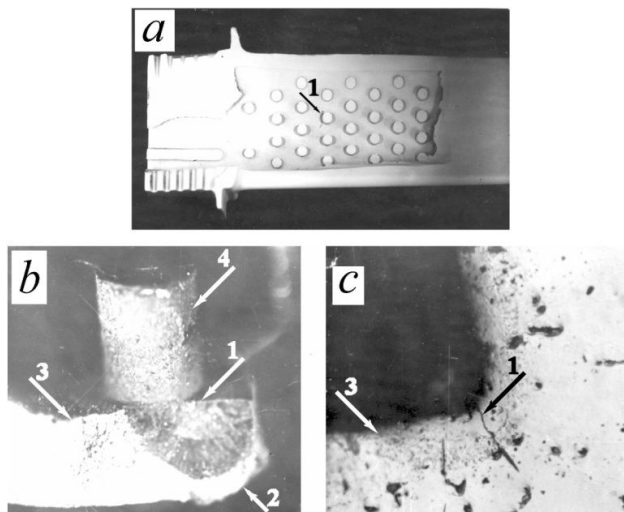
Subsequently all blades were subjected to tests to reveal the presence of cracks with the help of traditional methods. The carried out luminescent control did not show any defects on the outer surfaces of the blades. After opening, defects of crack type were detected in the blades. Fig. 6a presents an example of a photo of inner cavity of one of the cooled blades

Fig. 6 Photo of a blade with a crack: a) – general view of the internal cavity after opening, b) – area of fracture along the crack (x10), c) – metallographic section (X100): 1 - crack, 2 – outside surface of blade, 3 – inner surface of blade, 4 – cooling intensifier

Thus the high efficiency of α_{cr} operation is demonstrated, while the use of E_{cr} in these tests gave the opportunity to reliably register the appearance of fatigue cracks by using traditional methods. Further metallographic investigation demonstrated that the earlier the tests were stopped after α_{cr} registration the smaller was the crack. In cases when tests were stopped practically right after the registration of angle α , cracks could be detected only after long-term exposure (more than three days) with the help of the luminescent method. Subsequent metallographic analysis of sections of these areas confirmed the presence of fatigue cracks (Fig. 6c).

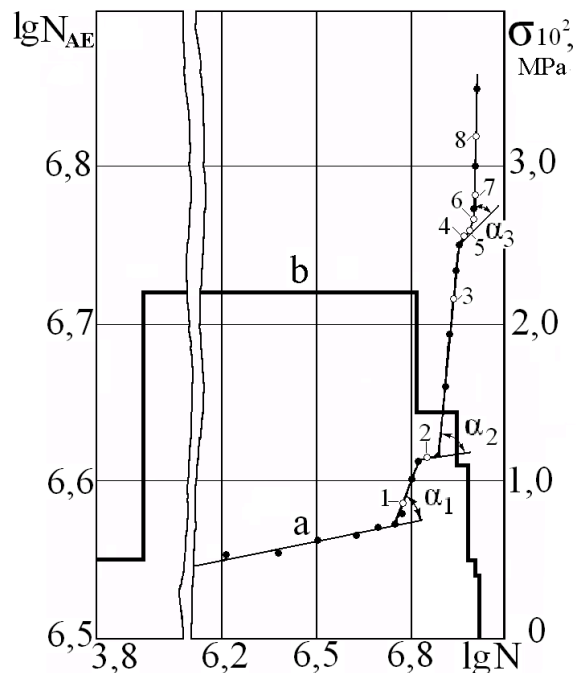
purpose arose. The process of “growing” in certain moments involved the repeated use of fatigue tests of α_{cr} and E_{cr} , the essence of which lies in the following facts: The investigated blade was preliminarily subjected to cyclic loading that created the stress equal to 50 MPa. If AE was not recorded, the blade was considered defect-free. Then, in order to accelerate the experiment, the stress was increased up to 220 MPa with subsequent stepwise decrease at the moments of time corresponding to the initial appearance of a crack and then corresponding to its accelerated growth with new stress values. Graphical construction of dependency $\lg N_{AE} = f(\lg N)$ was carried out right in the process of testing using the above described method. The load was reduced at the moments of time that corresponded to reaching AE signals energy value E_{cri} after the recording of angles α_{cri} (Fig. 7) where $i = 1, 2, 3, \dots$ is a number of stepwise reductions of load.

Fig. 7 The change of total AE (a) in case of staged step change of stress (b) in the process of cyclic loading:

● – experimental points; ○ – points corresponding to the record of acoustograms of AE signals energy change

Thus the first reduction was made after operating time $lgN = 6.81$ (see Fig. 7b) after the formation of angle α_{cr1} and subsequent operation of energy criterion E_{cr1} , which characterized the reliable appearance of fatigue crack. The change of AE signals energy in the area prior to the reduction of stress is presented in Fig. 8 (acoustogram area 1, obtained in point 1) with $lgN = 6.78$ (see Fig. 7a). With a new stress value which is equal to 145 MPa (see Fig. 7b) the deceleration of the crack occurs, which is confirmed by the change of total AE (see Fig. 7a) and the reduction of energy level (see Fig. 8, acoustogram area 2) obtained in point 2 with $lgN = 6.83$ (see Fig. 7a). In the process of subsequent cyclic loading, the growth of the crack accelerates (angle α_{cr2} is formed). The level of energy increases again up to value E_{cr2} , which can be well seen in Fig. 8 (acoustogram area 3 obtained in point 3) with $lgN = 6.94$ (see Fig. 7a). Then, with $lgN = 6.95$, the following reduction of stress up to 110 MPa was made (see Fig. 7b), which entailed the deceleration of the crack and, correspondingly, the reduction of values of AE parameters (see Fig. 8, acoustogram area 4). After the recording of angle α_{cr3} , the level of energy increases up to value E_{cr3} (see Fig. 8, area of acoustogram obtained in point 5). At the moment corresponding to operating time $lgN = 6.99$ the stress was reduced up to 50 MPa (see Fig. 7b). The growth of the crack decelerated for a short time, which is insufficiently reflected in Fig. 7a and well illustrated in Fig. 8 (area 6 of acoustogram obtained in point 6), with $lgN = 6.99$ (see Fig. 7a). Then the growth of the crack accelerates again, which is confirmed by the increase of AE energy level up to another energy criterion E_{cr4} (see Fig. 8, acoustogram in point 7). The next reduction of stress up to 40 MPa practically does not exert any influence on the velocity of crack growth; energy criterion remained at the same level of E_{cr4} (see Fig. 8, acoustogram in point 8). When the stress was below 40 MPa, counting with the help of the frequency meter stopped. During the subsequent luminescent control of blades tested with the help of the above described programme no cracks were detected on the outer surface. However, after the opening of blades, both the luminescent control and the metallographic analysis confirmed the presence of cracks of fatigue nature on inner surfaces.

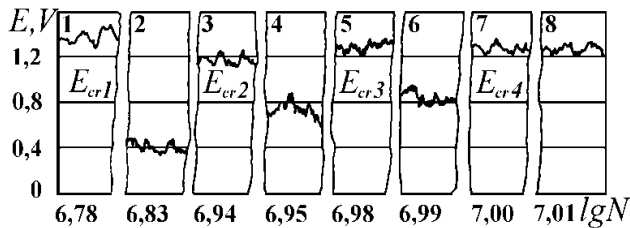
Fig. 8 Acoustograms of AE signals energy change at typical stages of loading of a cooled blade

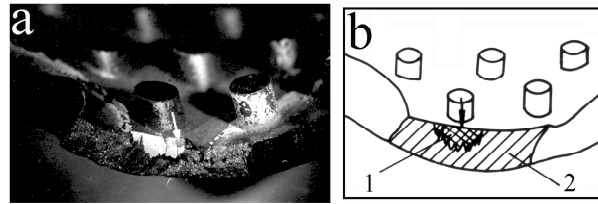
Fig. 9 presents a photo and a diagram of blade fracture along the crack (shown with arrows), for which the dependencies presented in Fig. 7 and 8 were obtained. It is seen that the crack in this blade has reached approximately half the thickness of the wall and has not reached the outer surface.

Fig. 9 Photo and diagram of blade fracture along the crack
