Seismic Behaviour of Romanian Orthodox Churches, Modeling of Failure Modes by Rigid Blocks

Marius Mosoarca, Victor Gioncu, Ovidiu Cosma

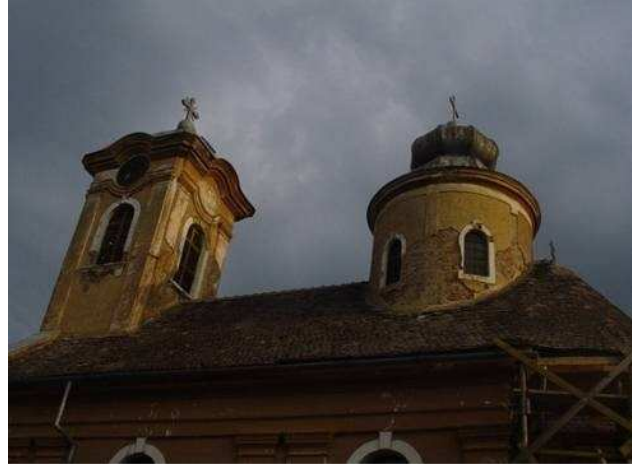
Fig. 9 The two towers of the church

Hall-type church building is covered with brick arches and wood framing. The church has two towers: the West Tower and East Tower in Fig. 9 and Fig. 10.

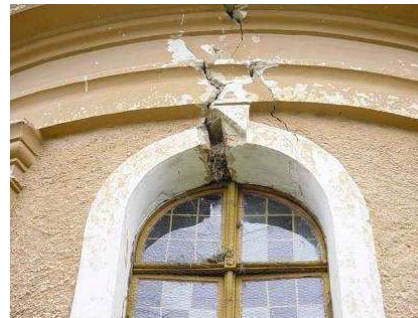
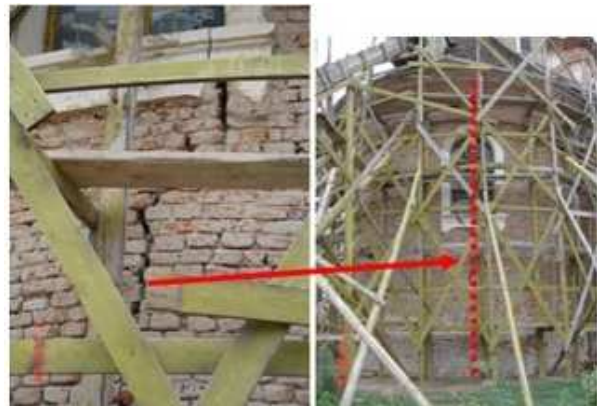
Brick walls are 75 cm thick, reinforced with brick pillars in front of the roof arches. Masonry structure has a longitudinal symmetry, except the West side where the presence of the stair has introduced an asymmetry characterized by walls with a thickness of 40-45 cm. The window openings on the altar apse and reduced thickness of the wall under the windows have caused cracks in Fig. 14.

Fig. 14 Cracks at the eastern wall

- i. The biggest cracks are developed in the eastern wall next to the altar, in full compliance with the structural issues outlined above in Fig.8.
- ii. Next, most important, are the cracks from the southern wall, the northern being much less cracked;
- iii. Asymmetrical turning tendency can be seen on the walls of the western tower, south wall is much more cracked than the northern, while at the western and eastern walls, cracks were insignificant;
