# Wear Mechanisms in High Speed Steel Gear Cutting Tools

M. Jalali Azizpour, H. Mohammadi majd

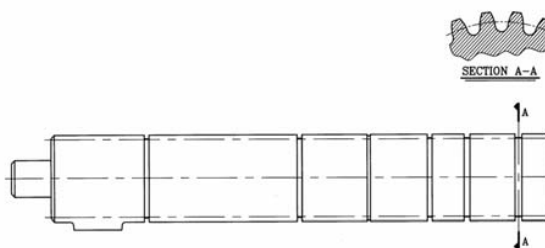
Fig. 1: Main shaft of a tractor as gear blank

The main shaft of a tractor (Fig.1) is selected as gear blank.

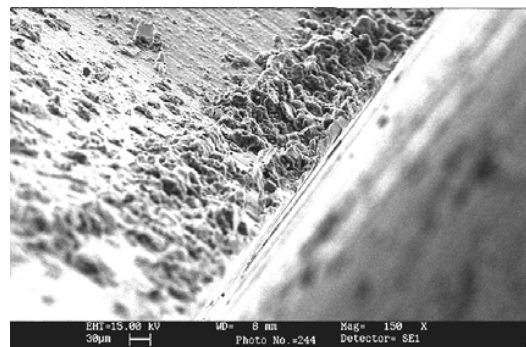
Fig. 2: SEM topography of built-up edge

BUE Causes a sudden failure in cutting edges in chipping form. The relative motion between Tool and blank at such condition is stick-slip. At higher cutting speeds, this relative motion changes to slip so that the BUE will be unstable to play a wear particle (debris) role, causes three body abrasion wear. Fig.2 shows the SEM topography of BUE in the cutting edge. The segregated carbides and hard partied from tool and blank have the same effects.

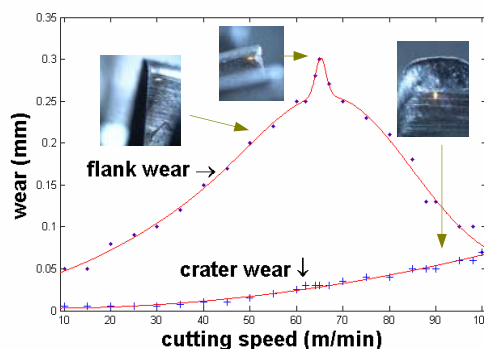
Fig. 3: Flank and crater wear vs. cutting speed

As shown in Fig.3 increasing the hobbing speed leads to high abrasion wear. The peak of flank wear is at 65 m/min. At  $V = 65$  m/min the flank wear is 0.3 mm. in this condition each of the adhesive and abrasive wear is present but the abrasion is the predominant wear mechanism. Fig. 4 shows the SEM topography of the adhesive wear that exists at each condition. This adhesive component often is referred to as mild adhesive wear.

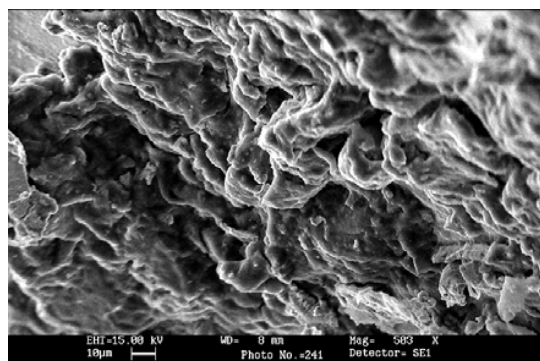
Fig. 4: SEM topography of adhesion wear mechanisms

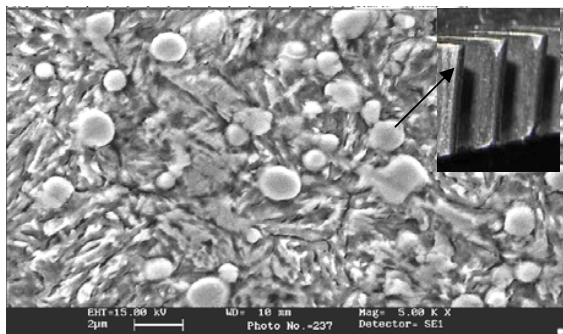
Fig. 5: SEM micrograph of ASP30 hob microstructure

Fig.5 shows a micrograph of the microstructure from ASP30 hobs. Fig.6 shows a micrograph of the microstructure from AISI M2 steel used as hob material. As can be seen, the microstructure consists of hard particles dispersed in a soft matrix. ASP30 that is the product of Anti Segregation Process has fine carbides as well as homogeneous distribution of carbides through the matrix. Then it is difficult for the particles to segregate from the matrix and hence there will be some debris at the interface. For this reason, abrasive wear in M2 hobs is more severe compared with ASP30 hobs (see Fig.7). High degree of C/V proportion in the chemical composition (such as M42) leads to a reduction in the hardness difference between the matrix and dispersed carbides. It has the same effect on the abrasion as well as adhesion wear. The critical cutting speed in M2 hobs is

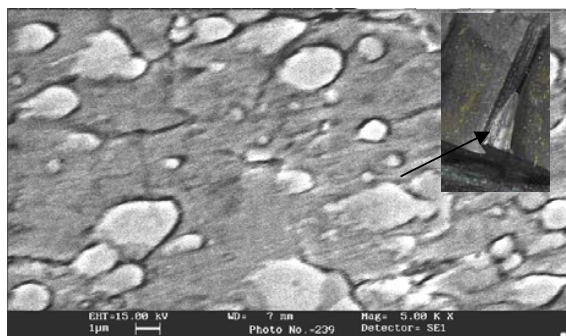
Fig. 6: SEM micrograph of M2 hob microstructure

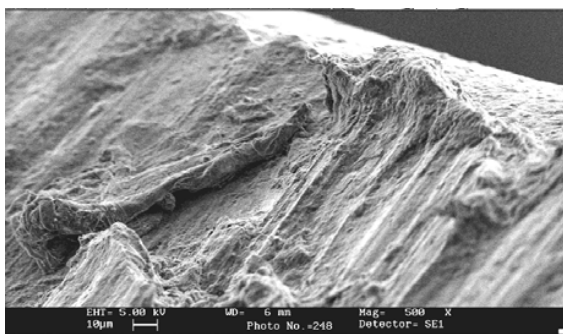
Fig. 7: SEM topography of severe abrasion wear mechanisms of M2 hob

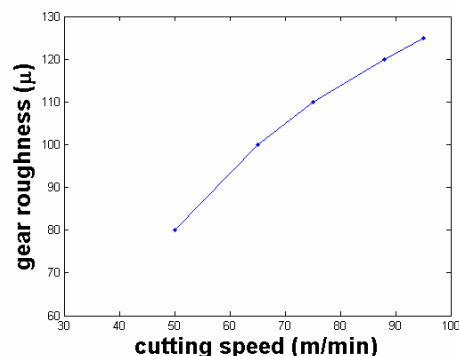
Fig. 8: Surface roughness of gear(μm) vs. cutting speed

reported to be 60 m/min [11]. The hot hardness of ASP30 hob is because of high amount of cobalt in the chemical composition. It means that the ASP30 hobs can be used at high speed hobbing. Moreover, at high cutting speeds, another wear criterion exists. Increasing the surface roughness (Fig.8) of the gear produced at such conditions, limits the cutting speed to be used. Therefore, for optimizing the cutting operation it is necessary to consider the surface roughness of gears as an important criterion. For high speed hobbing, we may use rigid machine tool and blanks with low length to diameter ( $L/D$ ) proportion.
