# Damage of Tubular Equipment in Process Industry

Pavel Lošák, Tomáš Létal, Radek Nejezchleb

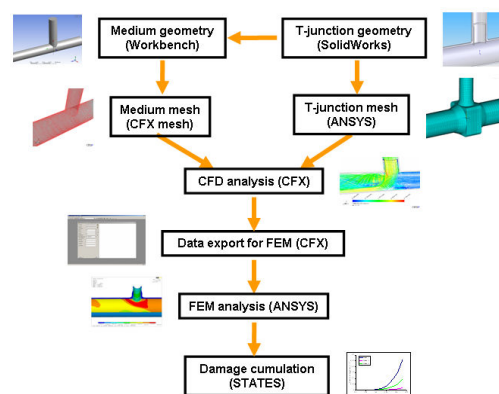
Fig. 1 Diagram of design procedure of the FSI method including the assessment of fatigue

As it is not possible to assess equipment only from the operational temperature and pressure point of view, a very often used method for solving different kinds of tasks is the method of interactions of CFD and FEM analysis (FSI). These interactions of heat-hydraulic and tension analyses are called Fluid Structure Interaction (FSI). This method has been frequently used for solving different tasks in many industrial branches for several years [1], [2]. One of the possible procedures of solving tasks with the FSI method including assessment of fatigue is depicted in the Fig. 1 It is an analysis of a nozzle where flows of different temperatures and flow rates are being mixed.

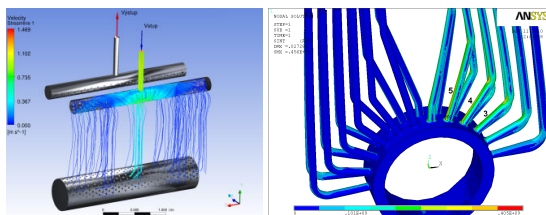
In this case it was an economizer of a waste-heat boiler, where after certain operation time spots where pipes connected to collectors were being damaged. It was not possible to determine the cause of the damage on the basis of operational conditions, because the stress in critical regions was negligible. Based on analytic heat-hydraulic calculations and CFD simulations the distribution of temperature fields was determined thus making this problem clear. The crucial problem was the low speed of water in the economizer and its imperfect distribution into other pipes. Because of that the speed in pipes under the distribution piping was high and in surrounding pipes it was significantly lower. In some of them the emerging negative pressure even caused flow in opposite direction (in the Fig. 2 on the left there are depicted the flowlines of medium in the correct direction, those not depicted flow in opposite direction).

Because of the uneven flow of medium the pipes were unevenly heated and those that were cooled better were gradually damaged. In the Fig 2 on the right one can see the stress distribution in critical areas near the connection of the pipes to the collector. Here there are apparent increased stress values in welded joints that were gained via stress analysis of temperature fields obtained from previous analyses and that confirm the cases of damaging in these areas.

Fig. 2 The results of CFD and FEM analysis of the economizer

The corrective action in this case would be to come with more appropriate structural design that would distribute the working medium better (the input and output piping must not be placed perpendicularly to the collectors but from the side) and that would be able to compensate the dilatations of the tube nests (avoid the connection of many pipes of small dimensions on firm piping of a large dimension). Thanks to these modifications it is possible to ensure a trouble-free operation of the boiler. Revision controls that must be planned and carried out should not be underestimated though.

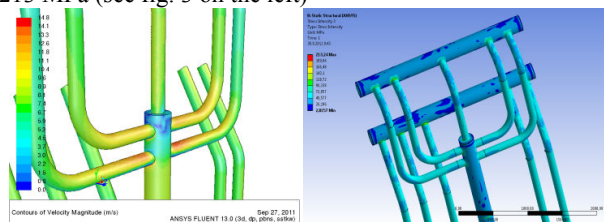
The second case solved in practice was a connecting piping of individual drafts of the evaporator of the fluidized bed boiler. It was a special construction that should have eliminated the dilatation of particular pipe manifold and distributed the working medium from one coil to another better (see Fig. 3). The working medium was saturated steam with the pressure of 3.3 MPa and working temperature about 290°C.

When carrying out the classical stress analysis using the FEM it was discovered that in the welded joint of the pipe and the main pipe the maximum tension was about 150 MPa. But this value was not significant considering the used material. That is why the examination of temperature fields was carried out, because water was distributed into the main vertical pipe through a little pipe coupling to regulate the temperature of the steam. In the Fig. 3 the flowlines are depicted, thanks to which it was found out that the flow rates of the working medium are not the same in all the pipes. Thanks to this analysis the distribution of the temperature fields that is crucial from the stress point of view was obtained.

The discovered distributions of temperature fields were the end conditions for the stress analysis of the transfer tubular construction. Because the temperature fields were specified, there occurred areas where the stress increased significantly to 213 MPa (see fig. 3 on the left)

Fig. 3 The results of CFD and FEM analyses of the transfer pipe of the boiler
