The Comprehensive Study Based on Ultrasonic and X-ray Visual Technology for GIS Equipment Detection

Abstract—For lack of the visualization of the ultrasonic detection method of partial discharge (PD), the ultrasonic detection technology combined with the X-ray visual detection method (UXV) is proposed. The method can conduct qualitative analysis accurately and conduct reliable positioning diagnosis to the internal insulation defects of GIS, and while it could make up the blindness of the X-ray visual detection method and improve the detection rate. In this paper, an experimental model of GIS is used as the trial platform, a variety of insulation defects are set inside the GIS cavity. With the proposed method, the ultrasonic method is used to conduct the preliminary detection, and then the X-ray visual detection is used to locate and diagnose precisely. Therefore, the proposed UXV technology is feasible and practical.

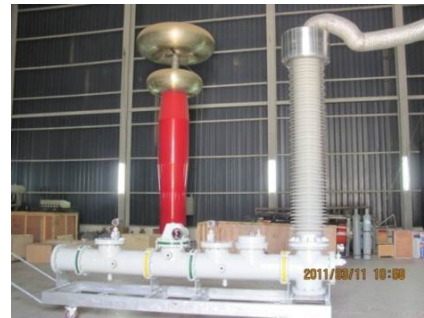
Fig. 2 The physical photo

From the experimental flow chart of the UXV in the Fig. 1, first, the measuring circuit is arranged for the experiment. Then, the insulation defect is set inside the GIS cavity. The ultrasonic method is used to detect preliminarily. If the PD signal is detected, X-ray is used to irradiate the GIS, It is to determine whether there is the insulation defect. The PD detection in GIS cannot depart from the actual operation. If it uses simply coaxial cavity as experimental object, the experimental results will be quite different from the actual situation. So the experiment uses 252kVZF11-252 (L)-type test model which is designed and manufactured specially. Fig. 2 and Fig. 3 show the physical photo and the structure diagram of the experimental model respectively.

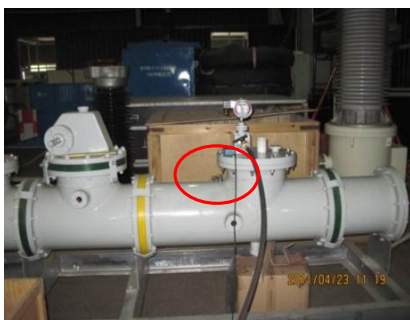
machine, the imaging plate, the computer workstation and other components. During the detection process, the X-ray machine is placed at a certain distance in front of the GIS model, and the imaging plate is close to the GIS cavity and is behind it. The head of the X-ray machine is at the same horizontal line with the center of the imaging plate, and the imaging plate is connected to the computer workstation through the software to receive, display, store and process the data. The site layout photos of the X-ray machine and the imaging plate are shown in Fig. 5 (b).

(a) Site layout of the ultrasonic detection equipment

(b) Site layout of the X-ray detection equipment

Fig. 5 The site layout photos of the detection equipment

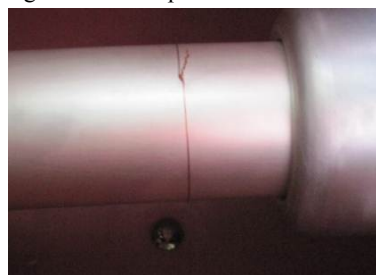
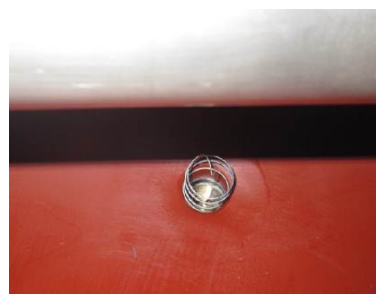
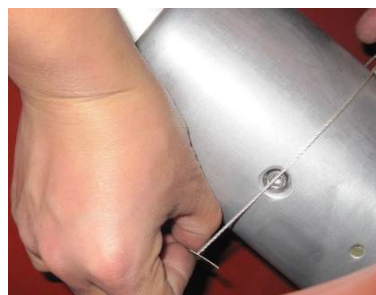
protrusion and the metal suspension as the insulation defect models which are usually caused by poor processing, mechanical damage or scratches when assembling. The high field strength area is created around the metal protrusion, and PD occurs consequently. During the experiment, a section of copper wire is wrapped around the high-voltage conductive pole in the bus segment chamber to simulate this defect type. It is shown in Fig. 6 (a). The length of the tip is 40 mm and the diameter is equivalent to 300 μ m. The second defect model is shown in Fig. 6 (b). A metal tip is set inside the GIS chamber wall. The material is iron wire whose equivalent diameter is 100 μ m and whose cutting-edge length is 30mm. The third model is shown in Fig. 6 (c). A piece of aluminum block is hung in the high-voltage conductive pole by the insulation rope. The distance is 20mm between the aluminum block and the high-voltage conductive pole.

(a) Tip on the high-voltage conductive pole

(b) Tip on the ground electrode

(c) Floating potential

Fig. 6 The physical layout photos of teh simulated insulation defects

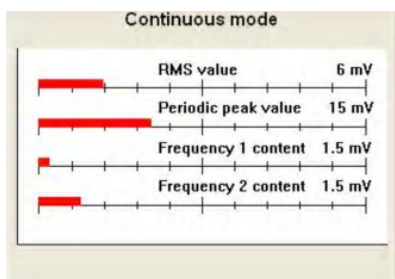
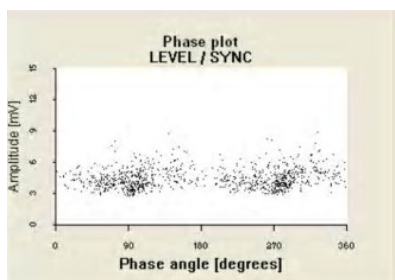
(a) Continuous mode

(b) Phase mode

Fig. 7 AIA ultrasonic detection spectrums

Under the applied voltage amplitude of 101kV, the continuous mode and the phase pattern are shown in Fig. 7. The ultrasonic detection spectrums can be seen: (a) By the continuous mode, 100Hz correlation is greater than 50Hz

correlation; (b) From the phase mode, the discharge pulse focuses near the peak value of the voltage.

From the ultrasonic detection spectrums in Fig. 9 of view, 100Hz correlation is greater than 50Hz correlation. The size of the discharge amount and the distribution shape of the discharge are still similar to the spectrums in Fig. 7, and the phase has some drift with the change of the applied voltage value.

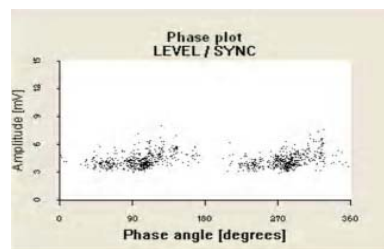
(a) Continuous mode

(b) Phase mode

Fig. 9 AIA ultrasonic detection spectrums
