The Comprehensive Study Based on Ultrasonic and X-ray Visual Technology for GIS Equipment Detection

Abstract—For lack of the visualization of the ultrasonic detection method of partial discharge (PD), the ultrasonic detection technology combined with the X-ray visual detection method (UXV) is proposed. The method can conduct qualitative analysis accurately and conduct reliable positioning diagnosis to the internal insulation defects of GIS, and while it could make up the blindness of the X-ray visual detection method and improve the detection rate. In this paper, an experimental model of GIS is used as the trial platform, a variety of insulation defects are set inside the GIS cavity. With the proposed method, the ultrasonic method is used to conduct the preliminary detection, and then the X-ray visual detection is used to locate and diagnose precisely. Therefore, the proposed UXV technology is feasible and practical.

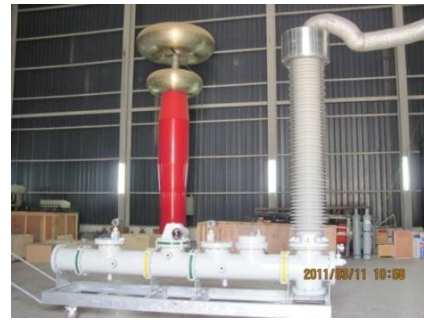
Fig. 2 The physical photo

From the experimental flow chart of the UXV in the Fig. 1, first, the measuring circuit is arranged for the experiment. Then, the insulation defect is set inside the GIS cavity. The ultrasonic method is used to detect preliminarily. If the PD signal is detected, X-ray is used to irradiate the GIS, It is to determine whether there is the insulation defect. The PD detection in GIS cannot depart from the actual operation. If it uses simply coaxial cavity as experimental object, the experimental results will be quite different from the actual situation. So the experiment uses 252kVZF11-252 (L)-type test model which is designed and manufactured specially. Fig. 2 and Fig. 3 show the physical photo and the structure diagram of the experimental model respectively.
