# The Effect of Micro Tools Fabricated Dent on Alumina/Alumina Oxide Interface

Taposh Roy, Dipankar Choudhury, Belinda Pinguan-Murphy

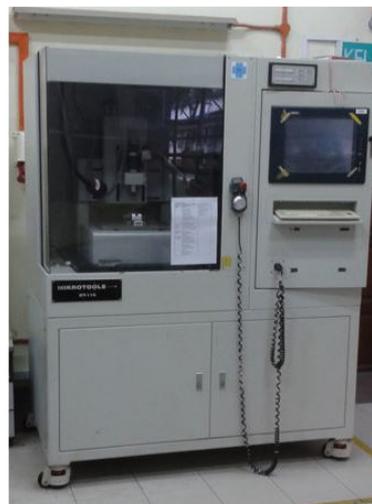
Fig. 1 (a) Mikrotools DT110 and (b) Micro drill tools

There selected three set of dent profiles based on literature — diameter 400µm, depth 20µm and distance between two dents were 2 and 1.5mm. The desired micro-dent surface were prepared by using a Mikrotools DT110 multipurpose micro machine with a set of solid carbide drill bit (0.4mm diameter, n=6). The drill bits were supplied by PrecisetechSdn. Bhd. (Selangor, Malaysia), where the recommended spindle speed was 55,000 rpm and feed rate was 334mm/min for effective drilling on hard ceramic substrate. The CNC Mikrotools DT110 and drill bits are shown in Fig. 1. Based on the recommendation and designed surface geometry, a numerical program (CNC) was prepared and installed in the Mikrotools DT110. To avoid the machining error due to wear of drill bit, every single surface was drilled by a brand new drill bit. Moreover, a further surface polishing was conducted in order to remove the dent burs. Finally an ultrasound cleaner was used to clean so; it was made sure that no foreign particles were stuck inside the dent generated from polishing material or drill bit. AnEDS examination was carried to confirm the purity of dent from these foreign particles.
