Performance of Bridge Girder with Perforations under Tsunami Wave Loading

Keywords—Bridge, force, girder, perforation, tsunami, wave.

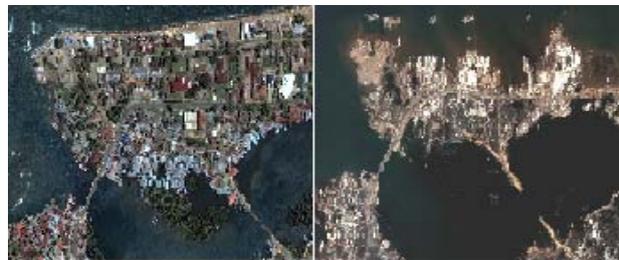
Fig. 1 Effects of tsunami 2004, along coastal line and bridge structures in Banda Aceh, Indonesia

destruction could be identified to be done by tsunami rather than earthquake. Tsunami has the power to destroy or collapse the infrastructures including bridges in its course. Fig. 1 showed the impact attributed by 2004 tsunami along coastal line in Indonesia. Several structural damages were featured by many researchers during 2004 tsunami [1]-[5]. Therefore, it is evident that the tsunami induced forces should be introduced in the design of coastal structures.

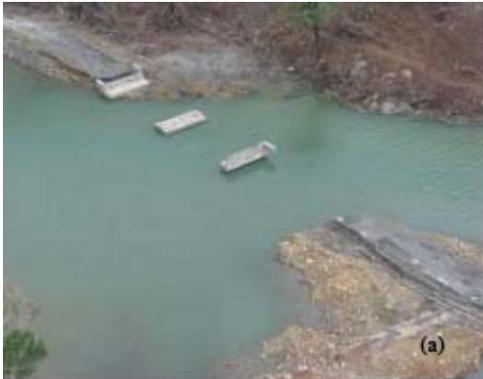
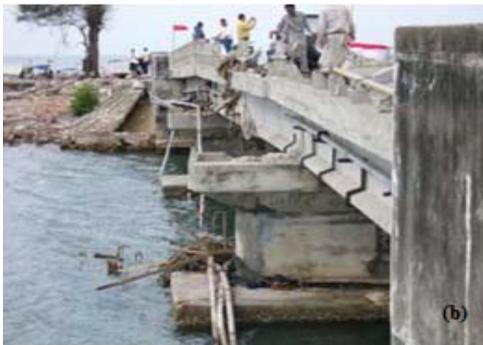
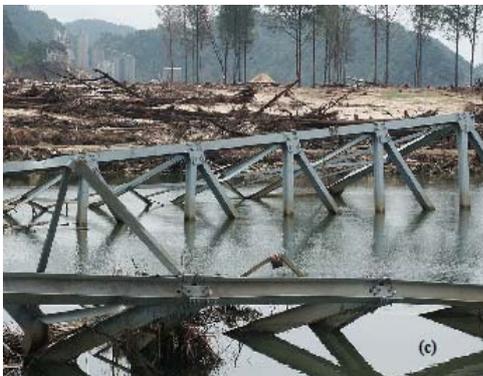
Fig. 2 Bridge damage due to tsunami attack in Banda Aceh (a) Total Wash-Away of Deck [7] (b) Excessive Deck Displacement [12] (c) Damaged steel truss bridge with damaged cement plant in the background in Lhok Nga, Banda Aceh

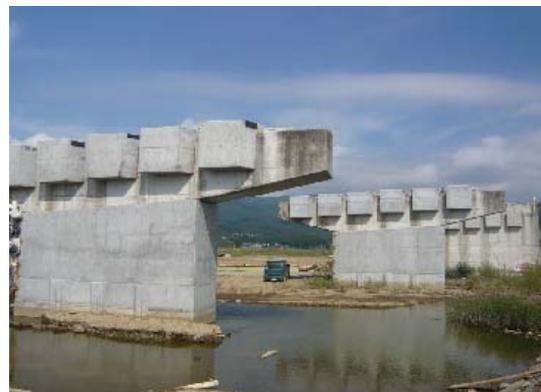
Fig. 5 Damaged Numata-Kosen bridge during Tohoku Tsunami

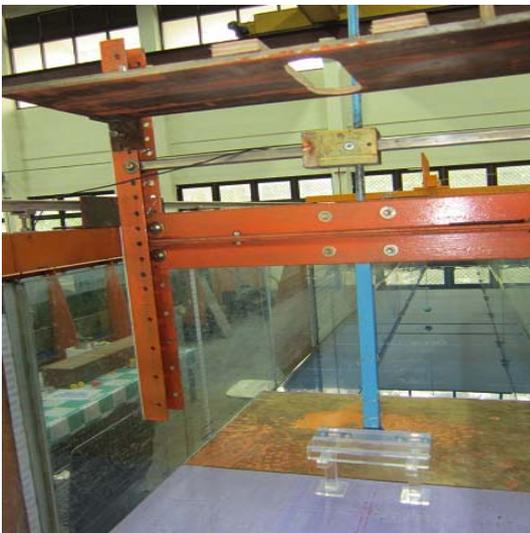
Fig. 9 Photo of the bridge model installed inside the flume
