Thermo-Mechanical Treatments of Cu-Ti Alloys

M. M. Morgham, A. A. Hameda, N. A. Zriba, H. A. Jawan

Abstract—This paper aims to study the effect of cold work condition on the microstructure of Cu-1.5wt%Ti, and Cu-3.5wt%Ti and hence mechanical properties. The samples under investigation were machined, and solution heat treated. X-ray diffraction technique is used to identify the different phases present after cold deformation by compression and also different heat treatment and also measuring the relative quantities of phases present. The metallographic examination is used to study the microstructure of the samples. The hardness measurements were used to indicate the change in mechanical properties. The results are compared with the mechanical properties obtained by previous workers. Experiments on cold compression followed by aging of Cu-Ti alloys have indicated that the most efficient hardening of the material results from continuous precipitation of very fine particles within the matrix. These particles were reported to be β' -type, Cu_4Ti phase. The β - β' transformation and particles coarsening within the matrix as well as long grain boundaries were responsible for the overagi

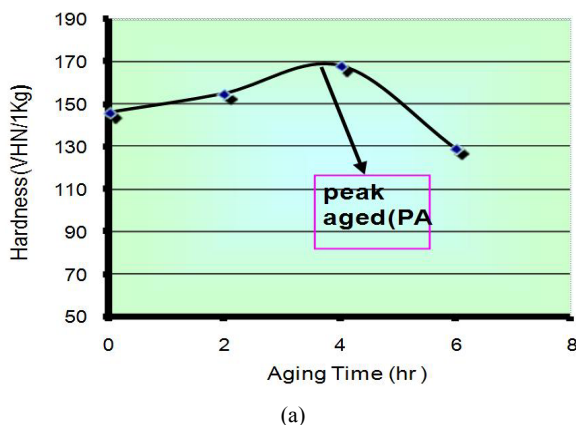
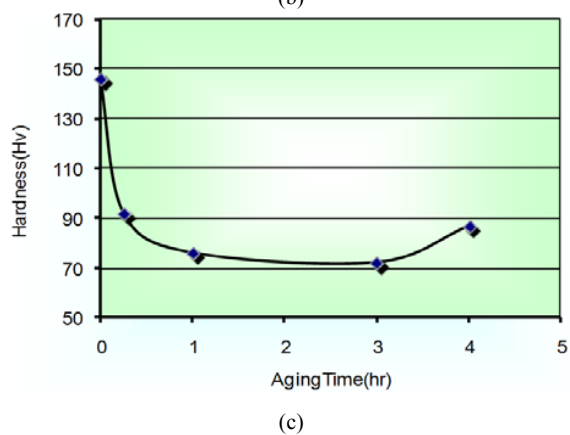
Fig. 1 Effect of prior cold work on age hardening in Cu- 1.5 wt% Ti alloy aged at (a) 550°C, (b) 600°C, (c) 650°C

Fig. 1 include variation in hardness with aging time of deformed alloy at the above aging temperatures. Cold work increased the hardness of Cu- 1.5 Ti alloy in the solution treated (ST +CW) as well as peak aged (ST+CW+PA) conditions.

The maximum hardness for Cu- 1.5Ti alloy varied from 70 Hv in the solution treated condition to 168Hv for 50 %deformation and aging at 550°C Fig. 1 (a). Similarly, the peak hardness obtained for 50 % deformed Cu- 1.5 Ti alloy aged at 600°C was 160 Hv and decrease drastically. It is seen from Fig. 1 (b). That hardness decreased with prolonged aging after a peak value. Formation of the equilibrium precipitate, Cu₃Ti has been reported to cause a decrease in hardness due to the overaging phenomenon in binary Cu- Ti alloys [7]. The overaging was observed at 650° C it is seen from Fig. 1 (c).

Figs. 1 (a), (b), and (c) show the effect of pre cold work on hardness of Cu – 1.5 Ti wt% alloy during aging at 550, 600 and 650° C.

1. The hardness increased from 70VHN in the solution treated state of Cu-1.5wt. %Ti to a peak value of 168VHN on aging at 550°C with prior cold deformation, while the hardness increased from 105VHN in the solution treated state of Cu-3.5wt. %Ti to a peak value of 338VHN on aging at 450°C with prior cold deformation.
2. At high aging temperature, (650°C) over aging were found to take place at the very short aging time for Cu-

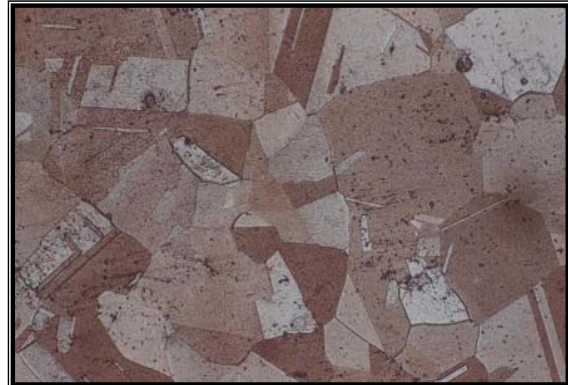
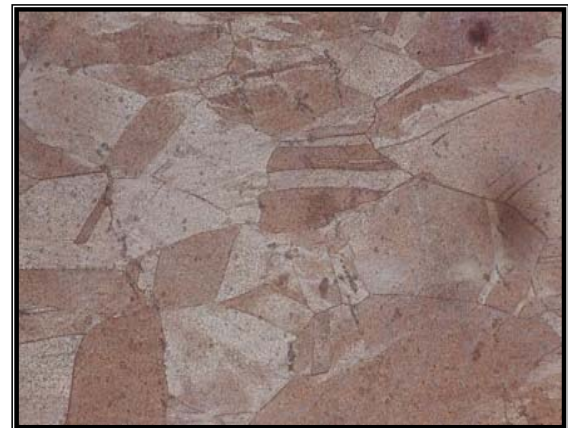
Fig. 3 shows optical microstructures of Cu- 3.5wt. %Ti, solution heat-treated at 900°C for 1hr followed by water

quenching Fig. 3 (a) and subsequently 50% deformed Fig. 3 (b). The structure shown consists of large equiaxed grains of α phase with annealing twins and many uniformly distributed particles. The particles are Cu_3Ti with a body-centered tetragonal (bct) crystal structure and that they are formed during casting and remain undissolved in the solution – treated state [8]. After cold compression of the solution treated samples; compression test mainly flats the grains shown and aligned in a direction perpendicular to the compression axis.

Fig. 3 Optical micrographs of Cu-3.5wt% Ti alloys: (a) solution treated at 900°C, (b) cold deformed 50% without aging (300X)

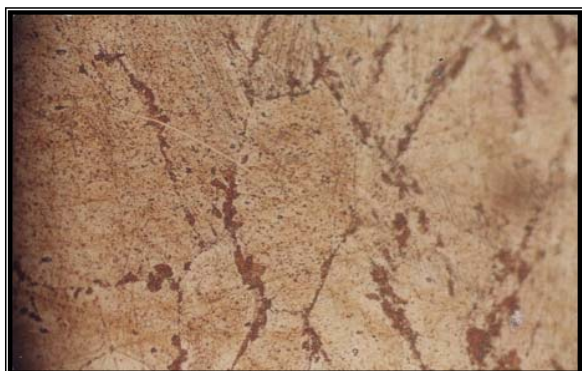
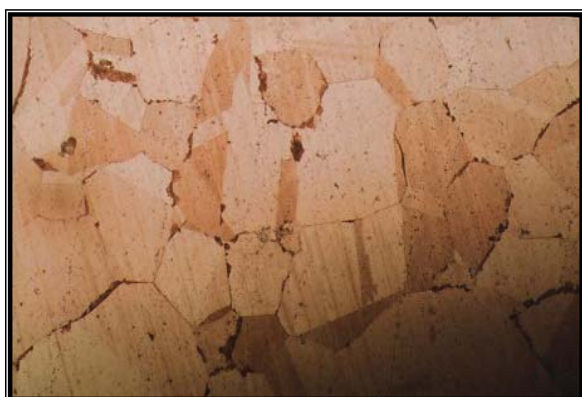
In Fig. 4 (a) the specimen which contains 3.5 wt. %Ti aged for (170 mins) at 500°C after the 50% deformation; it showed a precipitates at grain boundaries (as cellular colonies). Fig. 4 (b) displays the microstructure of Cu-3.5wt. %Ti aged at 500°C without pre deformation. It reveals that many of the particles are at the grain boundary and structural defects. Similar results are obtained for 4hrs aging of same sample (Fig. 4 (c)).

Fig. 4 Optical micrographs of Cu-3.5 wt. %Ti alloys (a) 50% cold deform. With aging at 500°C for 170 mins., (b) Aging at 500°C for 2hrs without deform (300x), (c) Aging at 500°C for 4hrs without deforms (300X)

The alloy tested aged at 500°C without deformation for 2hrs and 4hrs show equiaxed grains with annealing twin (see Figs. 4 (b) and (c)). Lamellar precipitation of equilibrium phase β at the grain boundaries as dark colonies growing into the grains which is attributed to overaging of the alloy at this

temperature since the optical micrographs of peak aged alloy are quite similar to those of the solution treated one.

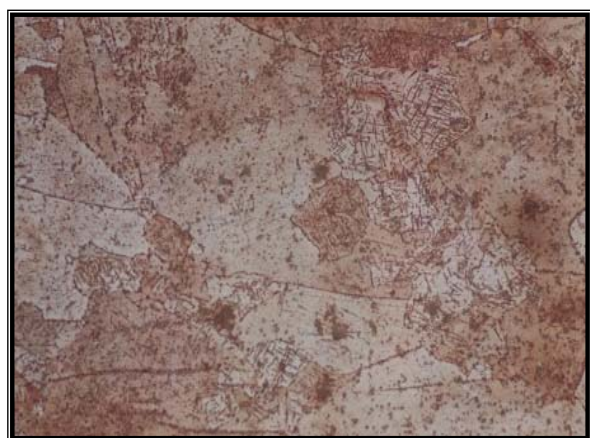
The optical micrograph for the Cu-3.5 wt. %Ti alloy aged for 8 hrs at 500°C after it has been given a 50% deformation (overaging stage) is given in Fig. 5 (a).

This micrograph shows deformed grains of α -phase. The equilibrium precipitates can be observed along the grain boundaries as well as on the structural defects, introduced by prior deformation: It is clear that deformation has affected morphology and distribution of precipitates, and equilibrium precipitates in the grain boundaries which appear as dark nodules in a light matrix. Striations in α matrix are the result of the concurrent metastable precipitate formation, not resolved by optical microscopy.

Fig. 5 Optical micrographs of Cu-3.5wt%Ti alloy: a) deformed and aging at 500°C for 8 hrs (300X) (b) Optical micrographs of Cu-1.5 wt. %Ti alloy, cold deform, and aging at 600°C for 1/2 hr; (c) Cu-1.5wt%Ti, cold deform and aging at 650 °C for 1/4hr (600X)

Over aging occurs at 500°C after 8hrs for Cu- 3.5wt. %Ti and at 600°C after 30 mins for Cu- 1.5wt.%Ti alloy, also at 650°C after (1/4hr). The lamellar morphology of discontinuous precipitation is converted to the globular morphology of coarse β needle-like structure within the α -matrix that are concentrated in the highly deformed areas as shown in Figs. 5 (b) and (c) this means the large strains induced by severe deformations are completely deformation are completely released on long time aging at high temperature of (600°C and 650°C) for Cu-1.5wt. %Ti and promoted the lamellar type discontinuous precipitation to dissociate into dual phase structure of coarse precipitate β surrounded by α -matrix.

The decrease in hardness reflects overaging of Cu- Ti alloys. Aging at 500°C for 8hr of Cu- 3.5Ti resulted in drastic fall in hardness after 50% deformation. This indicates that considerable recovery of the matrix has occurred in 50% deformed alloy on aging at 500°C. This can be observed in optical images of the deformed alloy in Fig. 4 (a). It was reported earlier [7] that on aging of solution treated and cold worked Cu- 1.81Be- .28Co alloy at 500°C produced faster rates of recovery, recrystallization and subgrain structure in the matrix. The deformed Cu- Ti alloys gets overaged with the formation of the incoherent and equilibrium precipitate of β Cu_3Ti in the matrix as well as lamellar type discontinuous precipitation at the grain boundaries of the matrix. This is observed in 50% deformation of Cu- Ti alloys. They are overaged at 500°C for 8hr of Cu- 3.5Ti and at 600°C after 30 min of Cu- 1.5Ti alloy. The lamellar morphology of discontinuous precipitation is converted to the globular morphology of coarse β surrounded by the α -matrix. That means the large strains induced by severe deformations are completely released on long time aging at high temperature (600 and 650°C) of Cu-1.5 wt %Ti and promoted the lamellar type discontinuous precipitation to dissociate into dual phase structure of coarse precipitate β surrounded by α - matrix.

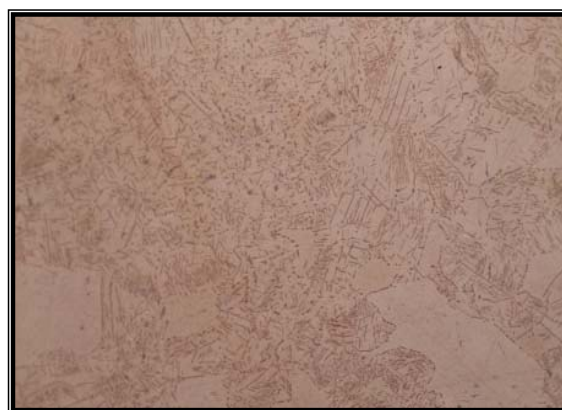
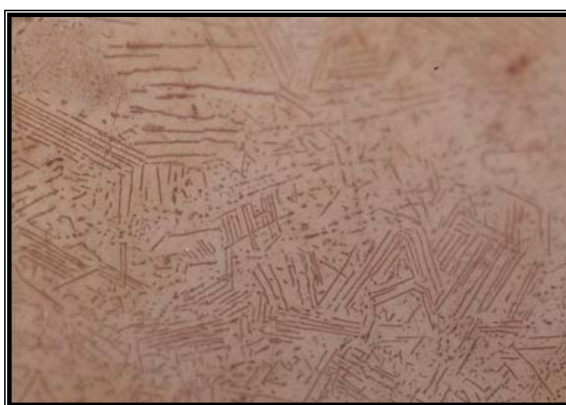
In Figs. 6 (a), (b), and (c) show a large amount of precipitation which clearly distributed all over the matrix and does not restrict to the grain boundaries, this also indicated that the cold work has affected the morphology and distribution of precipitates. The morphology of precipitates becomes a needle-like structure distributed all over the matrix. The microstructure is responsible for the overaging of this alloy composition.

Fig. 6 (a) Optical microstructure of Cu-1.5wt%Ti def and aging at 650°C for 4hrs (1000X), (b) Cu-1.5wt.%Ti, cold def and aging at 650°C for 4hrs (400X), (c) Cu-1.5wt. %Ti, def and aging at 600°C for 4hrs (1000X)

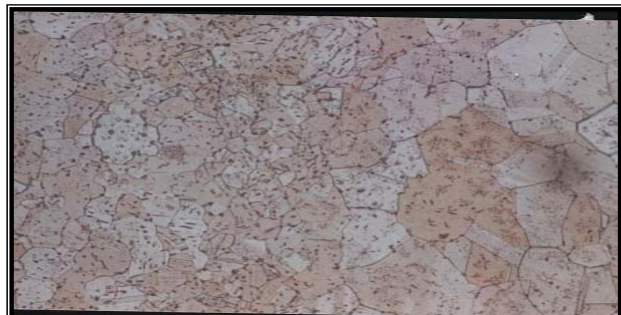
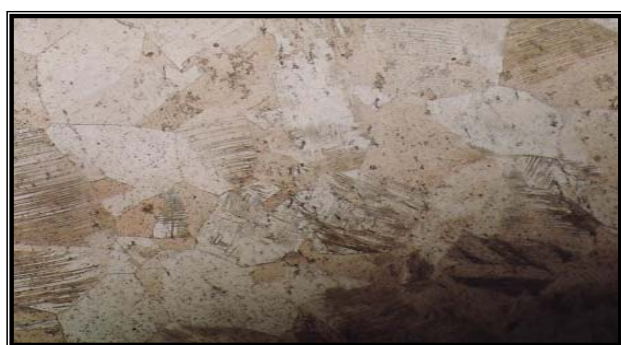
Fig. 7 (a) shows the microstructure of non-uniform distribution of grain size, which observed to be similar to that of the solution-treated condition. In this case, no discontinuous precipitation has been noticed in the overaged of Cu-3.5wt%Ti alloy at 750°C. During the deformation, the pinning effect of precipitates may have led to a significant multiplication of dislocations so that the specimen contains a higher density of dislocations. The deformed alloy with a higher density of dislocation has more potential to recrystallization due to the higher driving force [10]. This could be the reason behind why could not observe the needle-

The precipitates formed during the aging after deformation can act as the barrier that retard the recrystallization, however, they would coarsen and have increased interparticle spacing with increasing time during aging. In Fig. 7 (b) shows striation in the interior grain due to a concurrent metastable precipitate formation at this temperature (450°C).

Fig. 7 (a) Micrographs of Cu- 3.5 wt. %Ti alloy deformed then aged at 750°C for 2hrs (600 X), (b) Cu- 3.5wt%Ti deformed then aged at 450°C for 4hrs (300X)

The microstructure shows the nonuniform distribution of grain size, and also observed to be similar to that of the solution -treated condition. Further, no discontinuous precipitation has been noticed in the overaged of Cu- 3.5wt%Ti alloy at 750°C as shown in Fig. 7 (a).
