A Review on Concrete Structures in Fire

S. Iffat, B. Bose

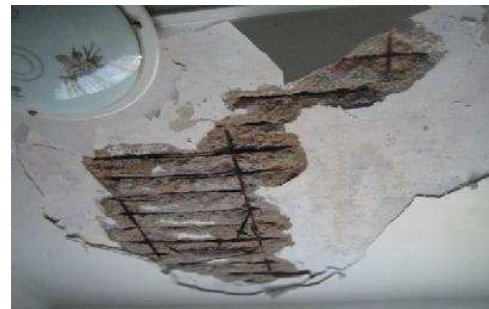
Fig. 3 Spalling of concrete

Spalling may significantly reduce or even eliminate the layer of concrete cover on the reinforcement bars, thereby exposing the reinforcement to high temperatures, leading to a reduction in the strength of the steel and hence a deterioration of the mechanical properties of the structure as a whole.

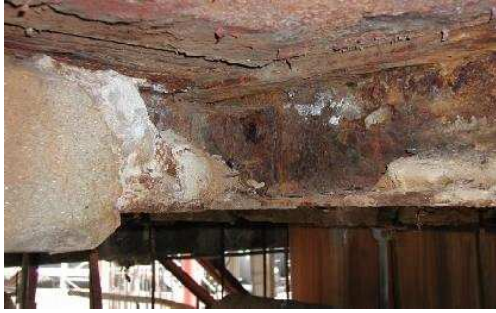
Fig. 4 Crack development in concrete structure due to fire

Geogali & Tsakiridis [31] made a case study of cracking in a concrete building subjected to fire, with particular emphasis on the depths to which cracking penetrates the concrete. It was found that the penetration depth is related to the temperature of the fire, and that generally the cracks extended quite deep into the concrete member. Major damage was confined to the surface in close proximity to the fire origin, but the nature of cracking and discolouration of the concrete pointed to the concrete around the reinforcement reaching 700°C. Cracks which extended more than 30 mm into the depth of the structure were attributed to a short heating/cooling cycle due to the fire being extinguished.

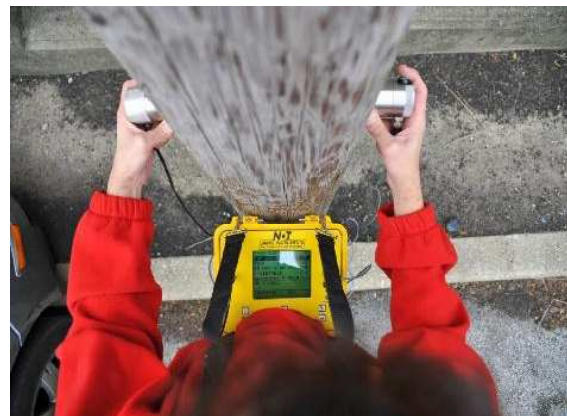
Fig. 6 UPV testing of concrete member

The UPV (Ultrasonic Pulse Velocity) measurement (Fig. 6) is one of the various non-destructive test methods used to evaluate concrete integrity and – more generally – the level of damage in the material. In particular, the velocity of sound in concrete is a high-quality thermal-damage indicator, due to its sensitivity to any change of the Young's modulus. When concrete is exposed to fire, the increase of temperature in the deeper layers of the material is rather slow and progressive. Because of this (due to the rather low thermal diffusivity of concrete), this process produces significant temperature gradients between the outer and inner layers of any given concrete structure (i.e. between the surface and the core). UPV technique may also be applied to determine the reduced quality of concrete by means of indirect or direct techniques on cores [36], [37].

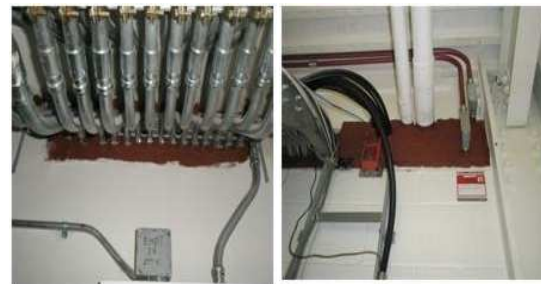
Fig. 9 Fire penetration protection system

Penetrating items are steel, ferrous or copper pipes, tubes or conduits. Annular space between the item and the fire-resistance-rated wall must be filled to maintain the fire-resistance rating with filling material - concrete, grout, or mortar (Fig. 9). Separation in buildings by structural elements prevent horizontal and vertical spread of fire [39]
