# Field Trial of Resin-Based Composite Materials for the Treatment of Surface Collapses Associated with Former Shallow Coal Mining

Philip T. Broughton, Mark P. Bettney, Isla L. Smail

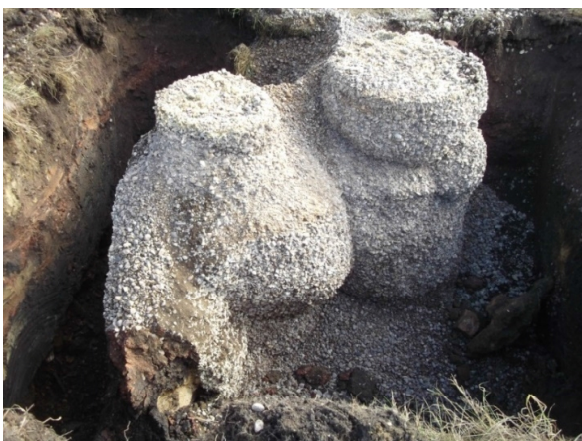
Fig. 1 Photograph of excavated TP02 showing polyurethane resin foam migration through 10 mm pea gravel fill

Incomplete resin penetration was observed in several of the excavated test pits. In several pits, the injected resin foam has migrated along preferential lines of weakness within the freely tipped and un-compacted fill material to form irregular shaped 'blocks' of composite (Fig. 1).

Resin foam permeation was poor through the 10 mm pea gravel fill. The polyurethane foam permeation was slightly better than the silicate foam permeation. In both cases, the resin did not permeate the entire test pit. It is suggested that closer injection points and/or increased resin foam reaction times may improve resin permeation through pea gravel.
