# Identifying Karst Pattern to Prevent Bell Spring from Being Submerged in Daryan Dam Reservoir

**Abstract**—The large karstic Bell spring with a discharge ranging between 250 and 5300 lit/ sec is one of the most important springs of Kermanshah Province. This spring supplies drinking water of Nodsheh City and its surrounding villages. The spring is located in the reservoir of Daryan Dam and its mouth would be submerged after impounding under a water column of about 110 m height. This paper has aimed to render an account of the karstification pattern around the spring under consideration with the intention of preventing Bell Spring from being submerged in Daryan Dam Reservoir. The studies comprise engineering geology and hydrogeology investigations. Some geotechnical activities included in these studies include geophysical studies, drilling, excavation of exploratory gallery and shaft and diving. The results depict that Bell is a single-conduit siphon spring with 4 m diameter and 85 m height that 32 m of the conduit is located below the spring outlet. To survive the spring, it was decided to plug the outlet and convey the water to upper elevations under the natural pressure of the

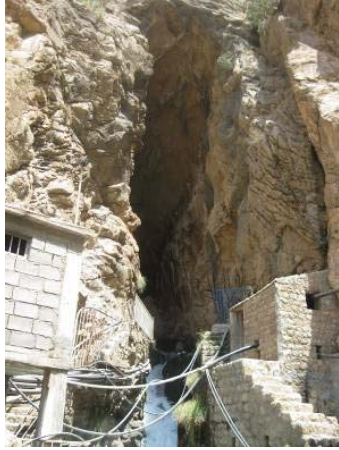
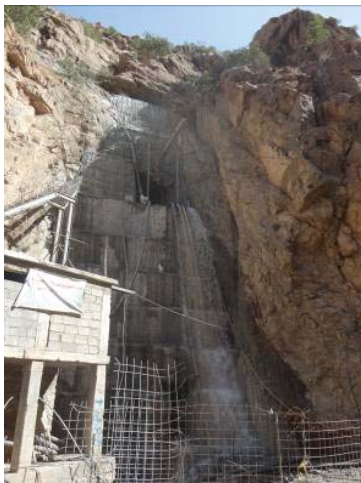
Fig. 11 Natural outlet and plugging of the spring

(a) Before plugging

(b) After plugging

The surface and sub-surface investigations depicted that Bell is a single-conduit siphonal spring (at least for 150 m distance to the spring outlet). Hence, it was decided to study on the alternative of water abstraction from karstic conduits in a distance not so far away from the spring outlet. This is one of the methods approved as for abstracting water from the karstic springs all around the world. The low permeable surrounding rocks of the conduit gave rise to the study on plugging the spring and conveying water to the upper levels under the pressure of the aquifer. In this plan, the siphon was plugged just from the shaft constructed at BH-24 location toward the spring outlet (Figs. 9 (b) or 11 (b)).
