Use of Short Piles for Stabilizing the Side Slope of the Road Embankment along the Canal

Abstract—This research presents the behavior of slope of the road along the canal stabilized by short piles. In this investigation, the centrifuge machine was used, modelling the condition of the water levels in the canal. The centrifuge tests were performed at 35 g. To observe the movement of the soil, visual analysis was performed to evaluate the failure behavior. Conclusively, the use of short piles to stabilize the canal slope proved to be an effective solution. However, the certain amount of settlement was found behind the short pile rows.

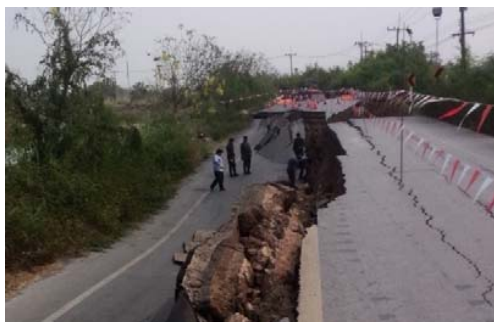
Fig. 1 Road along the canal no.13 collapsed

On the 2nd of March 2016, the road embankment along Canal no.13 (Klong 13) collapsed (Fig. 1) for approximately 100 m long. The canal at the failure area was found to be nearly dry, and a large water pond was found to be located near the failure section (Fig. 2).

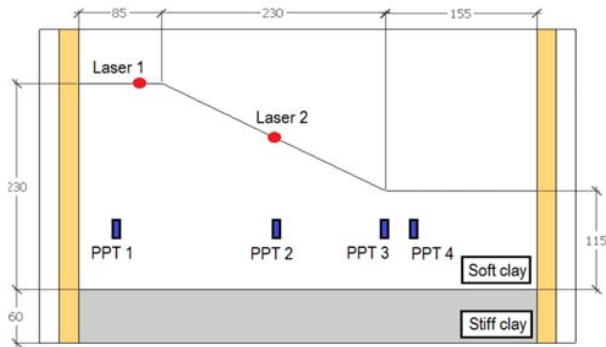
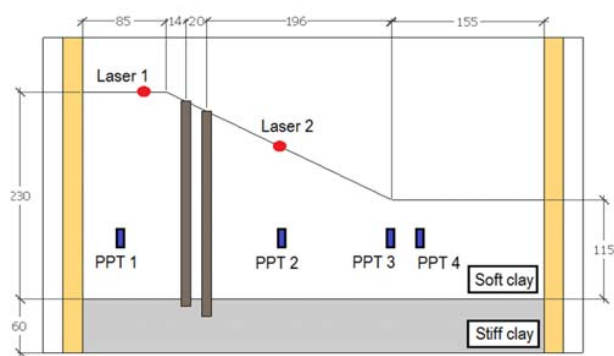
Fig. 3 The setup of instrumentations in both boxes (a) The box without reinforced piles (b) The box with reinforced piles

- PIV Camera: Located in front of the box to record the direction of soil movement.
- Laser: Record the settlement data.
- Pore Pressure water (PPT): Record the changes of water pressure.
- Water Tanks with flow control valve: Control the head of water while testing and the flow rate.

Fig. 3 illustrates the setup of instrumentations of both boxes.

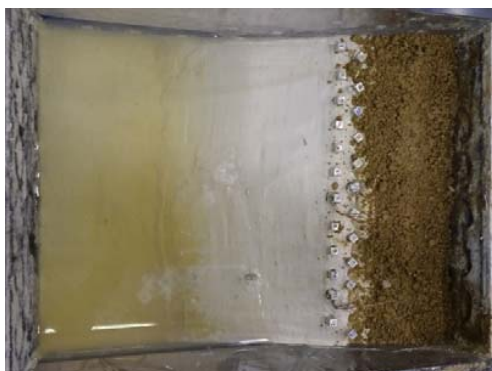
Fig. 5 Top view of piles group box

When the piles were placed alternately, the soil between these piles were virtually not moving because of soil arching, expectedly that the two pile rows will acted as a retaining wall (Figs. 4 and 5).

- Pile length: 8 m (230 mm)
- Material: Aluminium
- Amount: 24 pieces

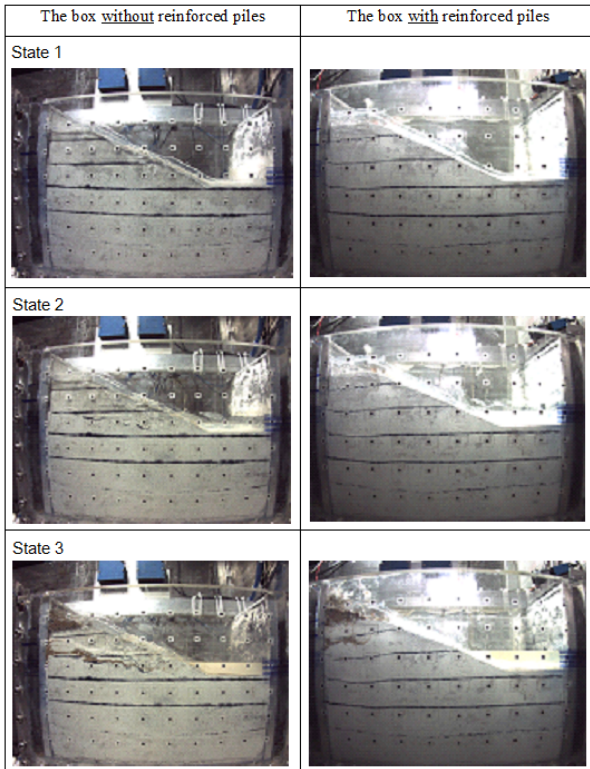
Fig. 6 The results of testing

The results of the centrifuge test can be classified into three states as (Fig. 6):

- State 1: Initial state, after soil preparation but before being spinned up to 35 g.
- State 2: Water level changes according to test plan but before CDG was added:
 1. In the box without reinforced piles, the soil moved down the slope, and the failure plane was found.
 2. In the box with reinforced piles, the soil behind short pile rows moved vertically, but no failure plane was observed.
- State 3: The final step, CDG was added to represent the embankment road:
 1. In the box without reinforced pile, the slope failure was clearly shown (Fig. 7).
 2. In the box with reinforced pile, the soil behind short pile rows moved vertically. Although, more settlement was found and the piles moved slightly, failure plane was not found (Fig. 8).
