# Assessment of Rehabilitation Possibilities in Case of Budapest Jewish Quarter Building Stock

Viktória Sugár, Attila Talamon, András Horkai, Michihiro Kita

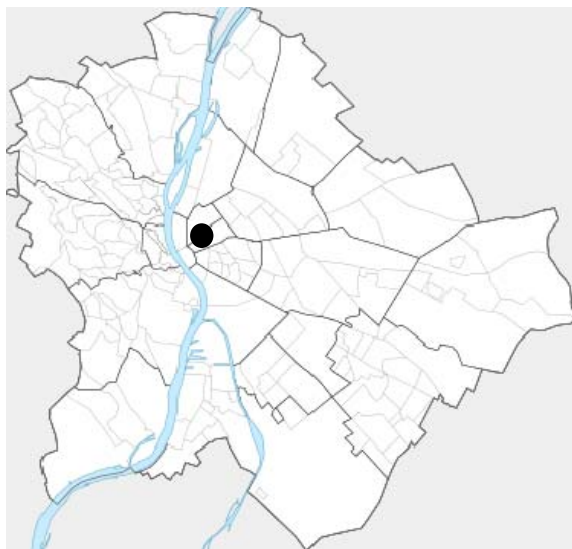
Fig. 1 The Old Jewish Quarter of Pest, in today's District 7 of Budapest [3]

The development started in the 18<sup>th</sup> century lasted nearly for a hundred years. The narrow, rectilinear streets, the organic

network, the frequent T-shaped intersections, as well as the diverse width of the streets can be originated from the agricultural past of the area. This kind of organic fabric can rarely be found in today's regulated Budapest [2].

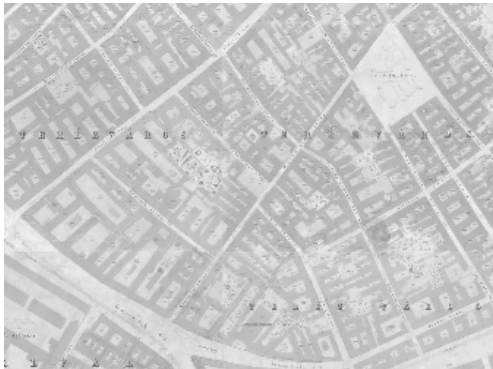
Fig. 2 Characteristic urban fabric of the turn of the 19<sup>th</sup> and 20<sup>th</sup> century in the district [4]

Until Joseph II, Emperor and King of Austro-Hungarian Empire, legislated the Patent of Toleration in 1783, Jews were prohibited to enter the walled Pest, and were also not allowed to settle until 1786. A law of 1840 at last permitted them to own real estate, until then, their praying rooms and apartments were also in rented houses. Naturally, the establishment started around the Jewish Market outside the city wall, alongside the main street of the area: Király Street (King Street, King of England Street at the time, Fig. 2) [2].

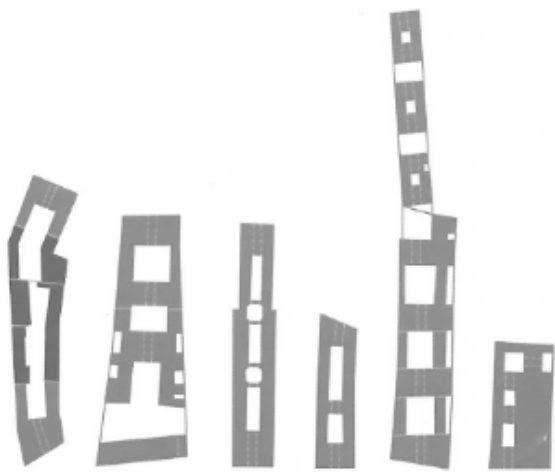
Fig. 3 Passage houses- chain layout connecting the streets and opening up the deep block for commercial life [2]

At the same time, the first passage houses (Fig. 3) and pedestrian crossings have developed through the deep blocks, later grown into a full system. The passage houses and crossings expanded the commercial life, at the same time

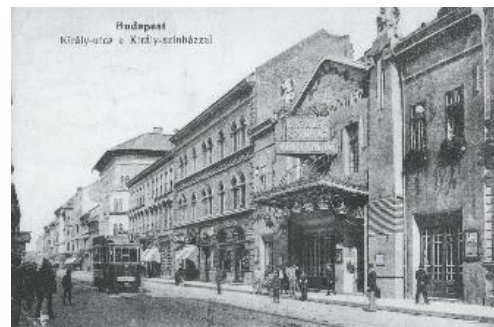
Fig. 5 Király Street, the main street of Jewish Quarter of Pest, archive photo [6]

The diversity of the houses is also increased by the combination of more and less ornate buildings (Fig. 5), as well as the mixture of apartments with and without the modern conveniences, resulting diverse social groups living side-by-side.

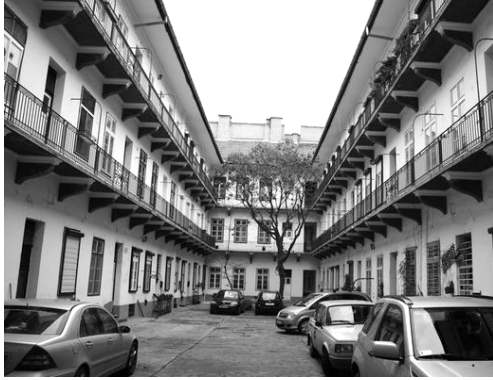
Fig. 7 Larger inner courtyard in the Jewish Quarter of Pest (Photo is courtesy of Kővári Csenge, Mészáros Mónika and Hegedüs Marcell – Ybl Miklós Faculty of Architecture)

In case of every architectural era, the enclosed geometry of the tenement houses with inner courtyard can be marked as characteristic. However, due to the higher ratio of early buildings, more L, U, or enclosed structure remained with spacious courtyard (Figs. 6, 7) – which is unique compared to the adjacent districts.

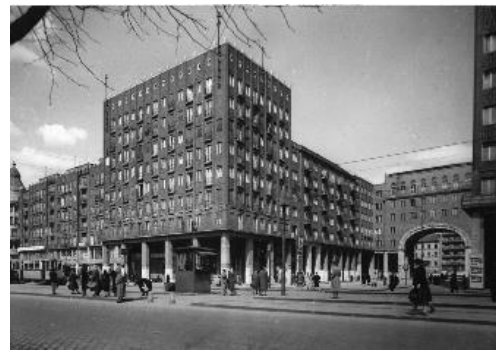
Fig. 8 Opening of Madách Boulevard the older buildings can still be seen through the gate motif [9]

The project of Madách Sugárút (Madách Boulevard) has been the most grandiose intervention in the mainly organic structure. The idea of the first so called Erzsébet (referring to Queen Elisabeth again) then later Madách Boulevard was first introduced in the beginning of the 20<sup>th</sup> century. The concept was to open a main road to rival the nearby Andrásy Boulevard, which is ever since its opening has been the most important avenue of the area. Several plans were created, from which in 1930's, the complex of 11 interlocking buildings were built with a great gate motif to open up the densely built in inner parts. The plan however halted here, and only the beginning of the boulevard was built (Figs. 8, 9) [8].

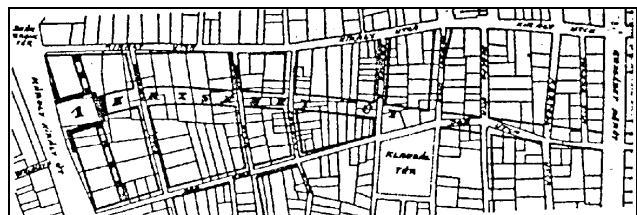
Fig. 9 Plan of Madách Boulevard – only the opening on the left part was finished [7]

Since the 1940's, various plans had been created and many suggestions were made to finish the project. Some critics pointed out that the plan is disregarding the current structure of the city [8] – the plan would have demolished significant early buildings and monuments, and would have brought a different scale of road and building stock to the area.

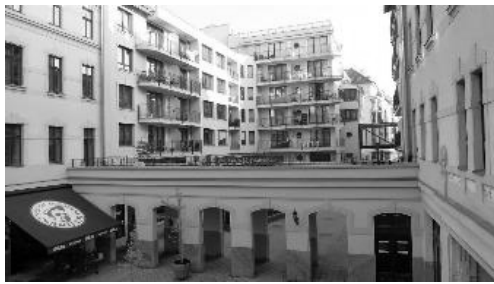
Fig.10 Contemporary buildings in the passage-section of the boulevard [10]

The Madách Promenade remained on topic ever since. The latest plans suggested the evolution of the boulevard to a promenade, then a passage [7], which is a more delicate intervention than its predecessors, reducing the Boulevard to a passage. The latest constructions have been created in this regard (Fig. 10). The investment undoubtedly increased the

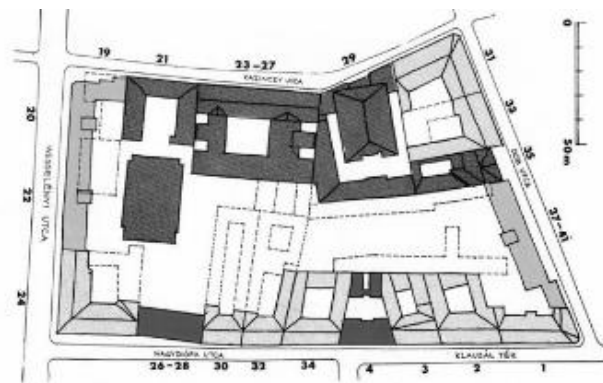
Fig. 11 Sample Block Nr. 15 after rehabilitation. The demolished wings are marked with dashed line [13]

The Erzsébetváros rehabilitation was started with the Sample Block Nr. 15 (Fig. 11).

The Sample Block Nr 15. contained a synagogue and other ecclesiastic buildings. Out of the existing 303 flats, 150 were

demolished, to build 170 in entirely new buildings. The average 49 m<sup>2</sup> floor space of the existing flats were enlarged averagely to 65 m<sup>2</sup>. The inside of the blocks were rebuilt as parks and playgrounds. Between 1982 and 1985, the construction was finished. Above residential development, the public buildings (a university, a museum and offices) were renovated or given new buildings. Majority of the new residents were the same as before, or moved here from the adjacent blocks [11].

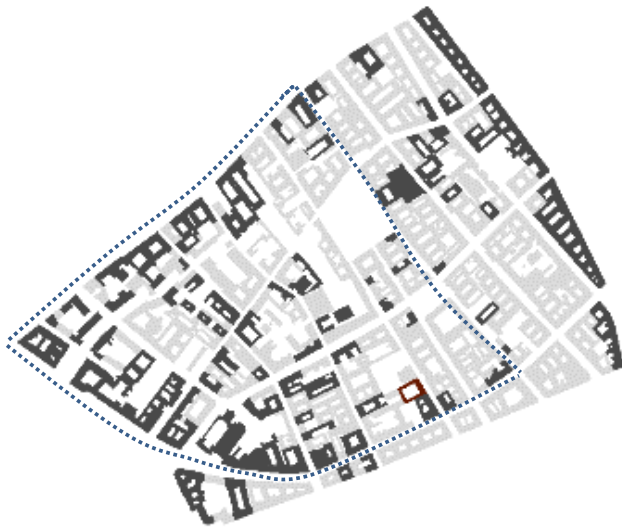
Fig. 12 Buildings under individual protection is shown with darker shade, the UNESCO buffer one area is marked by dotted line. It is also a conservation area. Based on [7]

As acknowledgement of its significance, it became part of the UNESCO World Heritage Area, which consist of the Buda Castle Hill, the Danube banks, the Andrassy Avenue (Fig. 12).
