# Risk of Occupational Exposure to Cytotoxic Drugs: The Role of Handling Procedures of Hospital Workers

**Abstract**—In order to study environmental contamination by cytostatic drugs in Portugal hospitals, sampling campaigns were conducted in three hospitals in 2015 (112 samples). Platinum containing drugs and fluorouracil were chosen because both were administered in high amounts. The detection limit was 0.01 pg/cm<sup>2</sup> for platinum and 0.1 pg/cm<sup>2</sup> for fluorouracil. The results show that spills occur mainly on the patient's chair, while the most referenced occurrence is due to an inadequately closed wrapper. Day hospitals facilities were detected as having the largest number of contaminated samples and with higher levels of contamination.

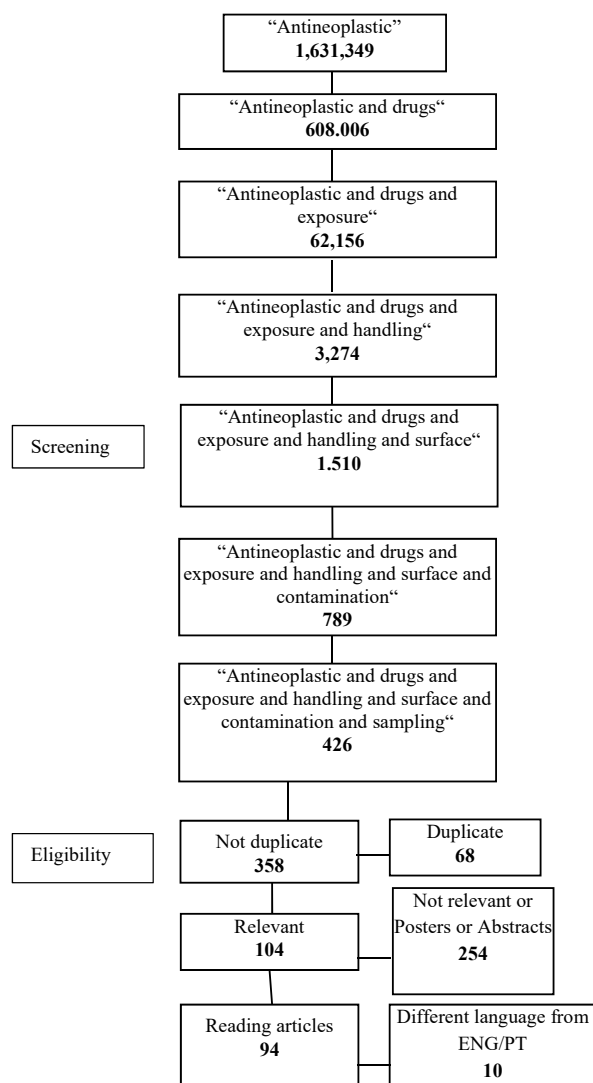
Fig. 1 Outline of the bibliographical research

methodology was Prisma, which defines criteria to be applied in the articles' sorting and eligibility [13]. After applying this methodology, 94 articles were selected for further and deeper analysis, as shown in Fig. 1.

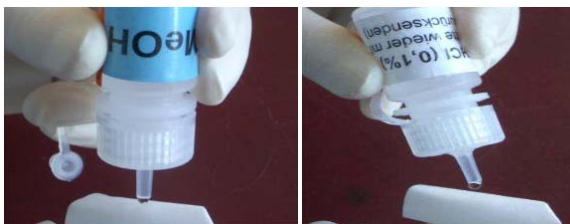
- 1) The filters are pre-moistened, but not in excess, in order to prevent the sample from being wet. Add six drops of methanol (MeOH) to fix the 5-fluorouracil (5-FU) and six drops of concentrated hydrogen chloride (HCl) to 0.1% to fix the platinum (Pt). The fixatives should be slowly applied on the filters' surface (Fig. 2).

Fig. 2 Application of the fixatives (HCl and MeOH) to the paper filter (based on [12])

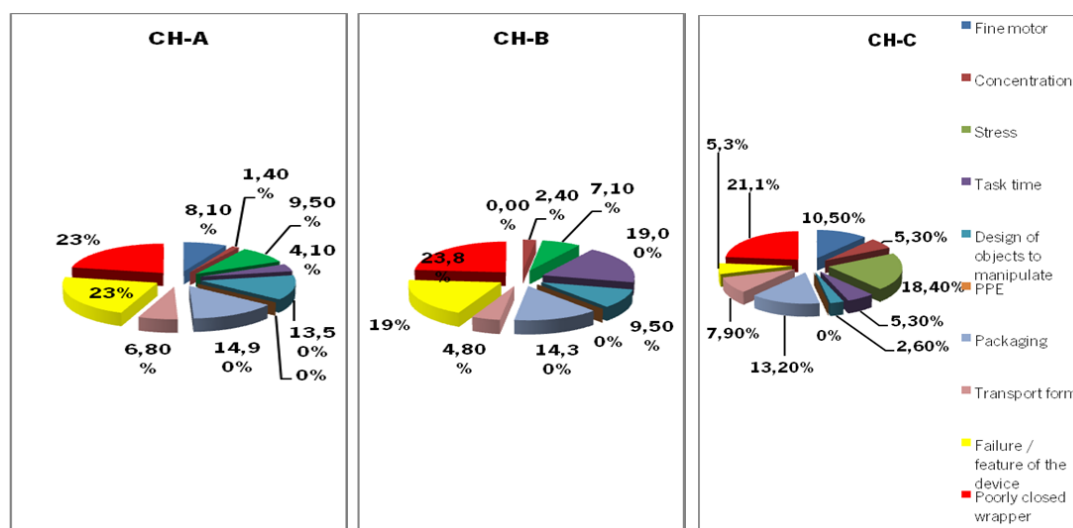
The survey and its results were mainly focused on reported spillage, especially regarding the places where contamination occurs more frequently, as well as time within the working day and possible causes. Thus, the places where most spillages occurred were on the patient's chair during treatment (25 or 16.2%) and the on the laminar flow hood (19 or 12.3%) for professionals. These spillages occurred mainly in the morning, at the second and fourth hours of the working day, according to 17 (11%) professionals. Regarding the causes for spillages, 35 professionals (22.7%) referred to the inadequately closed wrapper. However, the failure/features of the devices were indicated by 27 (17.5%) professionals as well (Fig. 4).

Fig. 4 Causes of spillage

Spillage occurs at different workplaces in health facilities, especially in the laminar flow hood and on the patient's treatment chair. These spillages occur predominantly in the morning, at the second and fourth hours of the working day. The most quoted cause for the occurrence of spillage is the
