# Design of a Hand-Held, Clamp-on, Leakage Current Sensor for High Voltage Direct Current Insulators

Morné Roman, Robert van Zyl, Nishanth Parus, Nishal Mahatho

ISSN: 2517-9438 Vol:12, No:11, 2018

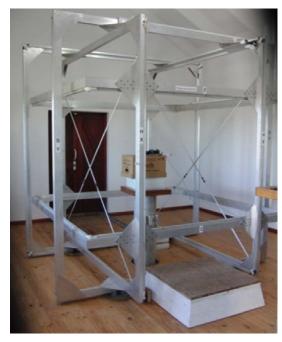
Fig. 11 3-axes Helmholtz coil system for calibration of the prototype LC sensor

Fig. 11 shows the coil system for calibration. The LEMI-011B fluxgate magnetometer is placed in the centre working volume. The measured B-I curve of the coil systems is presented in Fig. 12. The prototype is calibrated against this B-I curve.

A 3-axis Helmholtz coil, with a 1 m³ volume, has been used as calibration instrument since the prototype sensor is intrinsically based on magnetometers. The Helmholtz coil generates a predetermined magnetic field by injecting currents into the appropriate coils in each axis. A LEMI-011B fluxgate magnetometer determines the generated magnetic field within the centre working volume of Helmholtz coil. The coil system
