# Investigating the Effectiveness of a 3D Printed Composite Mold

**Abstract**—In composite manufacturing, the fabrication of tooling and tooling maintenance contributes to a large portion of the total cost. However, as the applications of composite materials continue to increase, there is also a growing demand for more tooling. The demand for more tooling places heavy emphasis on the industry's ability to fabricate high quality tools while maintaining the tool's cost effectiveness. One of the popular techniques of tool fabrication currently being developed utilizes additive manufacturing technology known as 3D printing. The popularity of 3D printing is due to 3D printing's ability to maintain low material waste, low cost, and quick fabrication time. In this study, a team of Purdue University School of Aviation and Transportation Technology (SATT) faculty and students investigated the effectiveness of a 3D printed composite mold. A steel valve cover from an aircraft reciprocating engine was modeled utilizing 3D scanning and computer-aided design (CAD) to create a 3D printed composite mold. The mold was used to fabricate carbon fiber versions of the aircraft reciprocating engine val

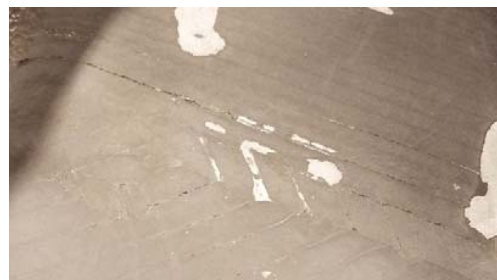
main defects the 3D printed composite mold had were chipping of the mold surface and some cracking on the mold surface between the bead interfaces as shown in Figs. 10 and 11 respectively.

Fig. 11 Mold surface cracking between beads

In terms of the mold's performance, the 3D printed composite mold performed as expected and was used to successfully fabricate all six of the carbon fiber valve covers. All carbon fiber valve covers were cured and demolded from the 3D printed composite mold with no issues. However, durability wise, the 3D printed composite mold sustained increasing amounts of defect after every part demolding. The

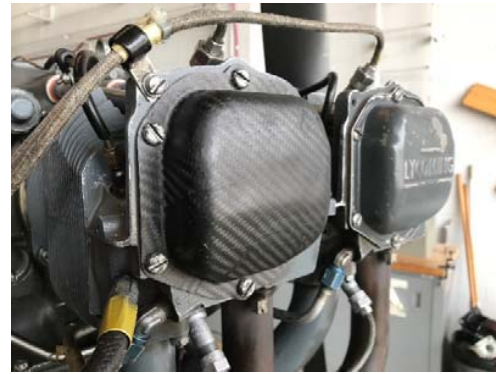
Fig. 14 Test fitting of carbon fiber valve cover

Based on the results from this study, the team was able to investigate the effectiveness of a 3D printed composite mold by producing six identical carbon fiber valve covers from a single 3D printed composite mold. The six carbon fiber valve covers were all test fitted onto the original aircraft reciprocating engine and all six carbon fiber valve covers fitted perfectly with no issues as shown in Fig. 14. The six carbon fiber valve covers however did have various surface defects that were caused by the mold surface gradually deteriorating from each part production, raising durability concerns for the 3D printed composite mold. There can be an abundance of factors that may have caused the deterioration of the mold surface. Some examples of these factors include porosity within the 3D printed composite mold, the 3D printing tool path of the 3D printed composite mold, and weak interfaces between printed beads of the 3D printed composite mold [1]. Many of these factors can essentially be removed by changes to the design and fabrication technique of the 3D printed composite mold. For example, the issue of porosity within the 3D printed composite mold can be rectified by heat treatments to the mold or by the application of surface coatings. Advance approaches forming molds with varying material composition also known as gradient materials may also be a suitable solution [6]. Other factors such as the printing tool path and weak interfaces between the printed beads may be solved by performing further tool-path optimization for the printing process of the 3D printed composite mold [7].
