The Effectiveness of Synthesizing A-Pillar Structures in Passenger Cars

Chris Phan, Yong Seok Park

Keywords—A-pillar, crashworthiness, design synthesis, finite element analysis.

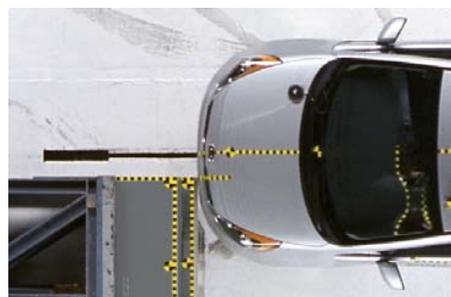
Fig. 1 Moderate Overlap Frontal Test Configuration

The most common type of crash resulting in fatalities is the frontal crash. For this reason, major efforts have been made to improve front protection, mainly from the crash test program that the NHTSA began in the late 1970s and the crashworthiness evaluations that IIHS began in 1995. When IIHS began the moderate overlap frontal crash test, the majority of vehicles were rated poor or marginal. Today, all vehicles earn good ratings since vast improvements have been made to occupant compartments and standard passive safety restraints such as safety belts and airbags protect the passengers. In the moderate overlap frontal crash test, a vehicle travels at 40 mph into a 2 feet tall deformable barrier made of aluminum honeycomb. A Hybrid III dummy representing an average-size man is positioned in the driver seat. 40% of the total width of the vehicle strikes the barrier on the driver side. This test simulates a frontal offset crash between two vehicles of the same weight, each traveling at 40 mph [5].

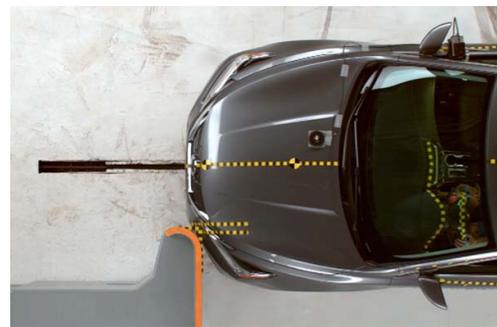
Fig. 2 Driver-side Small Overlap Frontal Test Configuration

Small overlap barrier crash tests are conducted at 40 ± 0.6 mi/h and 25 ± 1 percent overlap [4]. The test vehicle is aligned

with the rigid barrier such that the right edge of the barrier face is offset to the left (driver side) of the vehicle centerline by 25 ± 1 of the vehicle width. The vehicle is accelerated by a propulsion system at 0.3 g until it reaches 40 mph, and then released about 25 cm before contacting the barrier. The vehicle's rear brakes are activated 1 second after release.

The rigid barrier is made of a vertical steel plate, with a radius on the right edge of 150 mm and continues to form a 115-degree arc. The front plate has a thickness of 38.1 mm and is 1000 mm wide. The barrier sits on the floor with a height of 1524 mm, and is attached to a base unit. The dimensions of the base unit are: 184 cm high, 366 cm wide, and 542 cm deep. It is composed of laminated steel and reinforced concrete with a total mass of 145,150 kg. The rigid barrier is mounted to the right side of the base unit, which allows the test vehicle to continue its motion after contact [9].

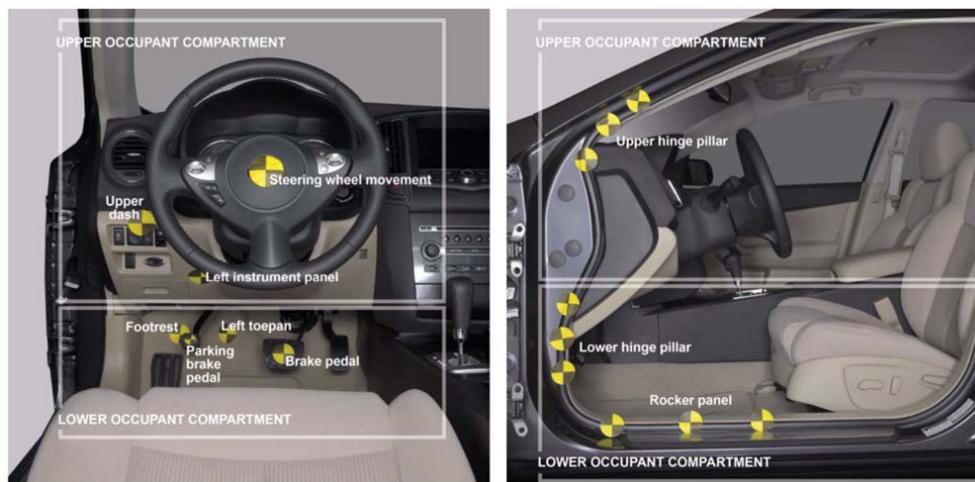
Fig. 3 Locations for Measuring Vehicle Intrusion

The lower and upper hinge pillars have three targets each. The hinge pillar is measured at the inner most surface of the door opening, usually on the pinch weld. The vertical coordinates for the three lower targets are obtained by adding 0 cm, 7.5 cm, and 15 cm, to the brake pedal reference point. The upper targets are obtained by adding 45 cm, 52.5 cm, and 60 cm from the pinch weld [10].

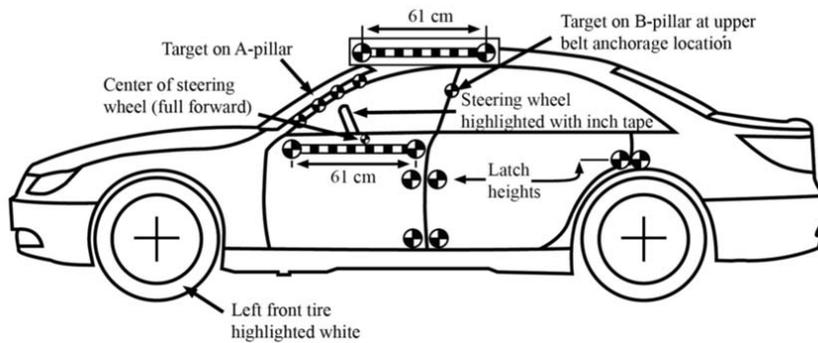
Fig. 4 Locations of Crash Test Targets

The exterior surfaces of the vehicle are trimmed with inch measurement tape and photographic targets are applied at specific points to enable analysis of the high-speed camera footage after the crash test. The targets are applied along the A-pillar, starting at the base, and every 10 cm in the longitudinal direction. By comparing the positions of these targets before and after the crash test, the amount of intrusion

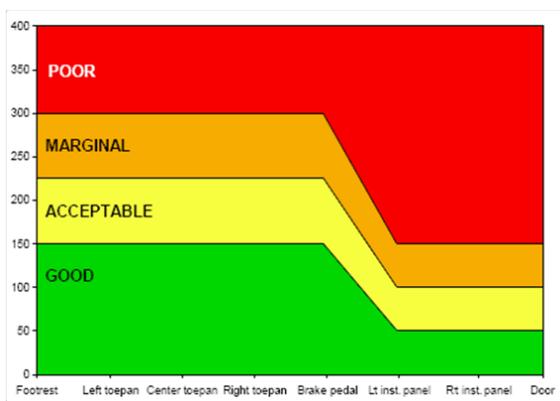
Fig. 5 Intrusion Plot

can be measured to determine the safety ratings. An intrusion plot is used to define the safety level thresholds for each target area, with ratings from poor, marginal, acceptable, and good.

A car is deemed safe when most of its targets have a displacement that is in the green (good) region.

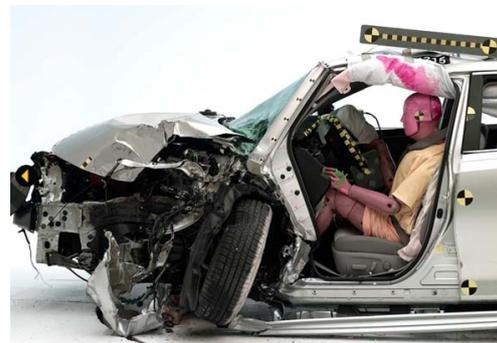
Fig. 6 2012 Camry Small Overlap Frontal Crash Results

The post-crash image of the 2012 Camry shows that the A-pillar has buckled and there is major intrusion into the occupant cabin. There is definite contact between the dummy's legs and the dashboard from firewall intrusion. The dummy's position in relation to the door frame, steering wheel, and instrument panel after the crash test indicates that the driver's survival space was not well maintained.

When comparing the two images of the 2012 and 2015

Camry post-crash images, it is apparent that the A-pillar deformed much less in the newer car. Thus, it is possible that Toyota upgraded the A-pillar structure in the 2015 Camry to earn a “good” rating in the frontal small overlap crash test.

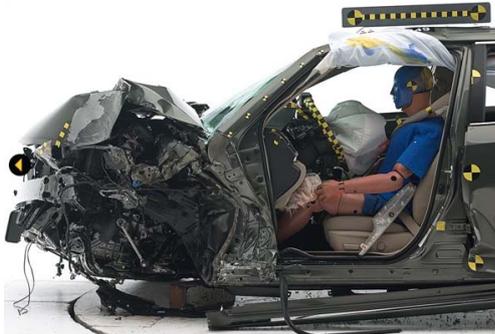
Conversely, the post-crash image of the 2015 Camry shows that the A-pillar has low deformation and the occupant compartment has little intrusion. The dummy's position in relation to the door frame, steering wheel, and instrument panel after the crash test indicates that the driver's survival space was maintained reasonably well in the IIHS' test.

Fig. 7 2015 Camry Small Overlap Frontal Crash Results

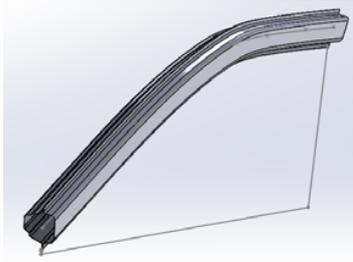
Fig. 10 CAD Model of 2015 Camry A-Pillar

Two A-Pillar CAD models were drawn in SolidWorks software to be analyzed. An image of the side profile of both the 2012 and 2015 Toyota Camrys were pasted into SolidWorks to accurately define the scale to find the actual size of the vehicle. Both vehicles had a wheelbase of 2772.2 mm and the scale was set accordingly. A spline was drawn to close follow the curvature of the A-pillar as a backbone. A generic A-pillar cross-section was drawn and extruded to follow the spline previously made to create the structure for the 2012 Camry. The wall thickness was set to 1.27 mm according to the 18-gauge steel commonly used in A-pillar sheet metal in most cars. The same process was executed for the 2015 Camry A-pillar, using the 2012 Volvo XC60 cross-section. These two A-pillars will have their performance tested in a simulation using ANSYS software.

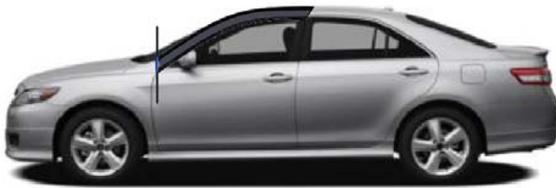
Fig. 11 CAD Modeled A-Pillar Overlay of 2012 Camry

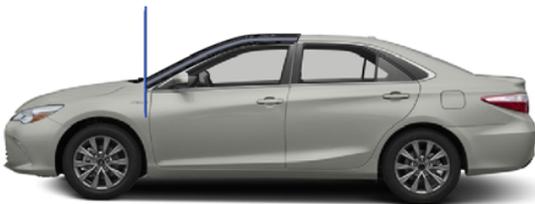
Fig. 12 CAD Modeled A-Pillar Overlay of 2015 Camry

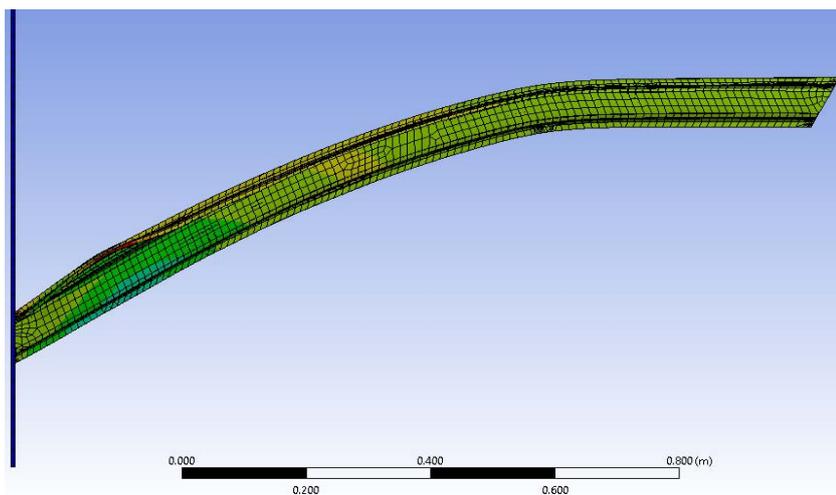
Fig. 14 ANSYS Simulation of 2015 Camry A-Pillar

After simulating the A-pillar models to an applied dynamic load similar to a small overlap crash, the output data for total deformation, stress, and strain was obtained. The total deformation was 254.3 mm (9.843 in.) for the 2012 Camry and 29.3 mm (1.154 in.) on the 2015 Camry. The maximum equivalent (von Mises) elastin strain for the 2012 Camry was 0.1407 m/m and 0.16631 m/m on the 2015 Camry. The maximum equivalent (von Mises) stress on the 2012 Camry was 3.30 GPa and for the 2016 Camry, 1.72 GPa.

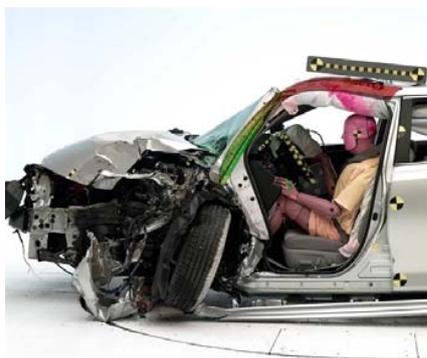
Fig. 15 Overlay of 2012 Camry A-Pillar Simulation on Actual Crash Photo

Comparing the results from the A-pillar simulations to the actual IIHS small overlap crash test photos containing the A-pillar structures, parallels can be seen. The total deformation of 9.843 in. in the longitudinal direction on the 2012 Camry appears to be consistent with the A-pillar buckling in the photo of the 2012 Camry in the IIHS crash test. Similarly, the lack of deformation of 1.154 in. from the 2015 Camry simulation matches the IIHS crash test photo for the 2015 Camry. Using the 61 cm. scale from the photo, the actual deformation is fairly close to total deformation from the simulation for both models. Examining the stress concentration denoted in red on the 2012 A-pillar in the simulation, it appears to be a match to the point of buckling on the actual 2012 Camry A-pillar. There is also a small stress concentration on the 2015 Camry pillar that matches the slight buckling on the actual pillar. Observing the data from NHTSA's NCAP test report for interior intrusion of the upper pillar, it appears to be a close match to the simulation results. The 2012 Camry reported an upper hinge pillar intrusion of 19 cm. whereas the simulation stated 25.4 cm. The 2015 Camry reported only 8 cm of upper hinge pillar intrusion and the simulation showed 2.93 cm. Comparing the values from the simulation, the data are a close match (within 6 cm) of the numbers from NHTSA's reports for both Camry models. Thus, the simulation performed validates the possibility of a cross-section shape upgrade between 2012 and 2015 in the Toyota Camry.

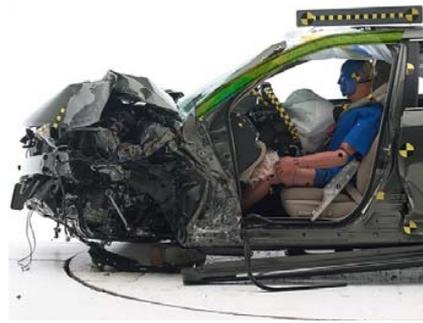
Fig. 16 Overlay of 2015 Camry A-Pillar Simulation on Actual Crash Photo
