# Cloudburst-Triggered Natural Hazards in Uttarakhand Himalaya: Mechanism, Prevention, and Mitigation

**Abstract**—This article examines cloudburst-triggered natural hazards mainly flashfloods and landslides in the Uttarakhand Himalaya. It further describes mechanism and implications of natural hazards and illustrates the preventive and mitigation measures. We conducted this study through collection of archival data, case study of cloudburst hit areas, and rapid field visit of the affected regions. In the second week of August 2017, about 50 people died and huge losses to property were noticed due to cloudburst-triggered flashfloods. Our study shows that although cloudburst triggered hazards in the Uttarakhand Himalaya are natural phenomena and unavoidable yet, disasters can be minimized if preventive measures are taken up appropriately. We suggested that construction of human settlements, institutions and infrastructural facilities along the seasonal streams and the perennial rivers should be avoided to prevent disasters. Further, large-scale tree plantation on the degraded land will reduce the magnitude of hazards.

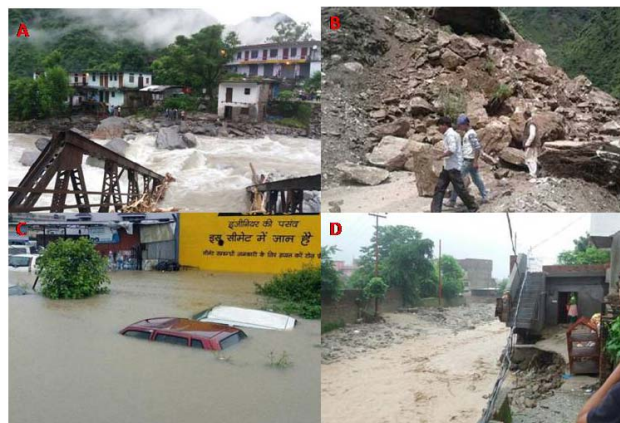
Fig. 2 A. Bridge collapsed due to flashfloods in Kanar village, Pithoragarh; B. Huge landslide on the Gangotri pilgrimage road; C. Roads are over flooded due to cloudburst-triggered floods in Dehradun city; D. Houses collapsed along the seasonal Nala in Kotdwar due to cloudburst (All these incidences occurred in the second week of August 2017)

In the second week of August 2017, cloudburst-triggered flashfloods and landslides have devastated Malpa village, Kotdwar town, and Dehradun city where a number of people died and huge property was damaged (Fig. 2).

We gathered data on rainfall in the second week of August 2017 from the Meteorological Department, located at Dehradun, a state capital of Uttarakhand. Haldwani received 120 mm rain, Bageshwar 80 mm, Garud 80 mm, Didihat 80 mm, Nainital 70 mm, Kapkot 70 mm, Ramnagar 60 mm, and Munsyari recorded 50 mm rainfall. In Garhwal, Mussoorie recorded 160 mm rain and Dehradun received 70 mm on the same period. Within 24 hours, Pantnagar recorded a whopping 52 mm of rain followed by Haridwar 48.8 mm. Heavy downpour caused havoc in many places. From Lambagarh on the Badrinath highway to near Tanakpur national highway in Pithoragarh, more than 100 link roads were cut off for several days due to landslides. Gangotri and Yamunotri national highways were also badly damaged.

In the Kumaon Himalaya, Pithoragarh district was severely affected by the natural disasters. In Madkot village (Bangapani area, Pithoragarh), about half-a-dozen houses along with a bridge were collapsed, six people died and 56 goats were drowned due to cloudburst-triggered flashflood. About ten people were missing. Mangti *Nala* (seasonal stream) near Tawaghat was over-flooded that swept away shops and Army camp. Similarly a massive landslide hit Malpa village (Dharchula Tehsil) on the way to Kailash Mansarovar Yatra route in August 2017 [9], which washed away the settlements and killed 25 people. Several times, Kailash Mansarovar Yatra (a pilgrimage procession) was suspended due to these natural catastrophes. Malpa village had been also affected by a huge landslide in 1998, which killed 200 people. In Tawaghat-Pangla highway, three bridges collapsed. Cloudburst-triggered flashflood also affected Vyas valley of Pithoragarh district and Bijrani village in Almora, which washed away cowsheds, houses and agricultural land. Similarly, in Garhwal Himalaya, a number of areas were hit by cloudburst-triggered hazards. A devastating cloudburst triggered flashflood killed nine people and affected many households in Kotdwar city. Floodwater (Paniala *Nala*) entered in houses and damaged them. About 40 settlements were swept away due to cloudburst in Rauthiya village of Jakholi Block, Rudraprayag. At Pinola between Joshimath and Govindghat, about 20 metres highway was blocked by debris that hindered the pilgrims' way to Hemkund Sahib and Badrinath. The Ganga has breached the warning mark of 293 meters in Haridwar. The heavy rainfall further led to water-logging in the city. In Dehradun, Rispana Bridge was over flooded and a huge landslide occurred in Kimadi-Lambidhar-Mussoorie Road. All these incidences led to huge losses of lives and property. The whole Garhwal region is highly prone to atmospheric hazards. In a number of times, it received huge catastrophes. The Kedarnath tragedy, which is also known as the 'Himalayan Tsunami' devastated the whole region in 16 June 2013.
