# Design and Construction Validation of Pile Performance through High Strain Pile Dynamic Tests for both Contiguous Flight Auger and Drilled Displacement Piles

S. Pirrello

**Keywords**—Contiguous flight auger, case pile wave analysis, high strain pile, drilled displacement, pile performance.

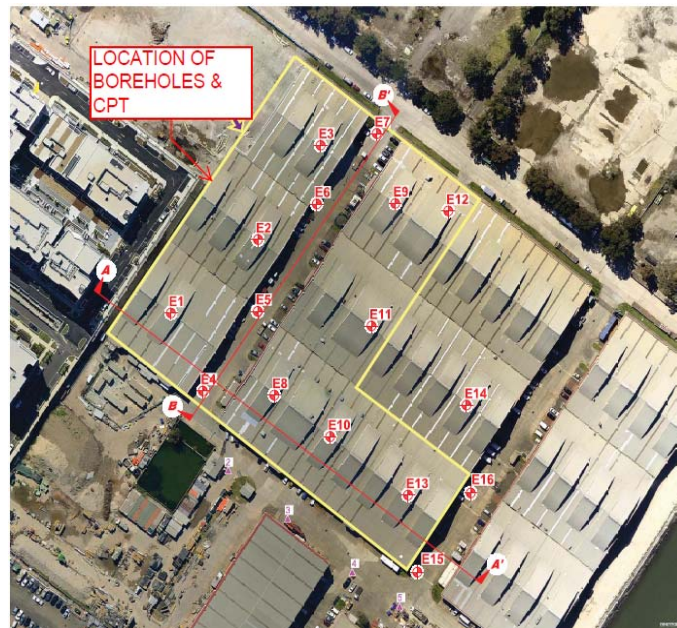
Fig. 1 Test locations

Stiff clay/dense sand (i.e. Unit C) variability can be appreciated on the two cross sections of the site given in Figs. 2 and 3, below. The locations of the cross sections along with the borehole locations are shown in Fig. 1.

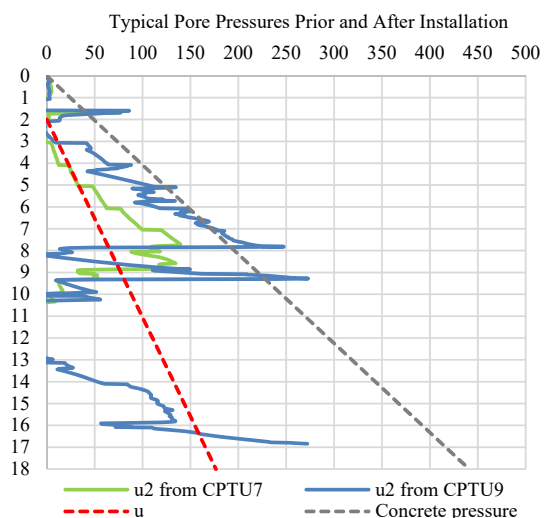
Fig. 9 Pore pressure results from CPTu7 and CPTu9, prior and after installation

Typical CPTu results prior and after the installation are given in Fig. 9.

The increase of pore pressure after installation can be appreciated in CPTu7 at 8-m and 9.5-m depth. However, this increase is very close to the concrete head pressure at the same depth in the worst case or less, and therefore the integrity of the newly formed pile shafts is not a concern. A substantial increase in pore pressure with depth greater than the concrete head pressure would be a potential indicator of damage to the pile, e.g. pile “necking” at the depths where the pore pressures exceeded concrete pressures.

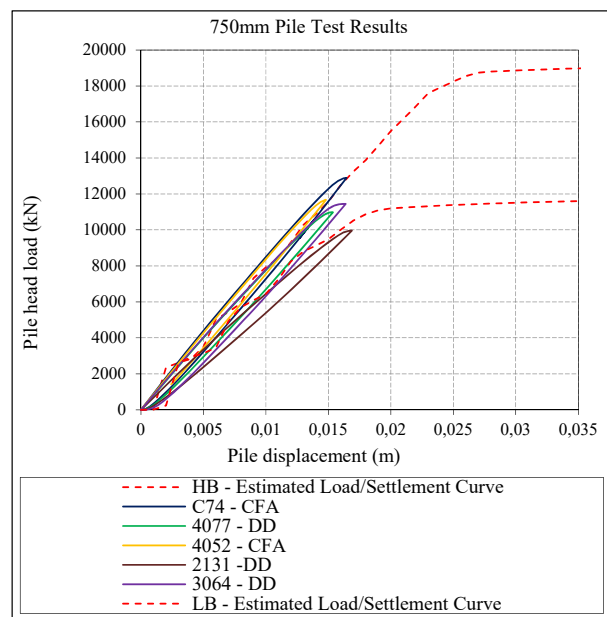
Fig. 101 750-mm estimated vs test load settlement curve

All piles tested were production piles socketed into the sandstone bedrock. A potential disadvantage of dynamic testing of reasonably highly loaded piles is that the hammer drop height must be sufficient to deliver enough energy on the pile to mobilise and prove the required pile resistance whilst not damaging the pile. None of the piles were damaged during the tests as the developed stresses within the piles due to the dynamic impact were continuously monitored. Test signals were recorded on site by means of PDA monitoring and testing devices. Table IV reports the test results. Pile test analyses were carried with CAPWAP, from which the interpreted load displacement curves at construction stage are given in Figs. 10 and 11.
