Diagnostics of Fatigue Damage of Gas Turbine Engine Blades by Acoustic Emission Method

A.Urbach, M. Banov, V. Turko, Y.Feshchuk

Abstract—the work contains the results of complex investigation related to the evaluation of condition of working blades of gas turbine engines during fatigue tests by applying the acoustic emission method. It demonstrates the possibility of estimating the fatigue damage of blades in the process of factory tests. The acoustic emission criteria for detecting and testing the kinetics of fatigue crack distribution were detected. It also shows the high effectiveness of the method for non-destructive testing of condition of solid and cooled working blades for high-temperature gas turbine engines.

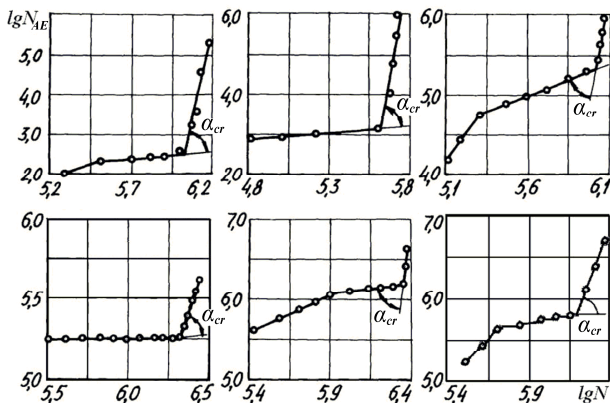
Fig. 1 presents the data characterizing dependencies $\lg N_{AE} = f(\lg N)$ at the example of six tests of the first lot of solid working blades. It is obvious that all dependencies have qualitatively similar nature: areas of slow growth of total AE are followed by areas of its sharp increase.

Intersection of the specified areas form angles α_{cr} (α -criterion) [5, 6] that characterize the presence of inflection point in the graph. Tests of the first lot of blades were stopped at the point when α_{cr} appeared. For the second lot, reaching maximum value E_{max} (energy criterion – E_{cr}) by AE energy E was considered the criterion for stopping the tests.

Fig. 1 Change of total AE during cyclic loading of solid blades with the use of α -criterion

In spite of different testing conditions from the point of view of stresses in the dangerous section of the body of the first and second lot of working blades, the behaviour of dependencies $\lg N_{AE} = f(\lg N)$ with the use of both α -criterion and E-criterion was identical (see Fig. 1, 3). The difference between graphs lies in the fact that testing of the first lot was stopped with the first appearance of α_{cr} (see Fig. 1), while the use of E_{cr} for the cessation of tests is followed by the appearance of one or more α_{cr} (see Fig. 3). Thus the graphs obtained for blades 2 and 3 have one α_{cr} ; the ones obtained for blades 1 and 4 have two α_{cr} ; the ones obtained for blade 5 have four α_{cr} .

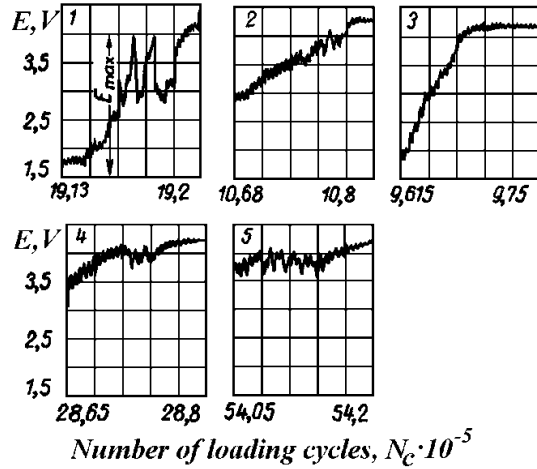
Acoustograms of energies and graphs of dependencies $\lg N_{AE} = f(\lg N)$ for tests of five solid blades from the second lot are shown in Fig. 2 and 3.

Fig. 2 Acoustograms of AE energy change during cyclic loading of solid blades with the use of E-criterion

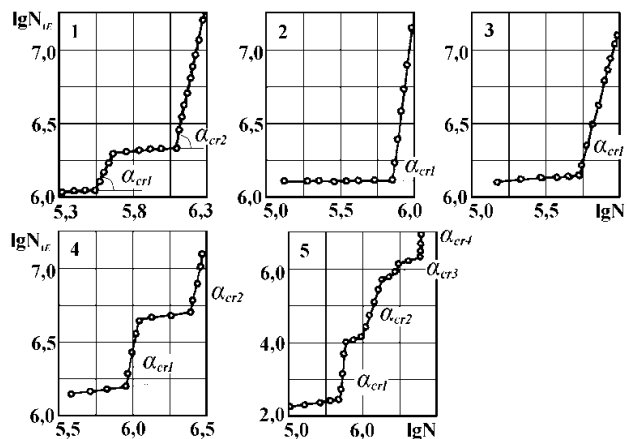
Fig. 3 Change of total AE during cycling loading of solid blades with the use of E-criterion

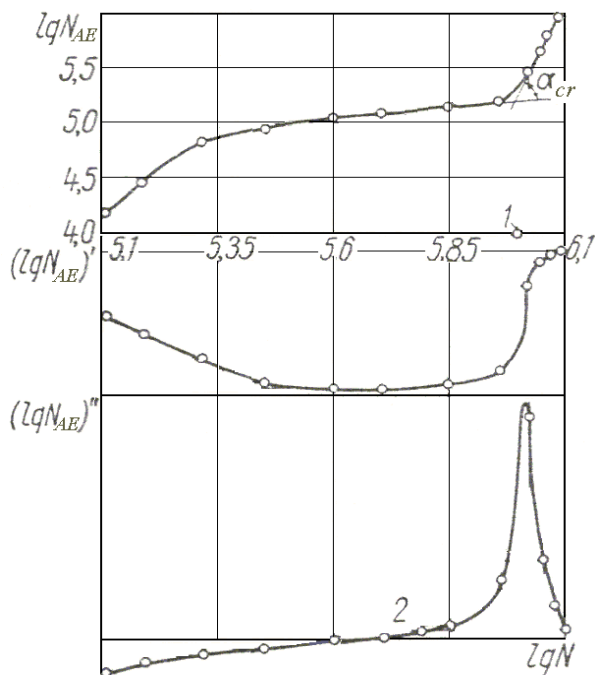
Using the above mentioned criteria, fatigue cracks were registered not only along the blade body but also in the root, i.e. in the place of nipping on the shake table. The comparative evaluation of blade fatigue cracks by length parameter, which was carried out with the help of luminescent control, showed that the length of cracks revealed on the basis of E_{cr} in all cases exceeded the size of cracks detected on the basis of α_{cr} . Thus it can be presumed that the appearance of an initial crack in a working blade during testing occurs long before reaching the specified threshold E_{max} (E_{cr}). Thus in Fig. 3, the first appearances of α_{cr} characterize the formation of initial cracks. However, the blade still does not lose its rigidity properties (natural-vibration frequency of a blade body measured using manufacturing technology still does not decrease) right till the end of the test. Therefore, the criterion assesses the real operability (survivability) of those blades that already have initial cracks. The quantitative estimation of this value showed that blades with cracks detected in accordance with the first α_{cr} do not lose their operability (by the criterion of natural-vibration frequency) in the range of 30 to 90% of the total loading time. One of the possible criteria for early detection of fatigue cracks in the process of fatigue loading is the second derivative $(\lg N_{AE})''$ by time from function $\lg N_{AE} = f(\lg N)$. Fig. 4 presents an example of change of the first $(\lg N_{AE})'$ and second $(\lg N_{AE})''$ derivatives on the basis of results of testing the third blade from the first lot (see Fig. 1). The behaviour analysis of derivatives in the process of cyclic loading shows that the stage of loading at which the second derivative becomes positive (see Fig. 4 point 2) corresponds to the moment of fatigue crack initiation.

Fig. 4 The changes in time of the first and second derivatives of functions $\lg N_{AE} = f(\lg N)$: 1 — moment of crack detection by α -criterion; 2 — moment of crack detection by $(\lg N_{AE})'' > 0$

Thus, to detect the moment of fatigue crack initiation during a fatigue test, which separates the first stage of fatigue accumulation of damage from the second one, α -criterion, E-criterion as well as the value of the second derivative when it takes on a positive value can be used. The latter criterion ensures earlier detection of a crack; then, from the point of view of accuracy, there follows α -criterion; and E-criterion is the “roughest” criterion for detection of longer fatigue cracks. α -criterion appeared to be the easiest-to-operate criterion for detection of the moment of fatigue crack initiation. The correctness of the given criterion choice as well as its reliability were checked on both solid working blades of other construction and cooled working blades of other construction.

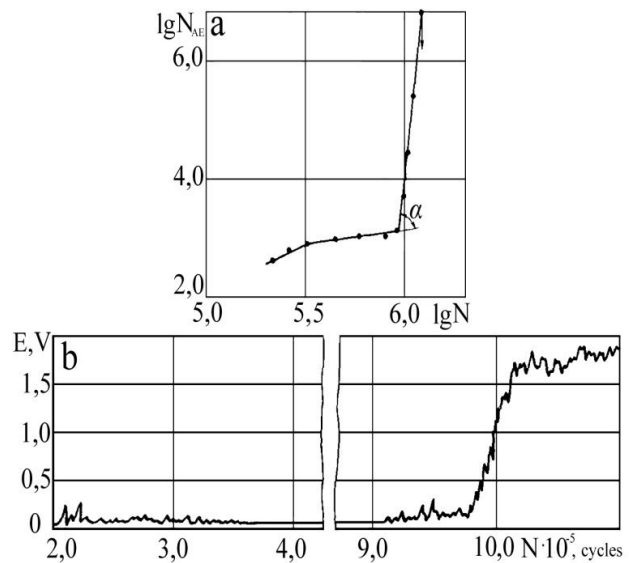
For cooled blades, investigation was carried out in three stages. At first, in the conditions of stationary cyclic loading with the stresses of $\sigma = 220$ MPa, the tests were carried out until the operation of the “roughest” criterion E_{cr} . In this case, the nature of dependencies $\lg N_{AE} = f(\lg N)$ is identical to the one that was obtained earlier for solid blades: areas of slow growth N_{AE} are followed by areas of sharp increase. Intersection of the specified areas form angles α_{cr} , similarly to the case with solid blades. At the same time none of the tested blades lost its rigidity properties (natural-vibration frequency of blade body remained constant). Fig. 5 presents the results of specified dependencies change at the example of one of the tested blades.

Fig. 5 The change of total (a) and energy (b) of AE signals in the process of cyclic loading of a cooled working blade (the point at which the tests were stopped is shown with an arrow)

after its opening. It is seen that the fatigue crack in the blade, for which the dependency was obtained and which is presented in Fig. 5, appeared near the base of the cooling intensifier of a cylindrical shape (shown with an arrow). Fig. 6b presents a photo of fracture area along the crack. It is seen that the fatigue crack in this blade has developed to the depth, which is greater than half the thickness of the wall of blade body back, however it has not reached the outside surface yet. The metallographic analysis of other fractures along such cracks showed that they also had fatigue nature and were developing from the inner surface of hollow blades to their outside surface.

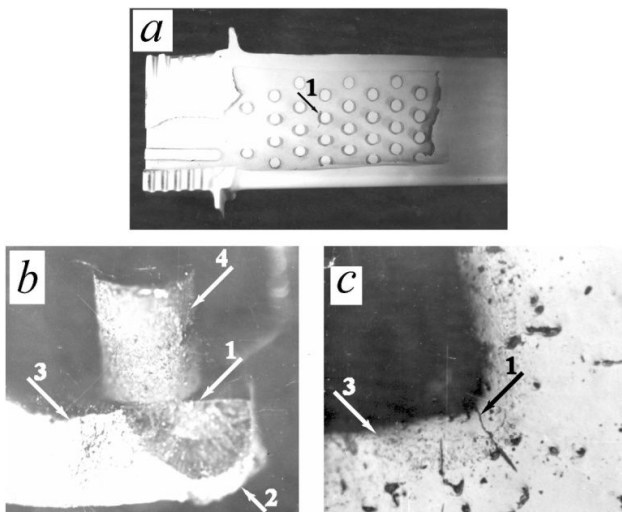
Subsequently all blades were subjected to tests to reveal the presence of cracks with the help of traditional methods. The carried out luminescent control did not show any defects on the outer surfaces of the blades. After opening, defects of crack type were detected in the blades. Fig. 6a presents an example of a photo of inner cavity of one of the cooled blades

Fig. 6 Photo of a blade with a crack: a) – general view of the internal cavity after opening, b) – area of fracture along the crack (x10), c) – metallographic section (X100): 1 - crack, 2 – outside surface of blade, 3 – inner surface of blade, 4 – cooling intensifier

Thus the high efficiency of α_{cr} operation is demonstrated, while the use of E_{cr} in these tests gave the opportunity to reliably register the appearance of fatigue cracks by using traditional methods. Further metallographic investigation demonstrated that the earlier the tests were stopped after α_{cr} registration the smaller was the crack. In cases when tests were stopped practically right after the registration of angle α , cracks could be detected only after long-term exposure (more than three days) with the help of the luminescent method. Subsequent metallographic analysis of sections of these areas confirmed the presence of fatigue cracks (Fig. 6c).

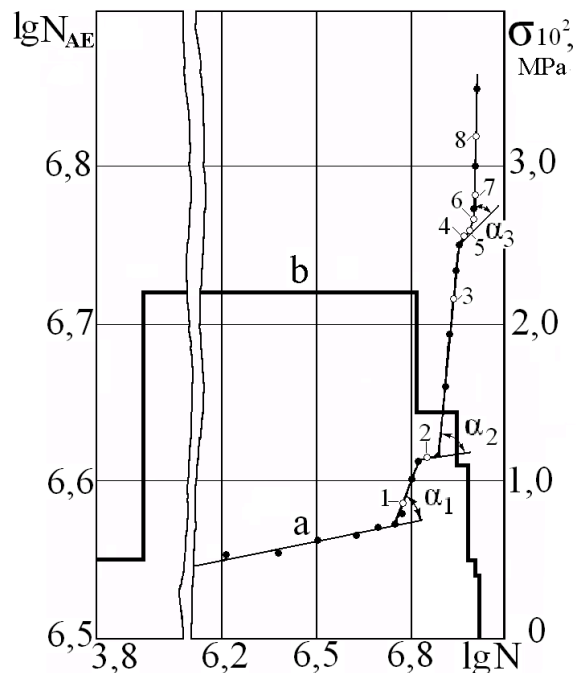
purpose arose. The process of “growing” in certain moments involved the repeated use of fatigue tests of α_{cr} and E_{cr} , the essence of which lies in the following facts: The investigated blade was preliminarily subjected to cyclic loading that created the stress equal to 50 MPa. If AE was not recorded, the blade was considered defect-free. Then, in order to accelerate the experiment, the stress was increased up to 220 MPa with subsequent stepwise decrease at the moments of time corresponding to the initial appearance of a crack and then corresponding to its accelerated growth with new stress values. Graphical construction of dependency $\lg N_{AE} = f(\lg N)$ was carried out right in the process of testing using the above described method. The load was reduced at the moments of time that corresponded to reaching AE signals energy value E_{cri} after the recording of angles α_{cri} (Fig. 7) where $i = 1, 2, 3, \dots$ is a number of stepwise reductions of load.

Fig. 7 The change of total AE (a) in case of staged step change of stress (b) in the process of cyclic loading:

- – experimental points; o – points corresponding to the record of acoustograms of AE signals energy change

Thus the first reduction was made after operating time $lgN = 6.81$ (see Fig. 7b) after the formation of angle α_{cr1} and subsequent operation of energy criterion E_{cr1} , which characterized the reliable appearance of fatigue crack. The change of AE signals energy in the area prior to the reduction of stress is presented in Fig. 8 (acoustogram area 1, obtained in point 1) with $lgN = 6.78$ (see Fig. 7a). With a new stress value which is equal to 145 MPa (see Fig. 7b) the deceleration of the crack occurs, which is confirmed by the change of total AE (see Fig. 7a) and the reduction of energy level (see Fig. 8, acoustogram area 2) obtained in point 2 with $lgN = 6.83$ (see Fig. 7a). In the process of subsequent cyclic loading, the growth of the crack accelerates (angle α_{cr2} is formed). The level of energy increases again up to value E_{cr2} , which can be well seen in Fig. 8 (acoustogram area 3 obtained in point 3) with $lgN = 6.94$ (see Fig. 7a). Then, with $lgN = 6.95$, the following reduction of stress up to 110 MPa was made (see Fig. 7b), which entailed the deceleration of the crack and, correspondingly, the reduction of values of AE parameters (see Fig. 8, acoustogram area 4). After the recording of angle α_{cr3} , the level of energy increases up to value E_{cr3} (see Fig. 8, area of acoustogram obtained in point 5). At the moment corresponding to operating time $lgN = 6.99$ the stress was reduced up to 50 MPa (see Fig. 7b). The growth of the crack decelerated for a short time, which is insufficiently reflected in Fig. 7a and well illustrated in Fig. 8 (area 6 of acoustogram obtained in point 6), with $lgN = 6.99$ (see Fig. 7a). Then the growth of the crack accelerates again, which is confirmed by the increase of AE energy level up to another energy criterion E_{cr4} (see Fig. 8, acoustogram in point 7). The next reduction of stress up to 40 MPa practically does not exert any influence on the velocity of crack growth; energy criterion remained at the same level of E_{cr4} (see Fig. 8, acoustogram in point 8). When the stress was below 40 MPa, counting with the help of the frequency meter stopped. During the subsequent luminescent control of blades tested with the help of the above described programme no cracks were detected on the outer surface. However, after the opening of blades, both the luminescent control and the metallographic analysis confirmed the presence of cracks of fatigue nature on inner surfaces.

Fig. 9 presents a photo and a diagram of blade fracture along the crack (shown with arrows), for which the dependencies presented in Fig. 7 and 8 were obtained. It is seen that the crack in this blade has reached approximately half the thickness of the wall and has not reached the outer surface.

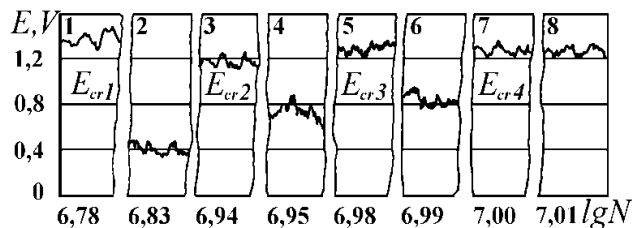
Fig. 8 Acoustograms of AE signals energy change at typical stages of loading of a cooled blade

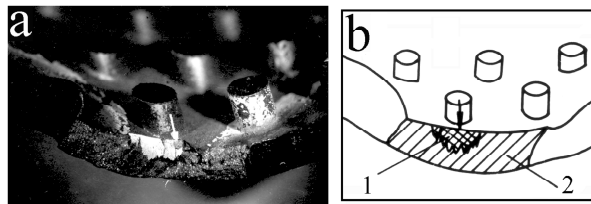
Fig. 9 Photo and diagram of blade fracture along the crack
