Effect of Stirrup Corrosion on Concrete Confinement Strength

Mucip Tapan, Ali Ozvan, Ismail Akkaya

Keywords—Bridge, column, concrete, corrosion, inspection, stirrup reinforcement.

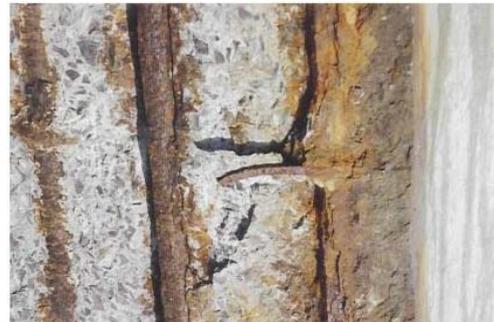
Fig. 1 Close-up of corroded rebars [5]

The deteriorating effects of corrosion are evident but stirrup corrosion has significant effects on load carrying capacity of the reinforced concrete columns (i.e. relatively larger cross-section reduction, loss of concrete confinement because of loss of bond and loss of anchorage). These significant effects are expected because stirrups start corroding earlier than the longitudinal reinforcement and since they are smaller in diameter, same corrosion rate leads to larger relative reductions in stirrup cross-sections (Fig. 1).

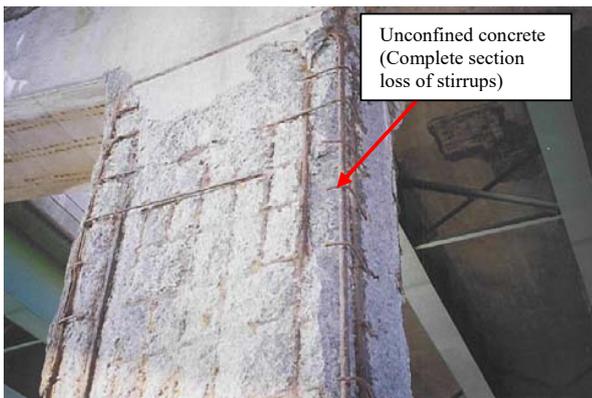
Fig. 2 Effect of corrosion on reinforced concrete column [5]

When the stirrup starts to corrode, the confinement effect of stirrups is reduced because of the loss of bond between reinforcement and concrete (Fig. 2). When the cover to the longitudinal reinforcement cracks, the load carrying capacity starts to decrease at a faster rate due to the reduction of stirrup anchorage. Loss of transverse reinforcement, as shown in Fig. 2, leaves the column section unconfined. In addition, loss of bond between the corroded bars and the surrounding concrete, as shown in dramatically decreases the axial load carrying capacity of the column (Figs. 3 (a) and (b)).

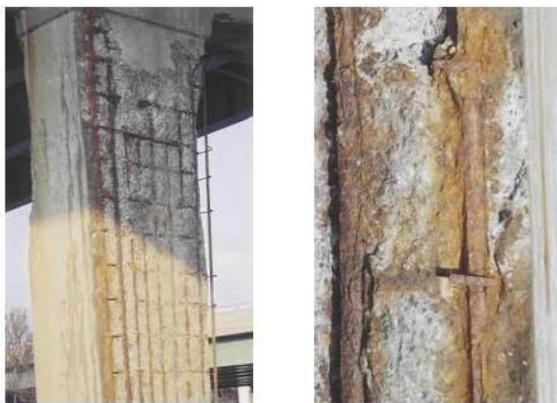
(a) Completed deterioration of Stirrups. (b) Severe corrosion of rebar.

Fig. 3 Corrosion damage of tall concrete bridge pier columns [5]

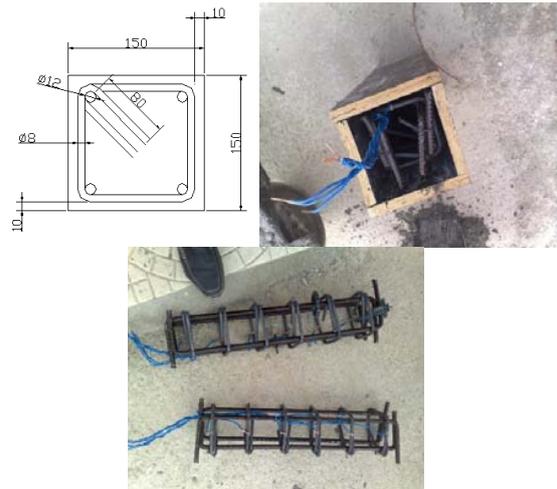
Fig. 4 Details of column specimens and reinforcement arrangement

In order to evaluate the effect of stirrup corrosion on confinement strength of concrete, 12 test specimens were cast, (two for control purposes (CON-1, CON-2, CR-1 to CR-10 having different corrosion rates)). The columns had a square cross section 150×150 mm and length 350 mm. 12 mm diameter reinforcement was placed into the corners of the cross section. The transversal reinforcement was formed by closed stirrups with a diameter of 8 mm with a spacing of 10 cm (c/c). The detailed drawing of the specimens and their reinforcement is shown in Fig. 4.

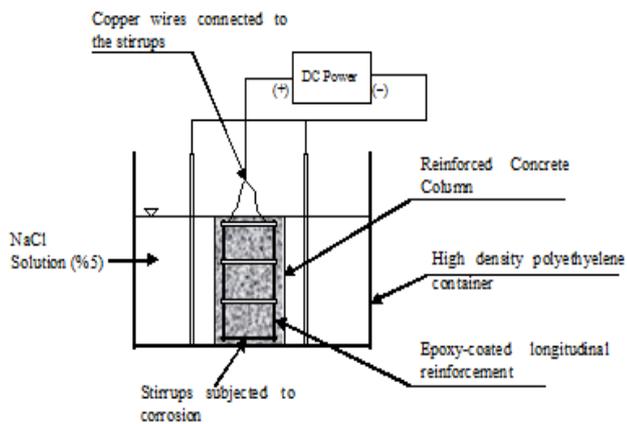
Fig. 5 Schematic representation of accelerated corrosion set-up

Ten specimens were subjected to accelerated corrosion. Fig. 5 represents the accelerated corrosion setup. Each specimen was placed in a tank where 5% NaCl solution was used as an electrolyte. The solution level in the tank was adjusted to slightly exceed the columns upper part. The specimens were incorporated with a direct current power supply with an output of 6 Amps. The accelerated corrosion process was conducted to result in 5%, 10%, 15%, 20%, 25%, 30%, 35%, 40%, 45% and 50% stirrup section-loss. However, because of the non-uniformity of the corrosion, and the presence of other reactions, the stirrups inside the tested columns were removed

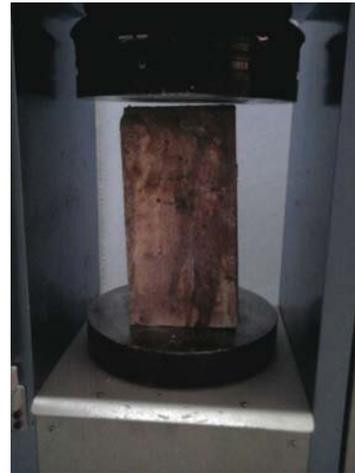
Fig. 6 A corroded column specimen before compressive testing

Fig. 6 shows a tested column and Fig. 7 shows a typical corroded column stirrup after cleaning from rust and concrete remains. In some cases, complete section-loss was also observed.

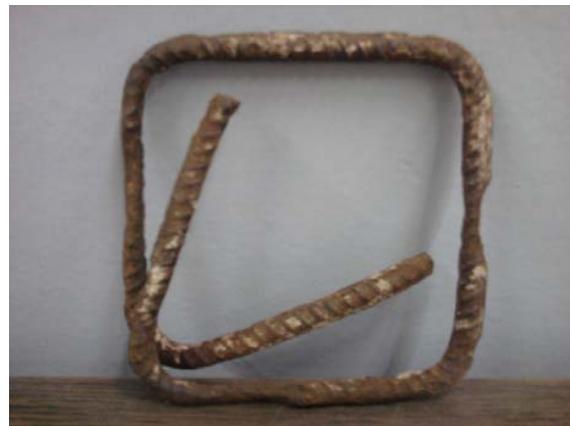
Fig. 7 Typical corroded column stirrup

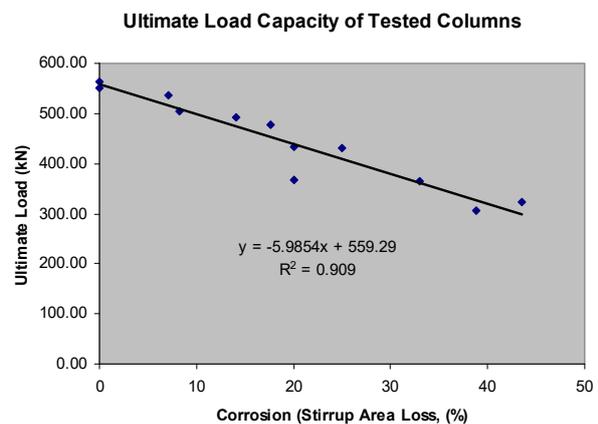
Fig. 8 Effect of stirrup corrosion on axial load carrying capacity of reinforced concrete columns

The load carrying capacity of tested columns is given in Table II. The reduction in ultimate capacity with increasing levels of corrosion damage was obvious. The major findings of these tests are the importance of effect of stirrup corrosion, stirrup debonding from the concrete and cover cracking because of stirrup corrosion on concrete confinement strength and consequently on axial load carrying capacity of corroded reinforced concrete columns. Section loss corrosion is determined calculating the average weight loss of corrosion damaged stirrups in the tested column. For the sake of simplicity pitting corrosion is not taken into consideration. Results indicate that, the axial load carrying capacity of corroded reinforced concrete columns significantly decreases as the rate of stirrup corrosion increases. Therefore, in order to avoid unsafe/over-conservative ratings the inspection procedures shall identify stirrup section-loss and incorporate in the analysis phase.
