Effects of Capacitor Bank Defects on Harmonic Distortion and Park's Pattern Analysis in Induction Motors

G. Das, S. Das, P. Purkait, A. Dasgupta, and M. Kumar

Keywords—Capacitor bank, harmonic distortion, induction motor, Park's pattern, PSCAD simulation.

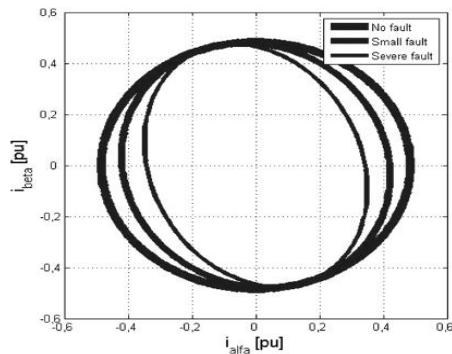
Fig. 1 Current Concordia pattern for faulty condition [18]

In the case of a fault in the stator winding, the $\alpha\beta$ trajectory no longer remains circular, but becomes elliptic whose major axis orientation is associated to the faulty phase. Such a situation is reproduced from [11] and is shown in Fig. 1.

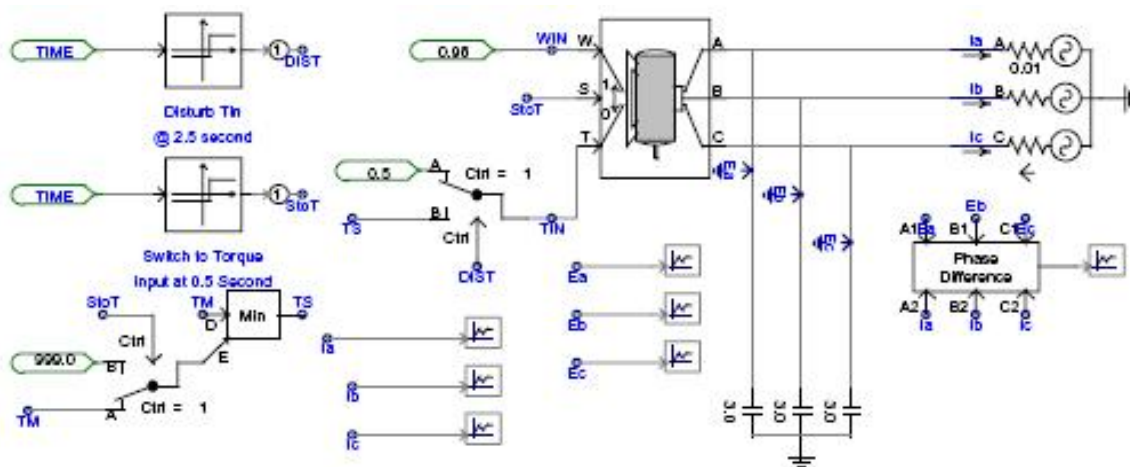
Fig. 2 PSCAD simulation model

In the present work, PSCAD has been used to construct model of a three phase induction motor, supplied from a balanced three phase supply through a capacitor bank. The simulation model in PSCAD is shown in Fig. 2. Faults have been simulated in the capacitor banks in three different phases and line currents are recorded. Average power factor and THD of the line current signal have been computed for different cases, as were Concordia patterns generated.

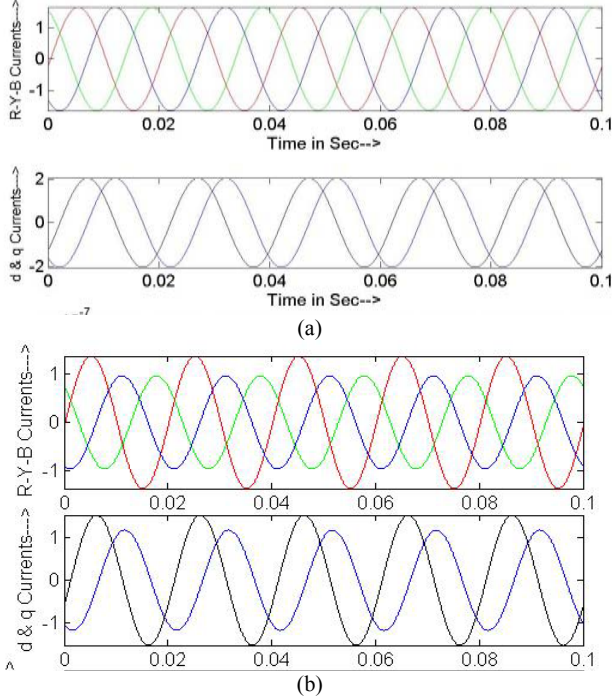
Fig. 3 Three phase current and α - β component currents for test case (a) S1 and (b) S4

Fig. 3 gives plot of the recorded three-phase current wave and the derived $\alpha\beta$ component currents corresponding to test cases S1 and S4. S1 represent a balanced capacitor bank test case, while S4 is for an unbalanced case. The variations and unbalancing in the current waves due to capacitor bank failure

is clearly visible in Fig. 3(b). Similar plots can be obtained for the other test cases. Concordia patterns obtained by plotting α vs. β component currents for test cases S1-S6 are plotted in Fig. 4 α and β axes are plotted in terms of per unit values where the instantaneous values are divided by peak of rated motor line current.

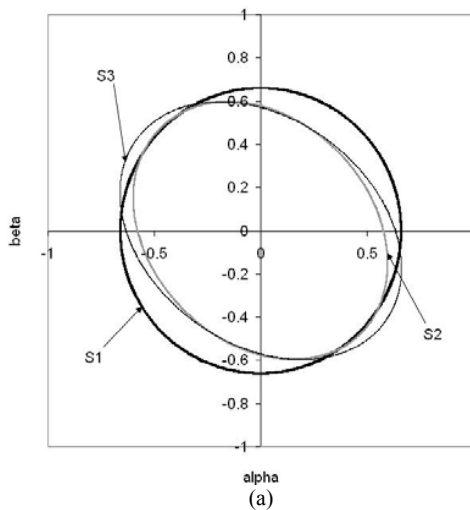
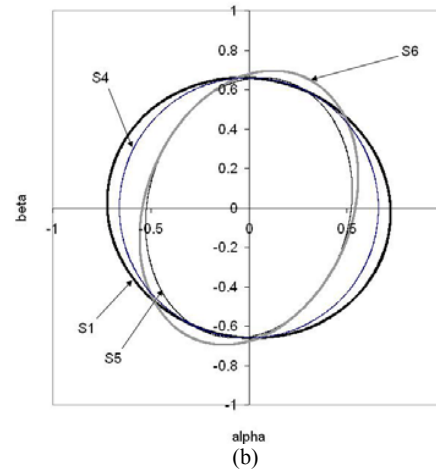
Fig. 4 Concordia patterns corresponding to test cases (a) S1 – S3 and (b) S4 – S6

As can be seen in Fig. 4(a) and Fig. 4(b) that the Concordia pattern corresponding to the healthy condition S1 is a perfect circle. However for other cases (S2 – S6) with different degrees of unbalance in capacitance connected in the three phases, the Concordia pattern is found to deviate from its regular circular shape to more elliptical shape with different angles and different directions of inclination.

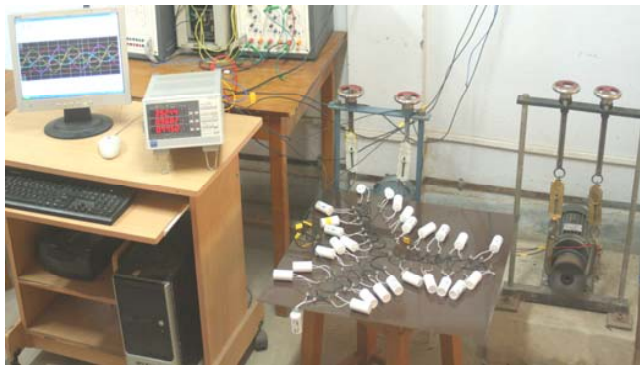
Fig. 5 Laboratory experimental setup

The test setup shown in Fig. 5 consists of one laboratory grade 1.5 kW, 3-phase, 440V, 50 Hz induction motor along with a capacitor bank with series parallel combination of six capacitors (1 μ F and 2.25 μ F, three each) in each phase. A number of variations could thus be obtained by different combinations of the externally connected capacitors in each phase. Motor line currents are measured with YOKOGAWA power meter [Model WT230], and then transferred to the PC for further analysis. Table II summarizes the different test conditions with corresponding values of THD and power factors.

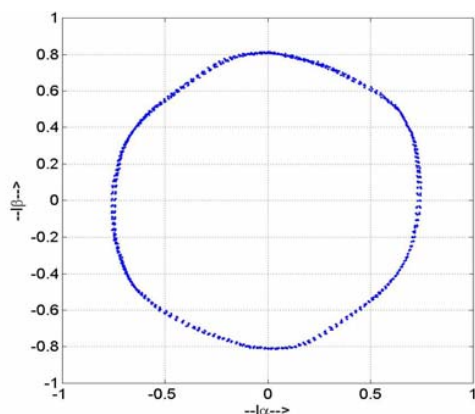
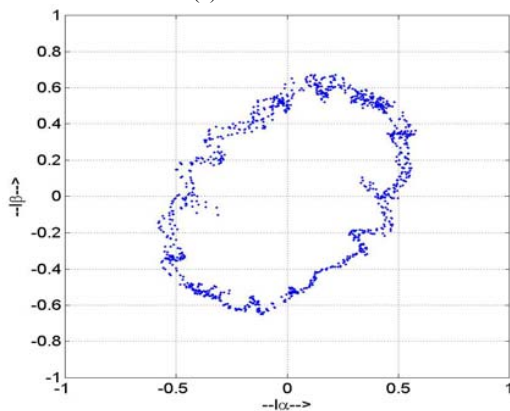
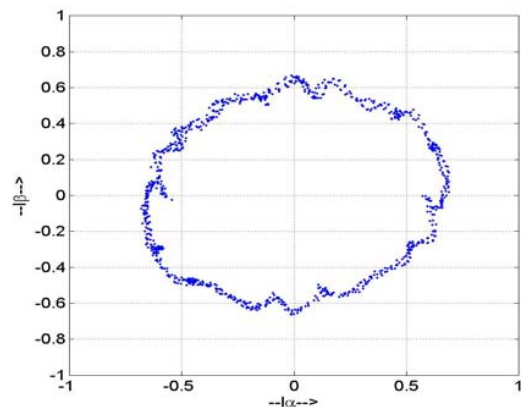
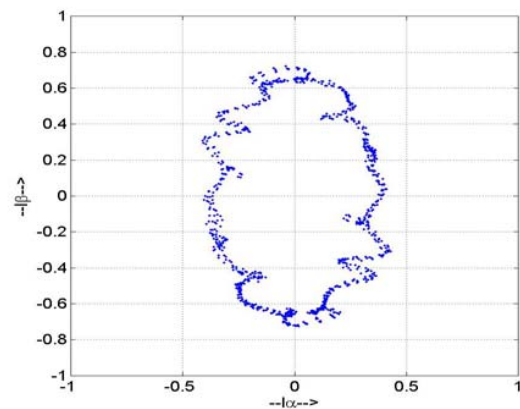
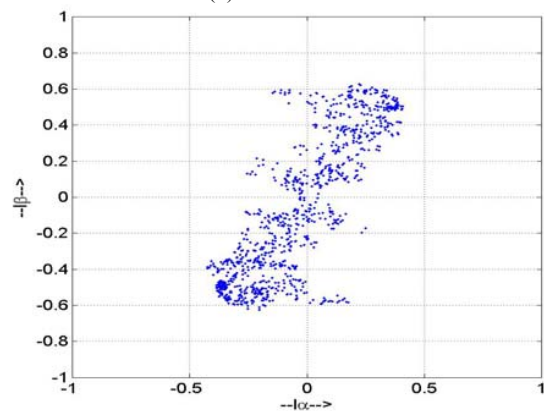
Fig. 6 Concordia patterns for test cases T1-T5 (a-e respectively)

Concordia patterns obtained by plotting α vs. β component currents for test cases T1-T5 are plotted in Fig. 6. α and β axes are plotted in terms of per unit values where the instantaneous values are divided by peak of rated motor line current.

It is clearly evident from the Concordia patterns shown in Fig. 6 that unbalance in capacitor bank drastically changes the shape of the pattern. The amount of distortion of Concordia pattern is largely related to unbalance in the capacitor bank values. Any assessment of the motor internal condition based on these Concordia patterns will thus be anomalous. The extremely distorted Concordia pattern shown in Fig. 6 (e) is attributed to the harmonic prone and completely unbalanced three phase current pattern of T5.
