# Experimental and Numerical Analysis of a Historical Bell Tower

**Abstract**—In this paper, a procedure for the evaluation of seismic behavior of slender masonry structures (towers, bell towers, chimneys, minarets, etc.) is presented. The presented procedure is based on a full three-dimensional modal analyses and frequency measurements. As well-known, masonry is a composite material formed by bricks, or stone blocks, and mortar arranged more or less regularly and adopted for many centuries as structural material. Dynamic actions may represent the major risk of collapse of brickworks, and despite the progress achieved so far in science and mechanics; the assessment of their seismic performance remains a challenging task. Then, reliable physical and numerical models are worthy of recommendation. In this paper, attention is paid to the historical bell tower of the Basilica of Santa Maria Gloriosa dei Frari - usually called Frari - one of the greatest churches in Venice, Italy.

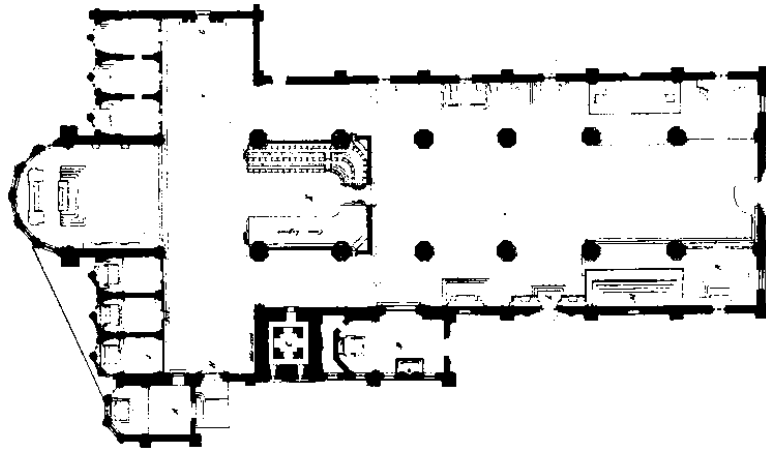
Fig. 1 Frari church, plan

The Latin cross shaped ground plan (Fig. 1) consists of three naves, defined by six pairs of columns and joined by a timber frame system. Its length is 102 m, while the transept is 48 m large. The maximum height is 28 m [7].

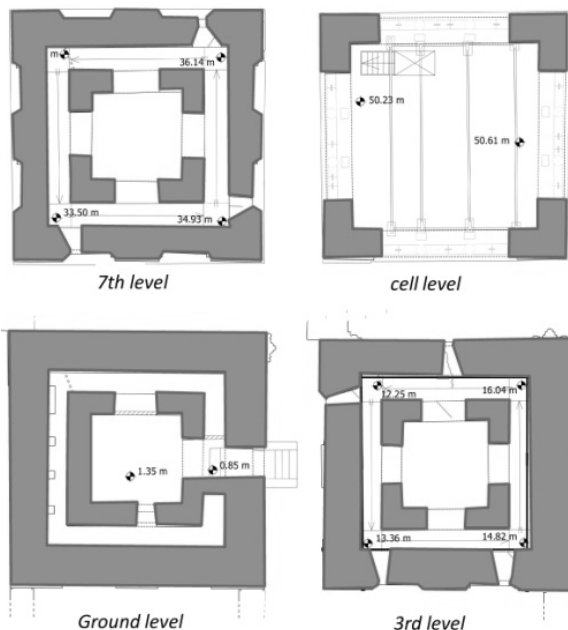
Fig. 3 Frari bell tower, plans

Analyzing the geometry of the bell tower (Fig. 3), the rectangular plan (9.40m x 9.20m) is composed by two concentric walls, joined by the masonry ramp which induces static collaboration between the internal and the external cores. The internal core has more regular geometry than the external one, which is characterized by the presence of asymmetric distribution of the windows and different thickness that decreases with the height. The cores reach a

height of 50.45 m, whereas the last terrace, on top of the belfry, is situated at 56.6 m. Like almost all Venetian bell towers, the Frari also presents a slight inclination in respect to the vertical axes. Considering that the sloping value, in the

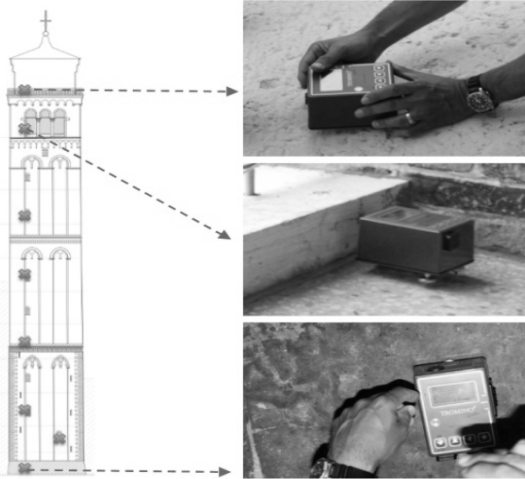
Fig. 4 Tromograph placements

The tromograph placements are recorded in Fig. 4. The instrument was used for non-synchronized measurements at  $f_s = 512$  Hz, for 16 minutes along the vertical profile defined by windows distribution. The first measurement was performed on the ground floor, the second at the belfry terrace, then the others descending from the top of the structure. The complete survey was performed in less than three hours.

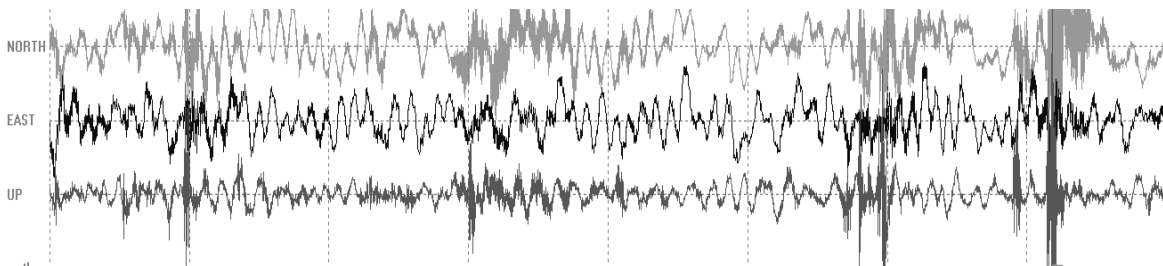
Fig. 5 Velocity propagation intensity

The accelerogram in Fig. 5, reports in abscissa time of recorded ambient vibration, while on the vertical axis represents the velocity propagation intensity. Time series represents the velocimetric components (North, East and vertical direction) recorded by means of the high sensitivity sensors. Successive analyses performed with software Grilla, allowed to calculate the amplitude spectra (Fig. 6).

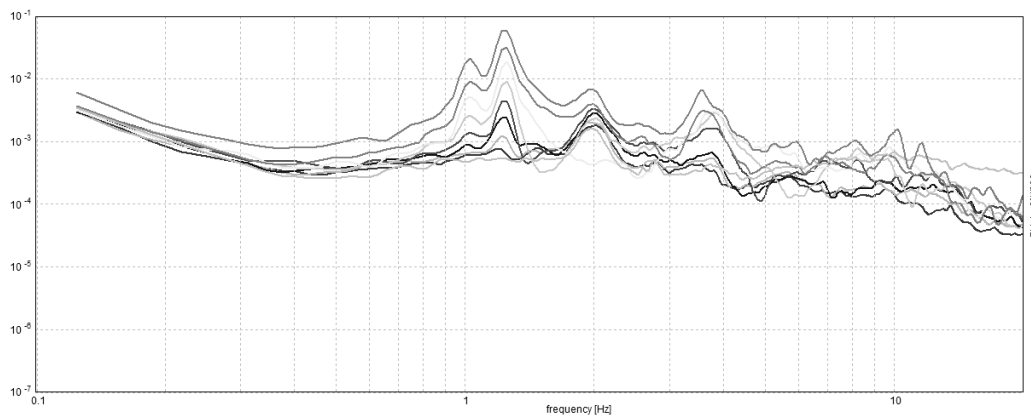
Fig. 6 Amplitude spectra

The fast Fourier transform is performed on the acquisitions at the different levels of the building. Consequently, for each building level the amplitude spectra are derived for each velocimetric component.

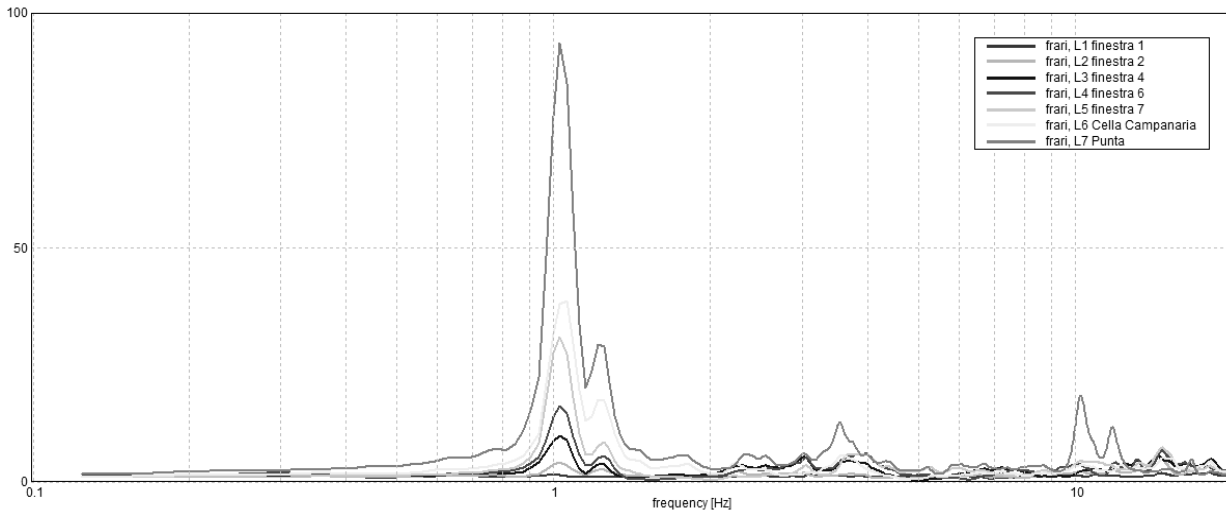
Fig. 7 Frequency peaks

Plotting the ratios of the velocimetric amplitude spectra acquired at the different levels versus the amplitude spectra at the ground level, can be observed that spikes around 1 Hz and 1.25 Hz should represent first and second mode respectively (Fig. 7). This trend should be related to a bi-modal resonance.

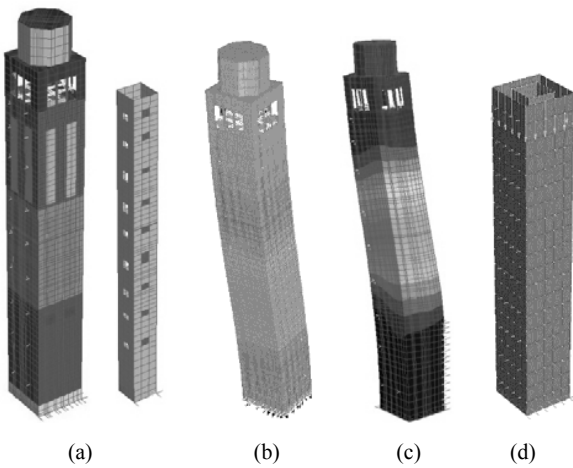
Some considerations about FE modeling of the Frari historical bell tower have been already presented in a previous paper [12]. The research demonstrated that defined model, which takes into account all the geometric irregularities as well as both inner and outer core, is the most suitable for modal analysis. Starting from the modelling consideration, and taking into account recent works that led to the structural separation of the bell tower from the transept, in this research, the attention has been paid on the boundary conditions and seismic behavior of the bell tower. Hence is proposed an FE model (Fig. 8 (a)) with 2 different boundary conditions: i) Model 1, with only base bonded (Fig. 8 (b)); ii) Model 2, with base and part of external core bonded (Fig. 8 (c)).

Fig. 8 FE Model: External and internal core , detailed model (a); 1st modal shape at different boundary conditions (b), (c); Simplified model (d)

In order to study the appropriate disposition and number of links, a simplified model (Fig. 8 (d)) reproducing the external and the internal core has been developed. Then, cores, have been joined to each other following schemes described in Fig. 9. Hence modal analysis has been performed, in order to compare the results obtained from each model (Table II) and to evaluate the percentage error between different schemes (Table III, Fig. 10). For these analyses, the scheme in Fig. 9 (a) was considered as reference.

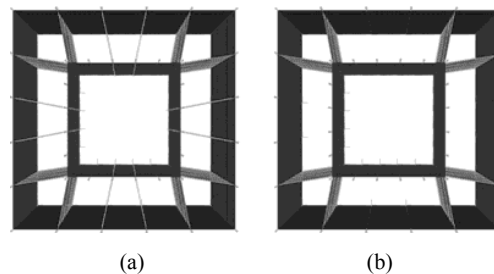
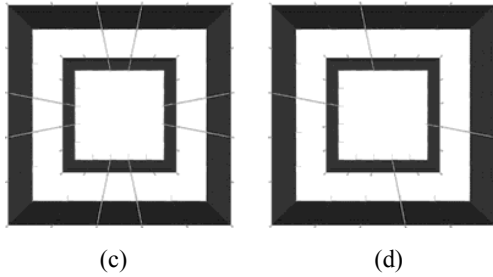
Fig. 9 Link distribution scheme, top view

Link elements have been chosen due the capacity to ensure the structural bond between two cores and distributed connecting each corner node of the inner core with two nodes of the external core (Fig. 9 (b)).

Observing the analyses results, in particular from 1<sup>st</sup> to 7<sup>th</sup> mode, can be outlined that distribution scheme proposed in Fig. 9 (b), departs from the reference value for 1.61%, for the 1<sup>st</sup> and 2<sup>nd</sup> modes, and less than 1% for superior modes. At the same time, schemes proposed in Figs. 9 (c) and (d), recorded variations from minimum 5.22% to, maximum 35.31%, respect to the reference value. This high value is certainly related to the inadequate link distribution that leads to an independent behavior between two cores. For this reason and, in order to reduce the computational burden, has been decided

to apply the scheme proposed in Fig. 9 (b) to the detailed model.

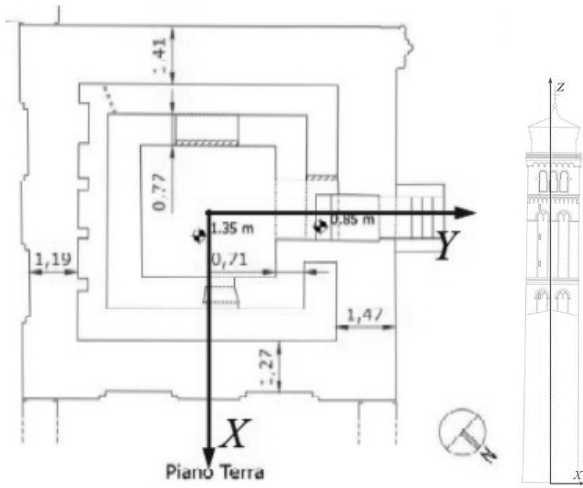
Fig. 11 Modal analysis axes reference

(PFs - Participation Factors) in direction X and Y (Fig. 12) have been evaluated. These values allow to define the main vibration modes and to evaluate the oscillating direction of the model along XY plane. For simplicity, the mass participation in Z axis has been ignored, since the structural behaviour in vertical direction is less significant than the others in plan.

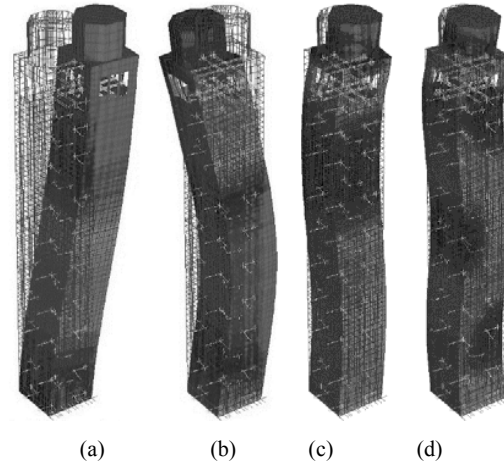
Fig. 12 Modal shapes obtained from Model 1

Table IV collects results of modal analysis carried on model with bonded base (Model 1). It is possible to observe that modes 1-2 have comparable frequencies, as same as the participant mass, even if in reverse directions. The result allows to identify a main vibration mode (Mode I), characterized by a sinusoidal deformation with one half-wave, with frequency equal to 0.8 Hz, which mobilizes the sum of the participant masses obtained for each mode (about 70% of total mass). The same consideration can be done for the modes 3 and 4. Together they constitute a main mode, Mode II, characterized by a sinusoidal deformation with one half-wave (Figs. 12 (b) and 13).

As mentioned before, the bell tower is characterized by a non-exactly symmetry of the cross-section referred to X and Y axes, due the presence of asymmetric openings and the inclination of the structure. This aspect causes a structure oscillation that doesn't occur exactly along the X and Y axes (Figs. 12 (a) and (b)). Analogous consideration are valid also for the modes III and IV (Figs. 12 (c) and (d)), that are constituted respectively by modes 6-7 and 8-9. These modes are characterized by sinusoidal deformation with two half-waves (Fig. 13).

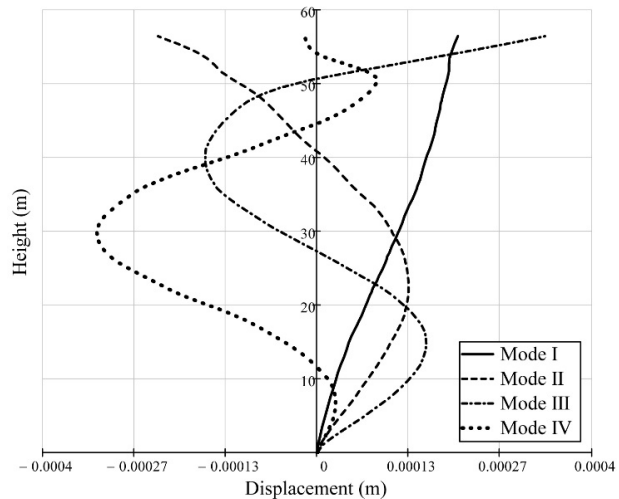
Fig. 13 Displacement evaluation on Model 1

In Fig. 13 is proposed an evaluation of the maximum displacement of the structure due the natural frequencies. From the graph, we can observe that for all main modes, the maximum displacement is lower than 0.4mm.

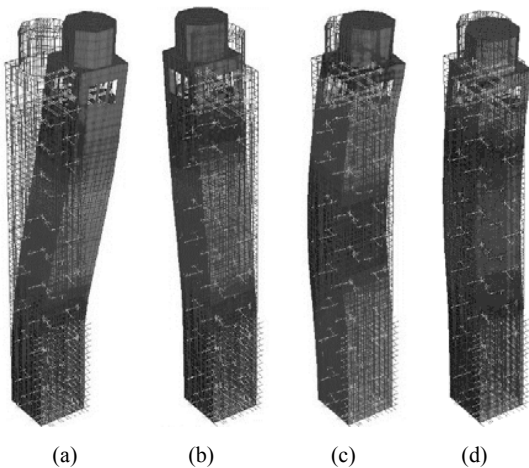
Fig. 14 Modal shapes obtained from Model 2

vibration mode, Mode I (Fig. 14 (a)), characterized by a sinusoidal deformation with one half-wave, with frequency equal to 1.03 Hz, which mobilizes the sum of the participant masses obtained for each mode (about 55% of total mass). In this case, due the boundary conditions the participant masses don't report same values in opposite directions.

Considering the geometric irregularities, cited before, and the boundary conditions imposed on the base and on the external core, can be observed a structure oscillation that does not occur exactly along the X and Y axes, like in the previous case (Fig. 14). Moreover, as reported in Fig. 15, for all main modes the displacement and oscillations start from an approximate quote of 10m, due the presence of St. Peter's chapel walls. This aspect provokes a maximum oscillation of the structure that reaches the displacement of 1mm.
