# High-Temperature Corrosion of Weldment of Fe-2%Mn-0.5%Si Steel in N<sub>2</sub>/H<sub>2</sub>O/H<sub>2</sub>S-Mixed Gas

Sang Hwan Bak, Min Jung Kim, Dong Bok Lee

**Abstract**—Fe-2%Mn-0.5%Si-0.2C steel was welded and corroded at 600, 700 and 800°C for 20 h in 1 atm of N<sub>2</sub>/H<sub>2</sub>S/H<sub>2</sub>O-mixed gas in order to characterize the high-temperature corrosion behavior of the welded joint. Corrosion proceeded fast and almost linearly. It increased with an increase in the corrosion temperature. H<sub>2</sub>S formed FeS owing to sulfur released from H<sub>2</sub>S. The scales were fragile and nonadherent.

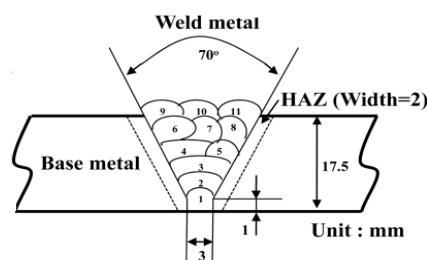
Fig. 1 Cross-section of the steel weld

An eleven-pass welded Fe-2%Mn-0.5%Si-0.2C steel pipe was tested in this study. The mechanical property and welding condition are listed in Tables I and II, respectively. The cross-section and the multi-pass welded pipe are shown in Figs. 1 and 2, respectively. The groove for welding was machined in a V-type. The thickness was 17.5 mm and the inner diameter of the pipe was 272 mm. The first and second passes were welded by gas tungsten arc welding (GTAW) and the other nine passes were welded by shielded metal arc welding (SMAW).

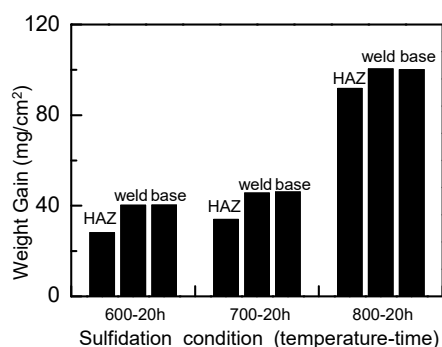
Fig. 3 Sulfidation kinetics of base, weld, and HAZ of Fe-2%Mn-0.5%Si-0.2%C steel after corrosion at 600, 700 and 800°C for 20 h in H<sub>2</sub>S/H<sub>2</sub>O/N<sub>2</sub> gas

The sulfidation behavior of the weldment of the steel in H<sub>2</sub>S/H<sub>2</sub>O/N<sub>2</sub> atmosphere was examined. Weight gains measured after sulfidation at 600-800°C for 20 h are displayed in Fig. 3. Large weight gains were recorded, indicating vastly fast sulfidation kinetics. The scale failure became more serious

as sulfidation progressed. The sulfidation appeared to follow the linear rate law, implying negligible protection owing to the formation of the FeS scale. Mn and Si could not protect the weldment from serious sulfidation due to their small amount or dissolution in FeS. An increment in the temperature from 600 to 700°C led to the increment of weight gains by about 5 mg/cm<sup>2</sup>. When the temperature increased from 700 to 800°C, weight gain increased by about 2.5 times. However, it is noted that there was uncertainty in weight gains measured, because scales formed in H<sub>2</sub>S-containing atmosphere were usually very thick and highly susceptible to spallation during corrosion and subsequent cooling stage. Nevertheless, it was evident that H<sub>2</sub>O and H<sub>2</sub>S gas increased the corrosion rate. Water vapor transports through voids cavities and cracks in the scale as H<sub>2</sub> (g) and H<sub>2</sub>O (g), and as H atom by dissolving in the lattice, affecting the point defect concentration [2].

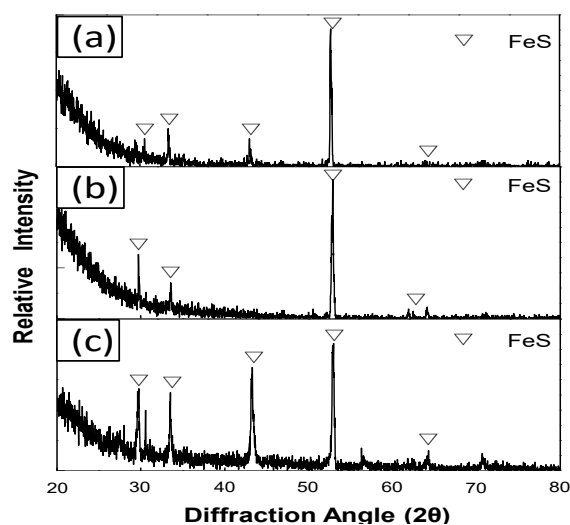
Fig. 4 XRD pattern of Fe-2%Mn-0.5%Si-0.2%C after corrosion at 700°C for 20h in H<sub>2</sub>S/H<sub>2</sub>O/N<sub>2</sub> gas. (a) base, (b) weld, (c) HAZ

Fig. 4 shows the XRD patterns of Fe-2%Mn-0.5%Si-0.2% steel after corrosion at 700°C for 20 h in H<sub>2</sub>S/H<sub>2</sub>O/N<sub>2</sub> gas. All the scales consisted primarily of FeS. H<sub>2</sub>S reacts with Fe according to the following reactions.

The net reaction is  $\text{Fe} + \text{H}_2\text{S} \rightarrow \text{FeS} + \text{H}_2$ . FeS has a very high concentration of cation vacancies so that it grows rapidly by the outward diffusion of Fe<sup>2+</sup> ions [3].

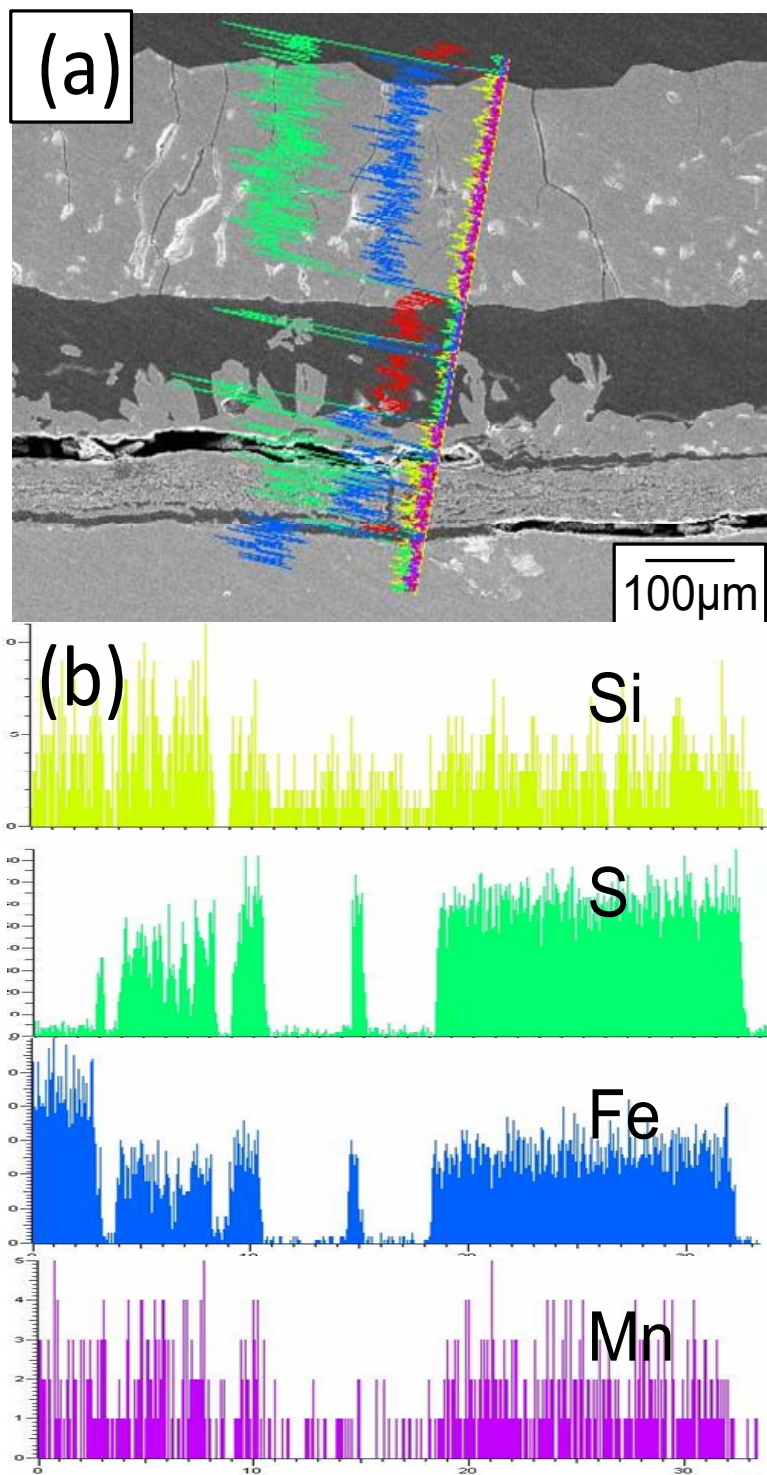
Fig. 5 Base metal of Fe-2%Mn-0.5%Si-0.2%C steel after corrosion at 700°C for 20 h in H<sub>2</sub>S/H<sub>2</sub>O/N<sub>2</sub> gas. (a) SEM cross sectional image, (b) EDS line profiles

Fig. 5 shows the SEM cross sectional image and EDS line profiles of the base metal of Fe-2%Mn-0.5%Si-0.2% after corrosion at 700°C for 20 h in H<sub>2</sub>S/H<sub>2</sub>O/N<sub>2</sub> gas. The outer thick FeS scale detached off, and the inner fragile FeS scale split into a few layers. The scale was ~400 μm thick, implying poor sulfidation resistance. The outer FeS layer had a columnar structure, and the inner FeS layer consisted of fine grains. The inner FeS dissociates according to the reaction:  $\text{FeS} = \text{Fe}^{2+} + 1/2\text{S}_2 + 2\text{e}^-$  [4]. This delivers sulfur gas for the inward growth of the innermost layer, whereas the released Fe<sup>2+</sup> ions and electrons diffuse to the outer surface to form FeS. In the FeS scale, Mn was rather uniformly distributed, while Si was segregated in the inner scale, because Si ions were relatively

immobile owing to the high bonding energy of Si<sup>4+</sup>-O<sup>2-</sup> (465 kJ/mol) [5].

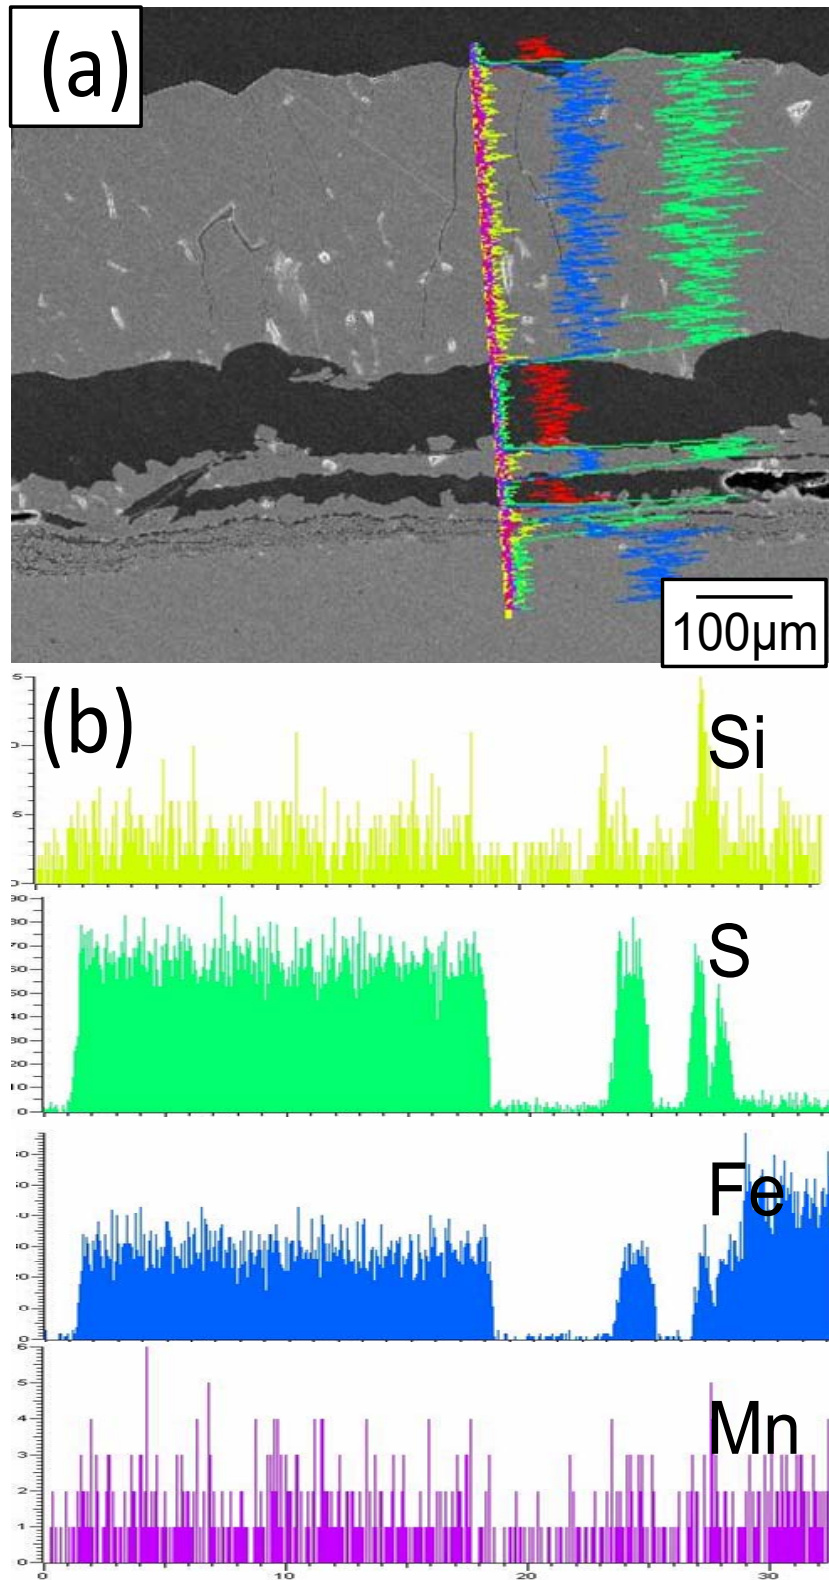
Fig. 6 Weld metal of Fe-2%Mn-0.5%Si-0.2%C steel after corrosion at 700°C for 20 h in H<sub>2</sub>S/H<sub>2</sub>O/N<sub>2</sub> gas. (a) SEM cross sectional image, (b) EDS line profiles

Fig. 6 shows the SEM cross sectional image and EDS line profiles of the weld metal of Fe-2%Mn-0.5%Si-0.2% after corrosion at 700°C for 20 h in H<sub>2</sub>S/H<sub>2</sub>O/N<sub>2</sub> gas. Cracks developed at the bottom of the nonadherent scale, the main cause of which was attributed to the stress developed in the thick oxide scale. Again, Si was segregated in the inner scale, although Mn was distributed rather uniformly throughout the whole scale.

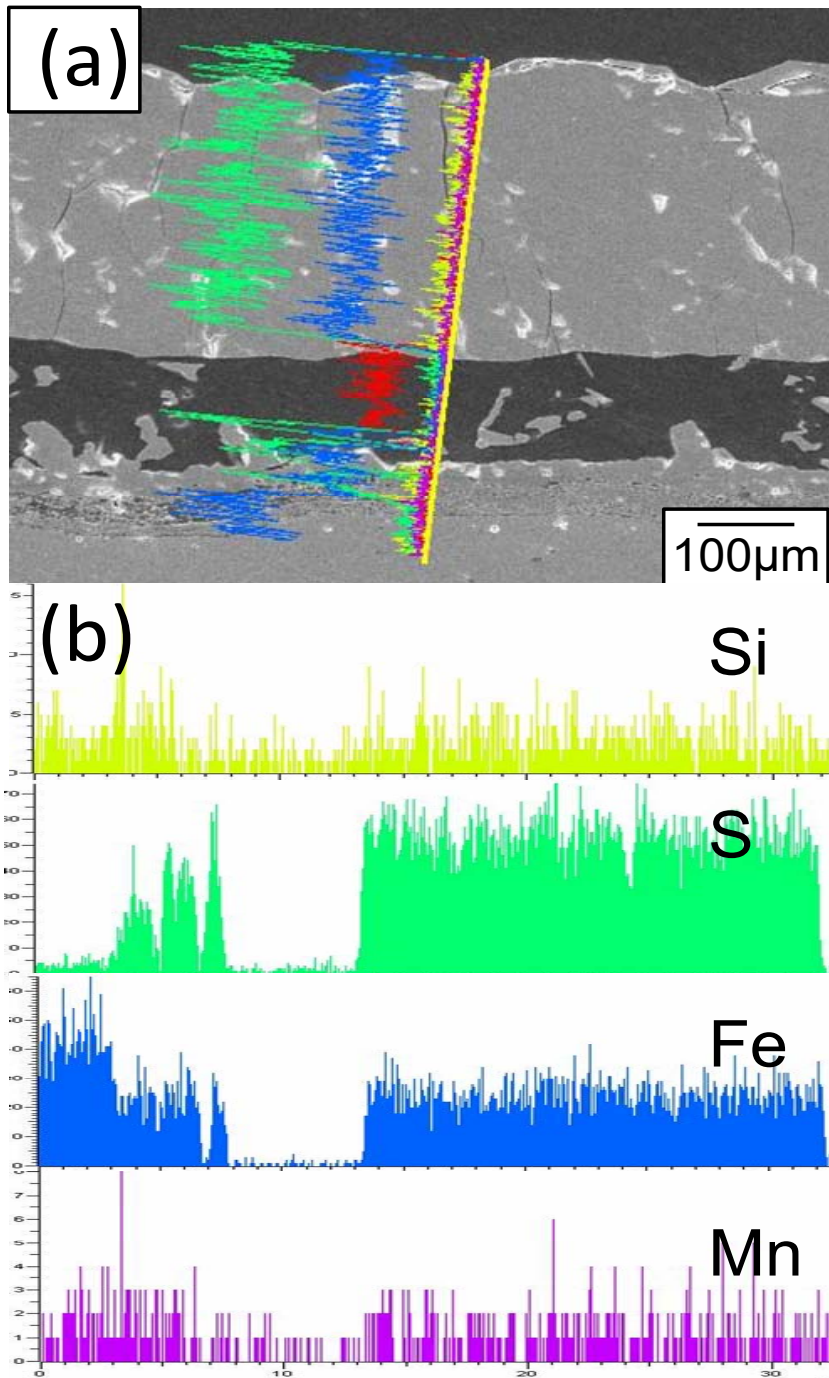
Fig. 7 HAZ metal of Fe-2%Mn-0.5%Si-0.2%C steel after corrosion at 700°C for 20 h in H<sub>2</sub>S/H<sub>2</sub>O/N<sub>2</sub> gas. (a) SEM cross sectional image, (b) EDS line profiles

Fig. 7 shows the SEM cross sectional image and EDS line profiles of the heat affect zone (HAZ) of Fe-2%Mn-0.5%Si-0.2% after corrosion at 700°C for 20 h in H<sub>2</sub>S/H<sub>2</sub>O/N<sub>2</sub> gas. The scale morphology and elemental distribution were similar with those shown in Figs. 5 and 6, because the principal sulfidation mode was the same in H<sub>2</sub>S/H<sub>2</sub>O/N<sub>2</sub> atmosphere.

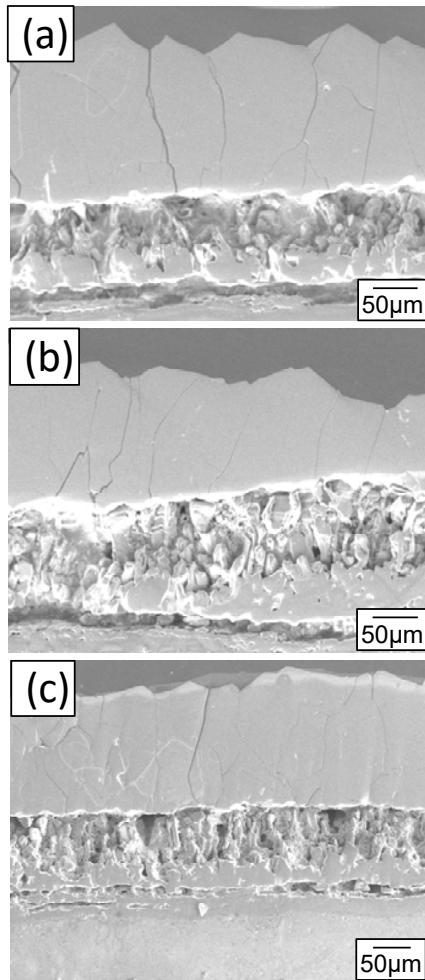
Fig. 8 SEM cross sectional image of Fe-2%Mn-0.5%Si-0.2%C steel after corrosion at 800°C for 20 h in H<sub>2</sub>S/H<sub>2</sub>O/N<sub>2</sub> gas. (a) base, (b) weld, (c) HAZ

Fig. 8 shows the SEM cross sectional image of Fe-2%Mn-0.5%Si-0.2% after corrosion at 800°C for 20 h in H<sub>2</sub>S/H<sub>2</sub>O/N<sub>2</sub> gas. The scale thickness increased with an increase in the temperature. Especially, the scale thickness of the base metal increased more rapidly than those of the welding and heat affect zone (HAZ). The outer FeS grains kept growing outwardly, as Fe continuously diffused out from the matrix via the pre-formed FeS grains. The outer scale was thicker than the inner scale. The outer fast-growing FeS grains were susceptible to cracking, and detached off from the inner mixed scale, owing to the large compressive stress developed. The scales were quite thick, brittle, cracked and detached easily. Mn and Si were incorporated in the FeS scale. The outer scales were formed by the outward transport of predominantly Fe and a small amount of Mn and Si, whereas the inner scales were formed by the inward diffusion of predominantly sulfur along cracks and interconnected pores that developed particularly around the interface of the outer and inner scale.

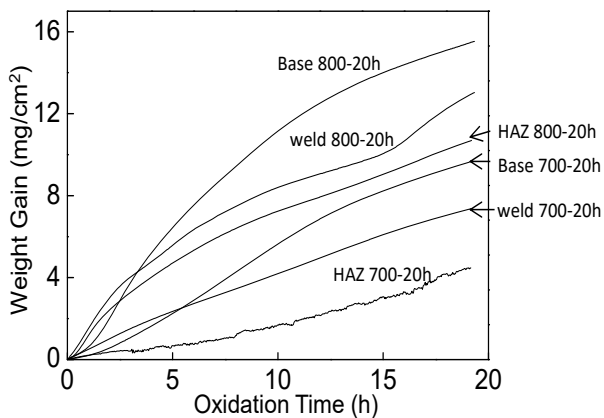
Fig. 9 Oxidation kinetics of base, weld, and HAZ of Fe-2%Mn-0.5%Si-0.2%C steel at 700 and 800°C in air

Fig. 9 shows the oxidation kinetics of the steel in air at 700 and 800°C for 20 h. Compared with sulfidation, the oxidation weight gains were much smaller. The base metal was the least

oxidation resistant. The weld metal was more oxidation resistant. HAZ was the most oxidation resistant, indicating that welding can change the oxidation resistance.
