Hydrophobic Characteristics of EPDM Composite Insulators in Simulated Arid Desert Environment

Yasin Khan

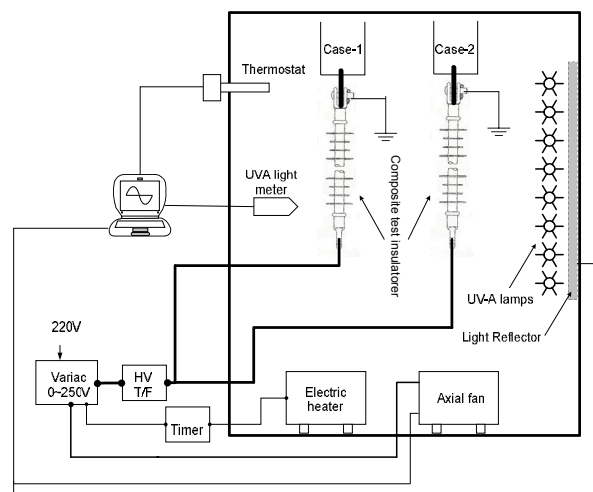
Fig. 2 Schematic diagram of accelerated aging cycle chamber

The actual UV-A radiations level and temperature variations in central region of Saudi Arabia is quite higher as compared to the values recommended in the IEC std. 61109 [9]-[10]. To simulate the ambient conditions of arid desert, a wooden chamber was fabricated for the accelerated aging process for the EPDM test composite insulators. Schematic diagram of the chamber with suspension insulators and other accessories in place is shown in Fig. 2. Based on the above discussion, two types of experimental conditions were created in the accelerated aging test chamber for the tested insulator by applying different stresses mentioned in Table 1, i.e.:

Case 2: Modified aging cycle based on the actual UV-A radiations level (40 W m^{-2}) as shown in Fig. 2.

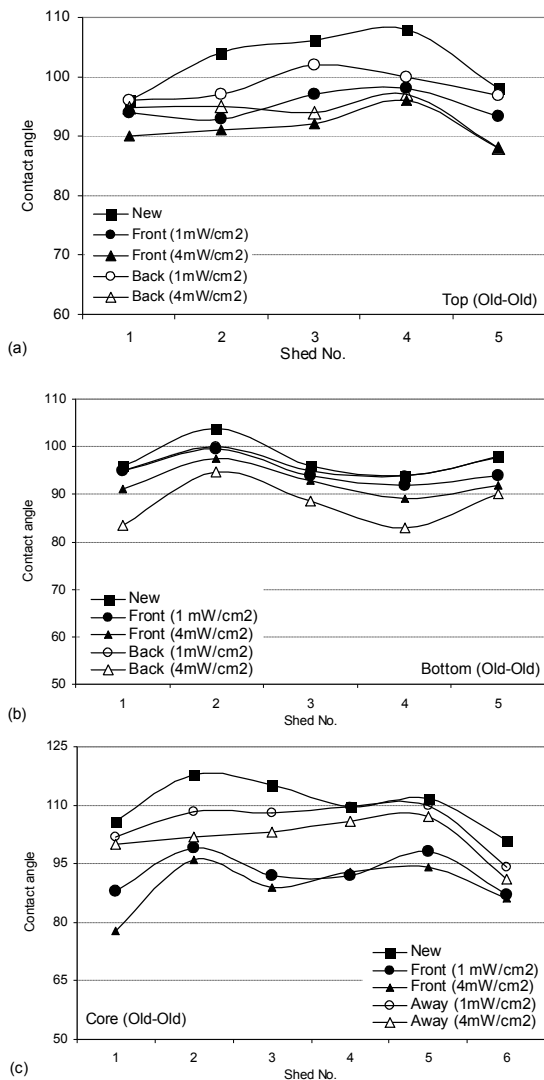
Fig. 6 Contact angle characteristics along the insulator sheds for old-old aged (a) Top (Position A, Fig. 5) (b) Bottom (Position B, Fig. 5) (c) Core (Position C, Fig. 5)

Fig. 6 compare the shed-wise top, bottom and core contact angle measurement results of front to back side for the old-old aged under UV radiations intensity of 1mW/cm² and 4mW/cm². Comparison of these figures clearly shows that contact angle for new (virgin) insulator is highest as compared to old aged insulators. Furthermore, it is also observed that the contact angle of aged insulator under UV radiation intensity of 1 mW/cm² is higher as compared to aged insulator under UV radiation intensity of 4mW/cm². It is also found that the part of the insulator facing the UV radiations have lower contact angle as compared to the back side of the tested insulator. Similarly, higher UV radiation intensity deteriorated the insulator surface more [9] and causes less contact angle as compared to lower UV radiation intensity thus the insulator shows a more hydrophilic behavior under higher UV radiation intensity.

The contact angle measured on both the front as well as back sides of the insulator were also measured and shown in Fig. (6) & (7). The contact angle measured was smaller on the front side as compared to the back side of the aged insulator. This shows that the front side of aged insulator was more hydrophilic as compared to the back side which suggests that natural environment plays an important role in the aging process. The variation in contact angle between the front and back face is several degrees. The greatest difference between the front and back is seen on the core in the center of the insulator length, may be due to enhanced electrical activity in this region.
