# Identifying Karst Pattern to Prevent Bell Spring from Being Submerged in Daryan Dam Reservoir

**Abstract**—The large karstic Bell spring with a discharge ranging between 250 and 5300 lit/ sec is one of the most important springs of Kermanshah Province. This spring supplies drinking water of Nodsheh City and its surrounding villages. The spring is located in the reservoir of Daryan Dam and its mouth would be submerged after impounding under a water column of about 110 m height. This paper has aimed to render an account of the karstification pattern around the spring under consideration with the intention of preventing Bell Spring from being submerged in Daryan Dam Reservoir. The studies comprise engineering geology and hydrogeology investigations. Some geotechnical activities included in these studies include geophysical studies, drilling, excavation of exploratory gallery and shaft and diving. The results depict that Bell is a single-conduit siphon spring with 4 m diameter and 85 m height that 32 m of the conduit is located below the spring outlet. To survive the spring, it was decided to plug the outlet and convey the water to upper elevations under the natural pressure of the

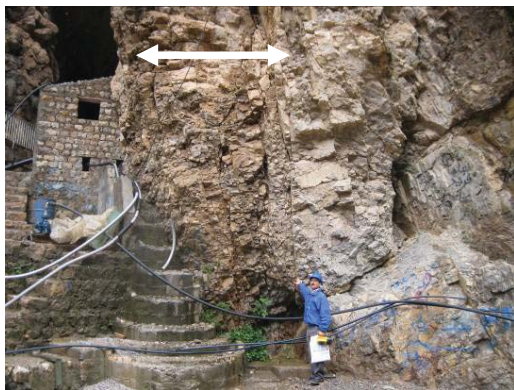
Fig. 5 Fractured zone of CBF

The spring outlet has been formed along this strike-slip fault. The fault dip is between 75 to 80 degrees and its dip direction is NE Fig. 4 (a). The fracture zone width of CBF around the spring is about 7 m (Fig. 5).

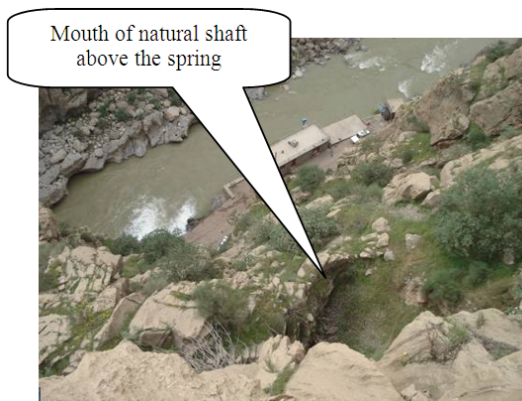
Fig. 6 Mouth of natural shaft before removing the infilling materials

An about 4 m diameter shaft with the height of about 52 m is another karstic feature around Bell Spring. The shaft was filled by angular materials (Fig. 6). After removing the materials, it was realized that the shaft is actually the remains of the old siphon conduit of the spring which has dried as a results of the formation of new outlets at lower levels (Fig. 7). The shaft is located in the intersection of CBF and F7. The shaft outlet is located at el. 770 masl.

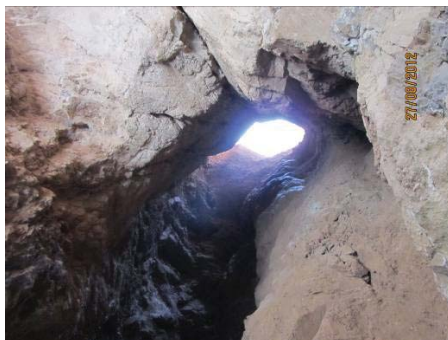
Fig. 7 Natural shaft after removing the infilling materials

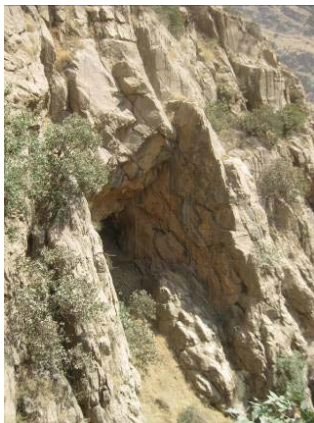
Fig. 8 Old spring conduit

The old outlet of the spring is located in about 28.5 m above the bottom of the present spring outlet at el. 746 masl (Fig. 8). After removing the materials via excavating G3 Gallery (Fig. 9), it was realized that the old conduit is a branch of the natural and vertical conduit of the spring or the natural shaft.

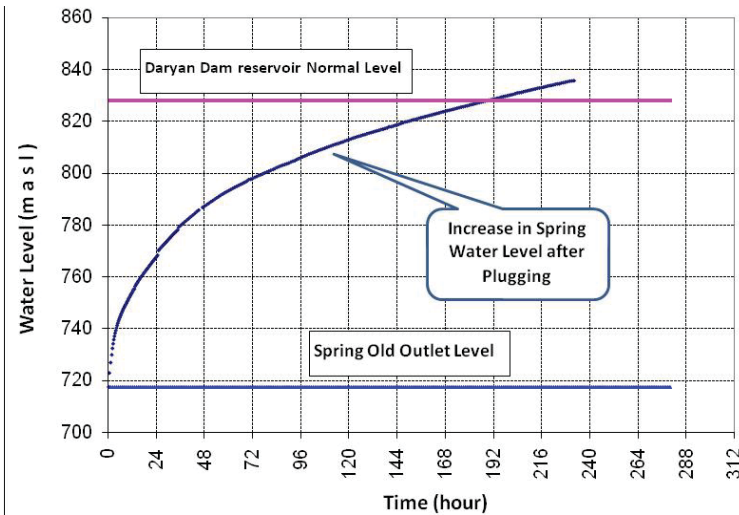
Fig. 10 Rate of Spring Raise after Plugging

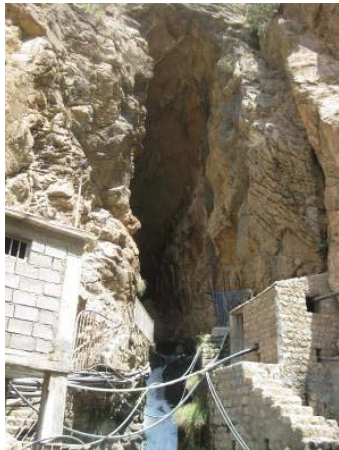
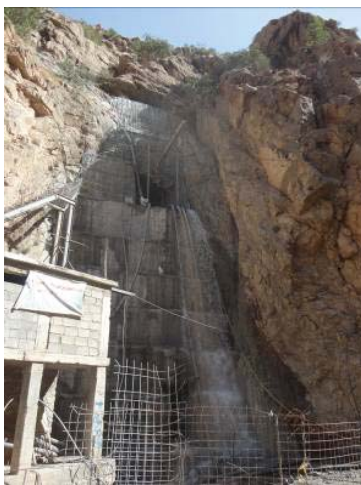
(a) Before plugging

(b) After plugging

Fig. 11 Natural outlet and plugging of the spring

The surface and sub-surface investigations depicted that Bell is a single-conduit siphonal spring (at least for 150 m distance to the spring outlet). Hence, it was decided to study on the alternative of water abstraction from karstic conduits in a distance not so far away from the spring outlet. This is one of the methods approved as for abstracting water from the karstic springs all around the world. The low permeable surrounding rocks of the conduit gave rise to the study on plugging the spring and conveying water to the upper levels under the pressure of the aquifer. In this plan, the siphon was plugged just from the shaft constructed at BH-24 location toward the spring outlet (Figs. 9 (b) or 11 (b)).

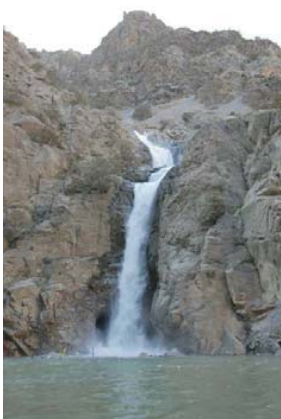
(a)

Fig. 12 A new waterfall beside the reservoir from 120 m above the natural outlet without pumping and water spilling out of the conveyance shaft

In addition, all natural and artificial cavities including the natural shaft and old conduits connected to the shaft, exploratory boreholes drilled towards the siphonal conduit and the access galleries were plugged to leave no connection between the dam lake and the siphonal conduit. So as to manage the water outside the reservoir, a 135 m long gallery was excavated at el. 720 masl and a 100 m high shaft was constructed to discharge water from el. 837 masl (Fig. 9 (b)). In order to assess the efficiency of the proposed plan, the valves installed on the spring outlet pipes were closed to measure the spring water pressure and rising rate of water in the pipes. As per the graph presented in Fig. 10, after 10 days, the water pressure reached 12 bars and the water spilled out of the shaft which its portal level is 8 m above the normal level of the dam lake (el. 837 masl) with no pumping. Fig. 12 depicts the new fall of Bell Spring beside Daryan Dam Reservoir after plugging (in a height about 120 m above the old spring outlet).
